2018 Sonar Scan and Water / Sediment Testing Results for Lake Peekskill

**Prepared for:
Town of Putnam Valley
265 Oscawana Lake Road
Putnam Valley, NY 10579**

**Prepared by:
Clean-Flo International LLC
827 Lincoln Avenue
West Chester, PA 19380**

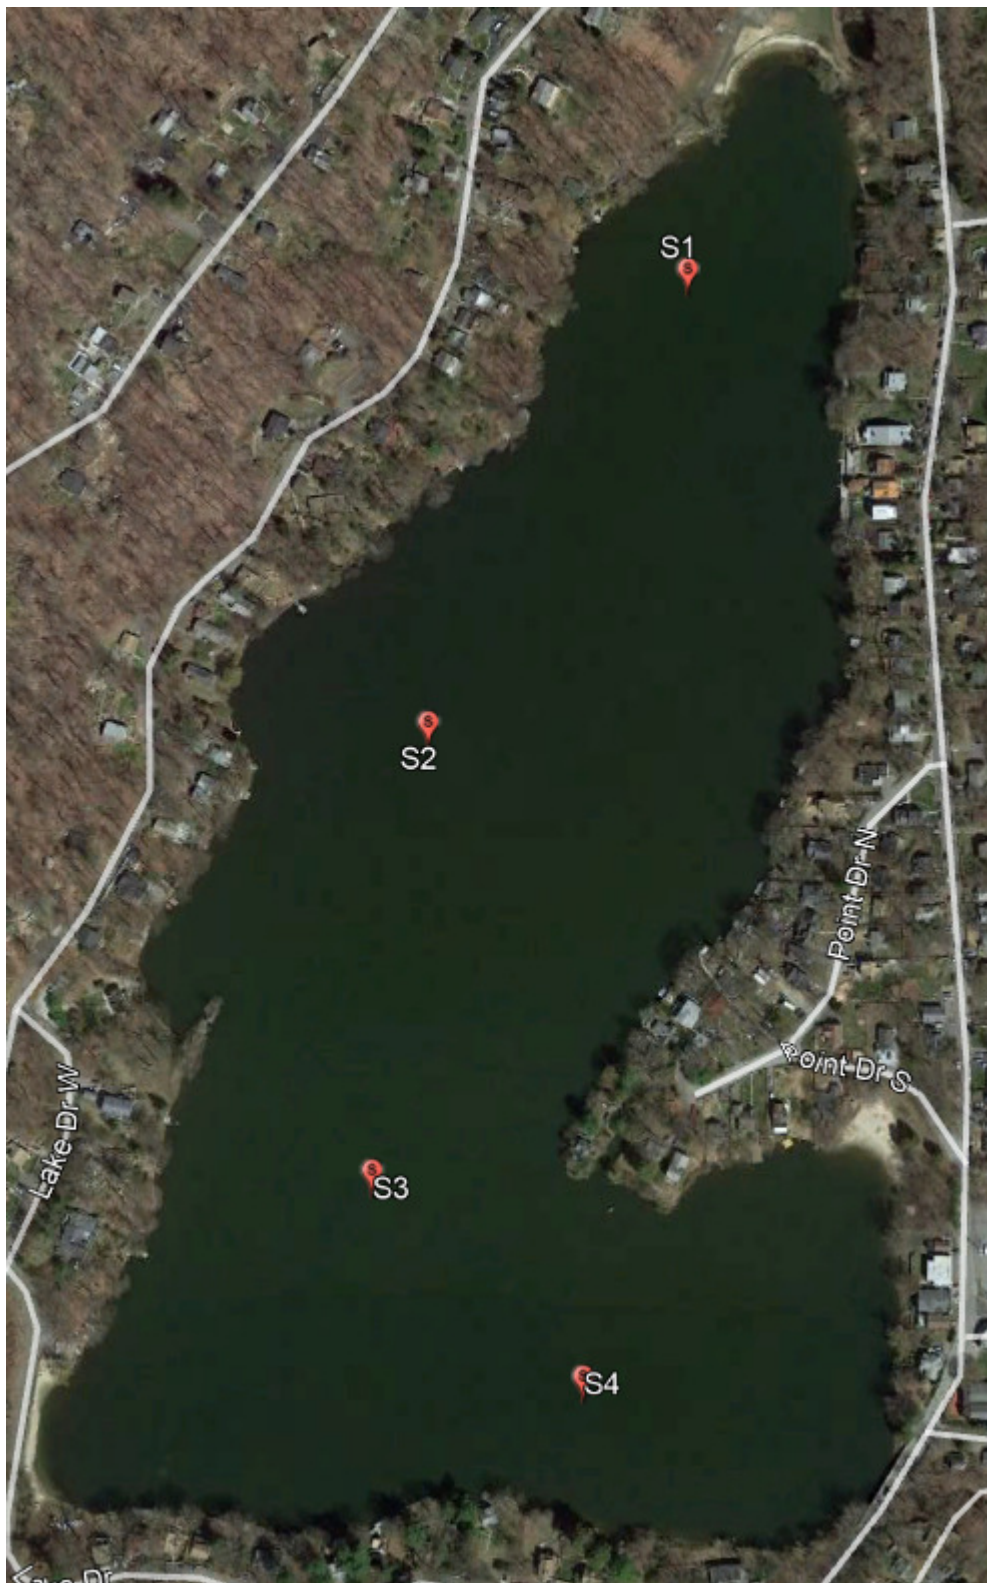
Figure 1 – Sampling locations on Lake Peekskill

Water samples were taken 4 times during 2018. These samples were taken on May 5th during system installation, June 20th during system start-up, August 23rd after the system was running about 2 months and October 22nd which was about 4 months after start-up. These samples were analyzed for dissolved oxygen, total phosphorus, ortho phosphorus and algal community. All samples were taken in 4 locations with the exception of algal community which was only

taken in 3 locations per the contract. Sediment samples were taken twice, at system start-up and on October 22nd.

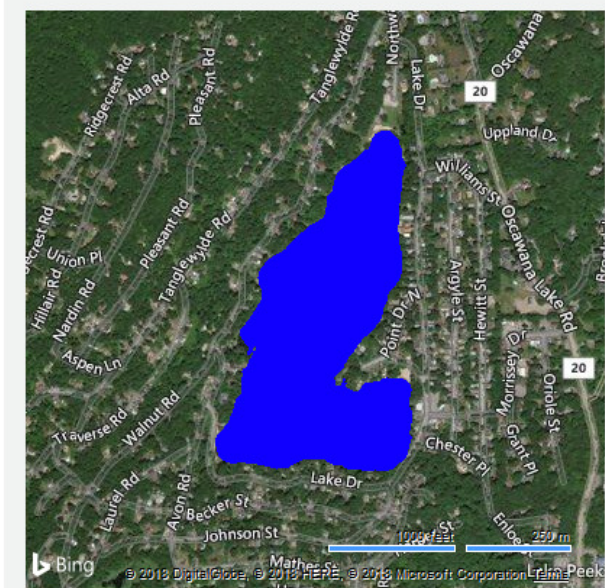
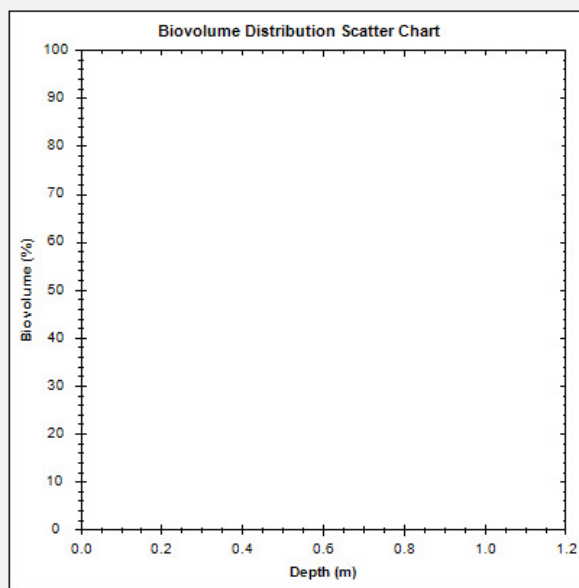
Vegetation Biovolume 4/24/18 – The vegetation biovolume details are shown below. The vegetation biovolume map shows areas of vegetation and density of the vegetation. The measurement scale shows that red is the highest density of biovolume followed by yellow, green and then blue. At the time of the scan in April 2018 there was no vegetation detected in the lake.

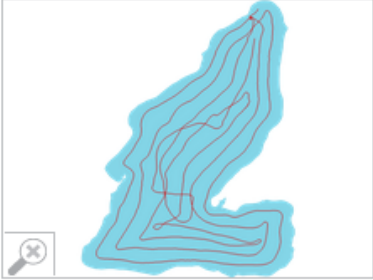
Scan Details 4/24/18 – Additional details of the scan are shown below. The Clean-Flo process targets the reduction of organic sediments and associated nutrients to reduce nuisance plant and algal growth. Biobase calculates the volume of water at the time of the scan. The volume of water in April 2018 was estimated at 724.23 acre-feet of water. Based on the lake size of 60.11 acres, the average depth was 12.05 feet.

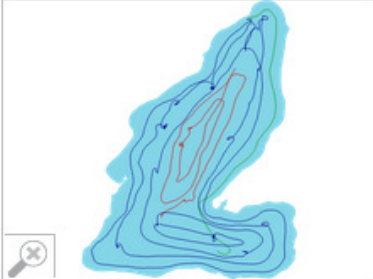
Scan Details 10/22/18 – The scan details below show the volume of water in October 2018 is 754.97 acre-feet. That is an increase in water volume of 30.74 acre-feet or 10,016,673 gallons of water. The increase in water volume due to reduction of the organic sediments has increased the average depth from 12.05 feet to 12.56 feet.
