# TOWN OF PUTNAM VALLEY

## Town Board Meeting

# Report Outline

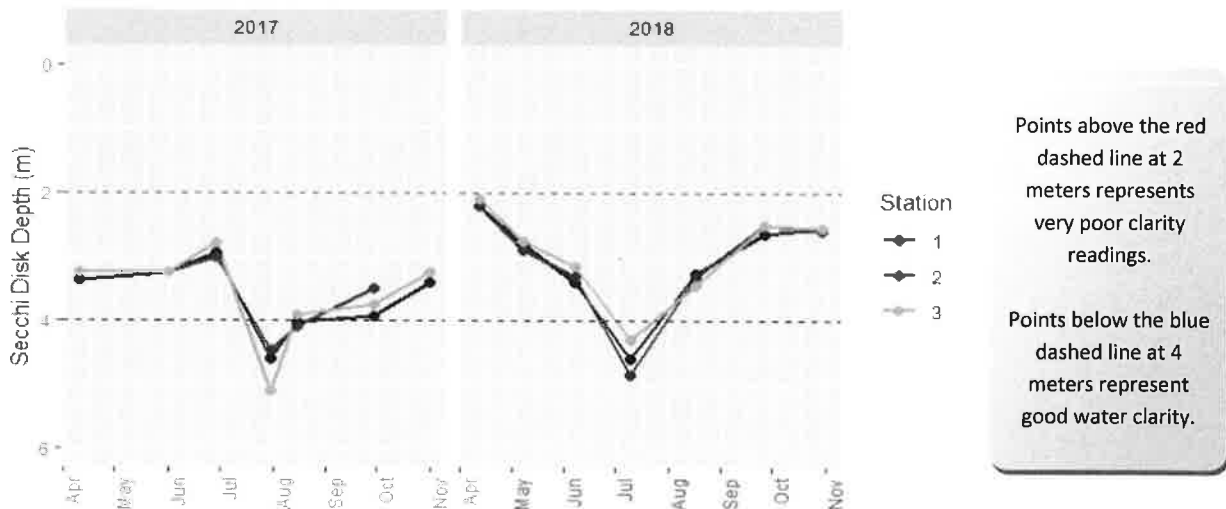
Figure 1: 2017 & 2018 Seasonal Variability in Water Clarity

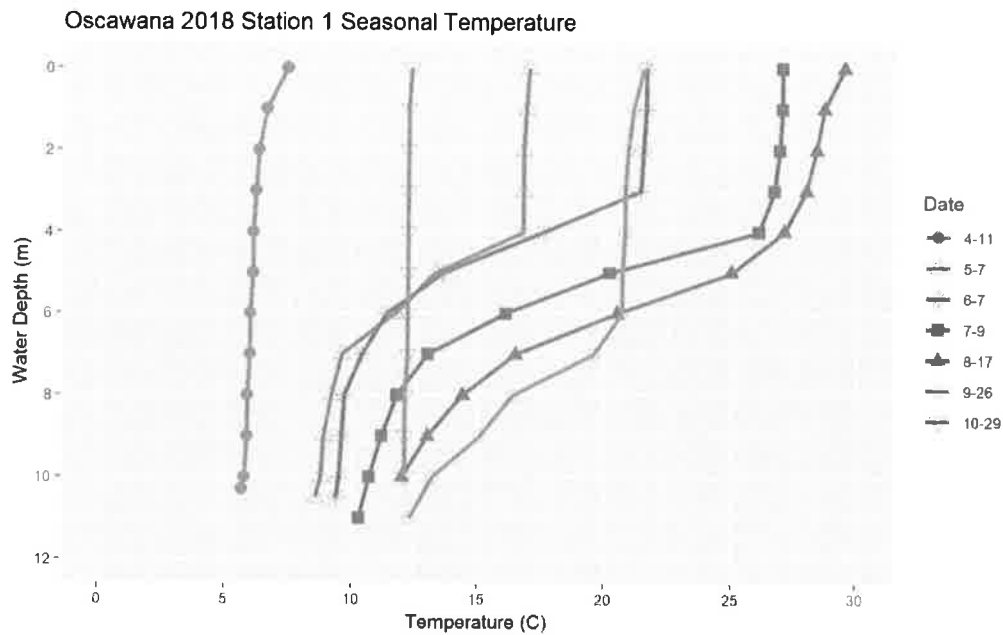
Monthly temperature profiles (Figure 2) indicate fully mixed conditions in April but strongly stratified conditions by early May, lasting through the end of September. The late October temperature profile was once again uniform from top to bottom during fall fully mixed conditions. The thermocline was very strong from mid-May and began to erode by mid-September. Temperature profiles at Stations 2 and 3 followed similar trends. There was no indication of storm-induced deep-water mixing, and the thermocline range appears to extend all the way to 9 meters in summer months. The resistance to mixing (RTRM) is highest at around 4 to 5 meters at all stations, which should have prevented bottom-phosphorus from reaching the surface before fall turnover.

Figure 2: Station 1 Temperature Profiles 2018

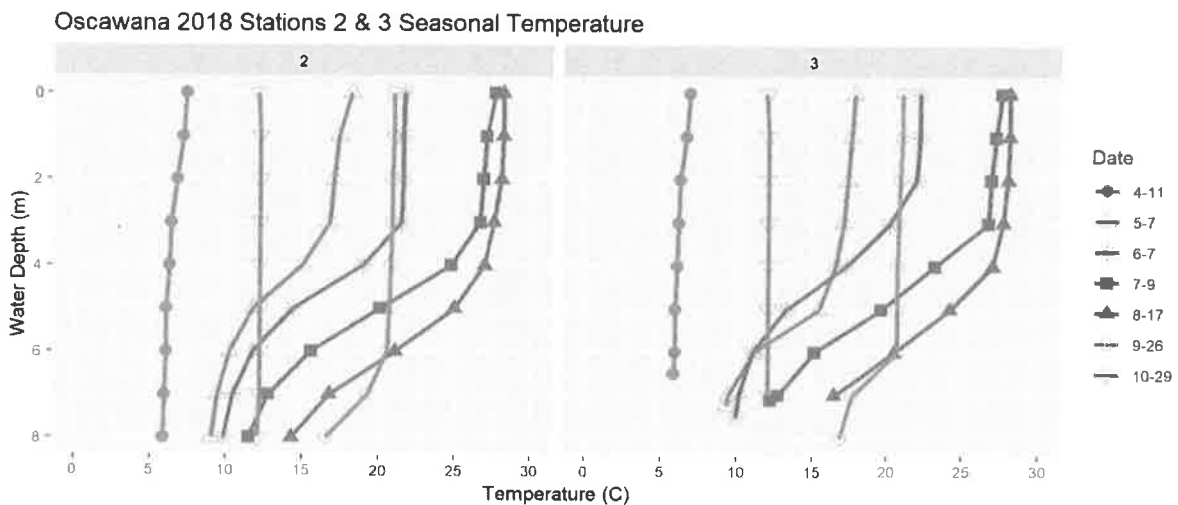
Figure 3: Stations 2 & 3 Temperature Profiles 2018

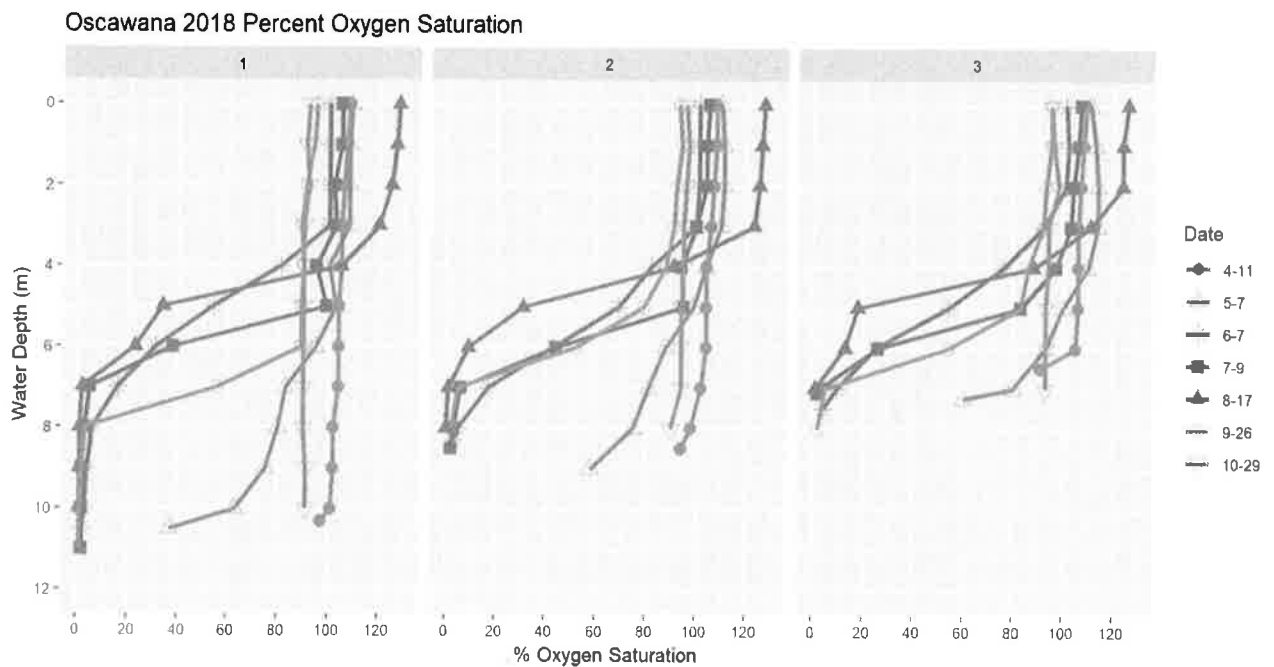
The monthly profile measurements were similar to other years, but there was much more oxygen on May 7, 2018 than there was on the May 31st sampling date in 2017. Comparing the annual rate of dissolved oxygen loss is a way to measure improvements or decline in overall water quality through the years. Dissolved oxygen was the primary parameter in the initial development of "trophic" categories back in the 1930s, before knowledge of limiting nutrients became commonplace. The May visits in 2017 and 2018 demonstrate the severe loss of oxygen in bottom waters that occurs annually almost entirely in the month of May. The rapid rate of oxygen loss points towards an enormous sediment oxygen demand that is unlikely to be overcome with aeration or bottom-water oxygenation. This fact is one of the reasons why we have not recommended aeration as a feasible lake restoration technique. Another important thing to note is that the surface waters were supersaturated with oxygen in August. Supersaturation is notable because greater than 100% saturation is indicative of excessive phytoplankton production in the water column.

Figure 4: 2018 Percent Oxygen Saturation Profiles At Station 1, 2, & 3

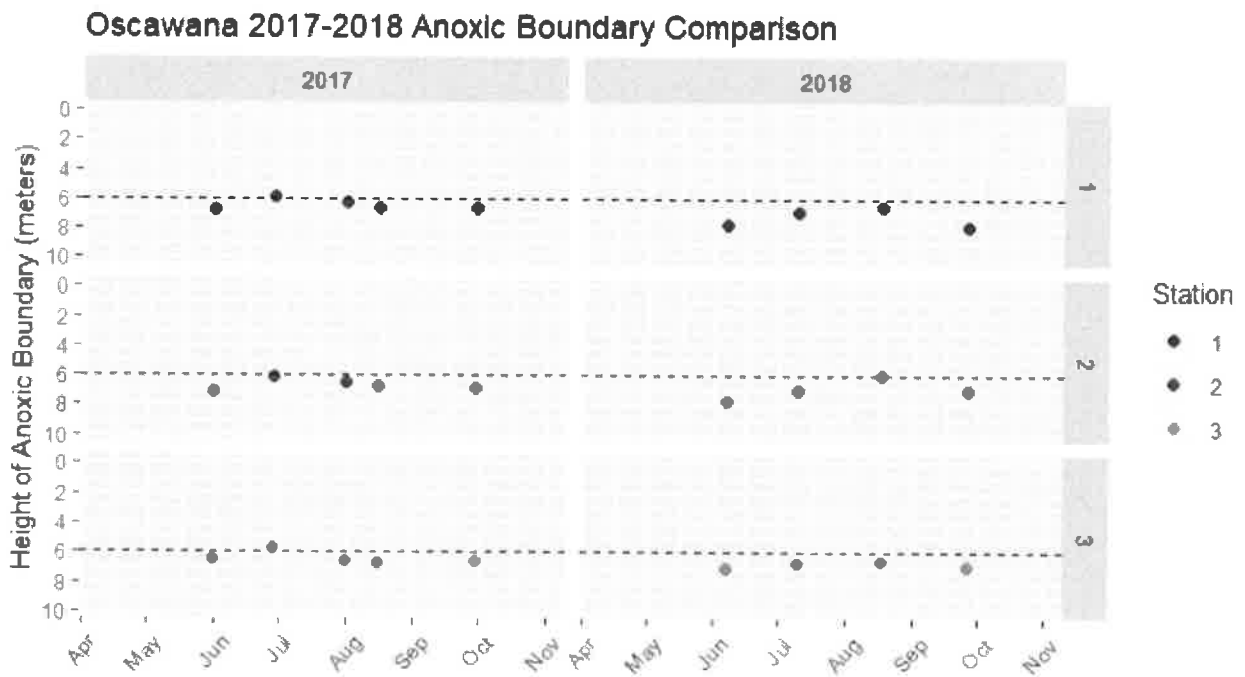
Figure 5 compares the 2017 and 2018 anoxic boundaries at all three stations. Overall, there is no major change in the maximum height of the anoxic boundary. Since data collection began in the 1990s, the anoxic boundary annual maximum has hovered around 6 meters, which is indicated with a horizontal dashed line. In previous years, we had hypothesized that the height of the anoxic boundary at Stations 2 and 3 played an important role in the migration of bottom-water nutrients to the surface, fueling algae blooms because the thermal stratification at these two shallower stations was not as strong as at Station 1. Weaker thermal stratification at the two shallower stations could theoretically allow more bottom-water phosphorus to be mixed into the surface waters during periods of anoxia. However, the 2017 and 2018 dissolved oxygen profiles indicate that relatively good water clarity is possible in summer months despite anoxic water and associated internal loading of nutrients. This relationship will be tracked into the future.

Figure 5: Anoxic Boundary 2017-2018

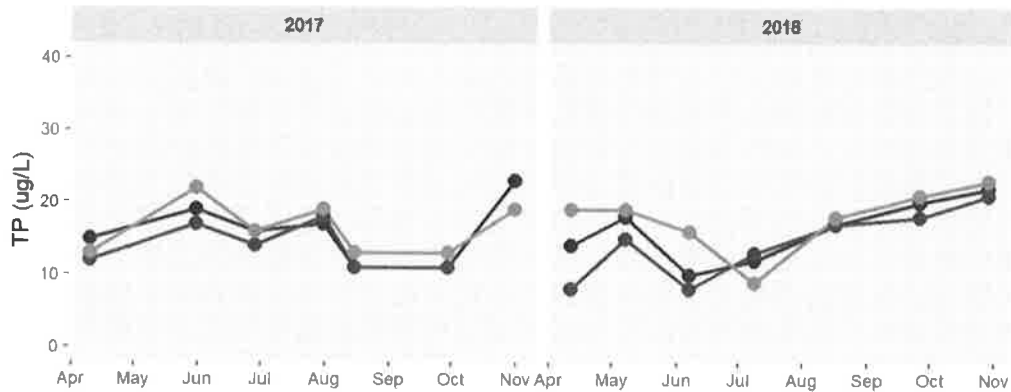
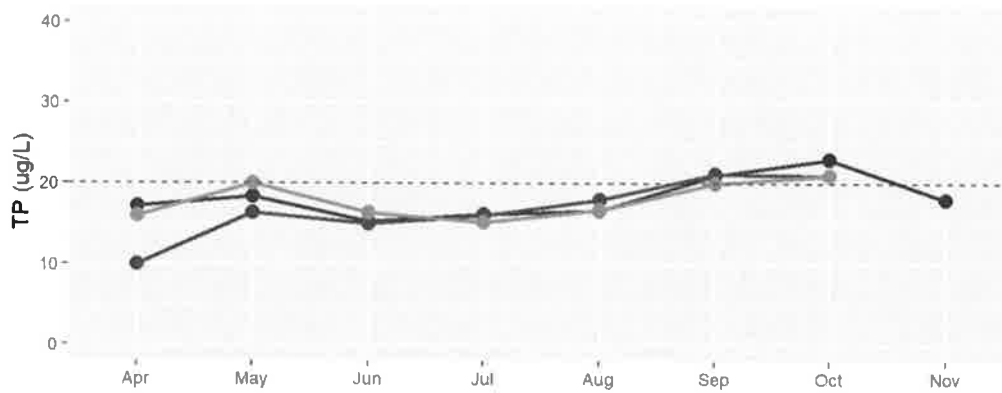
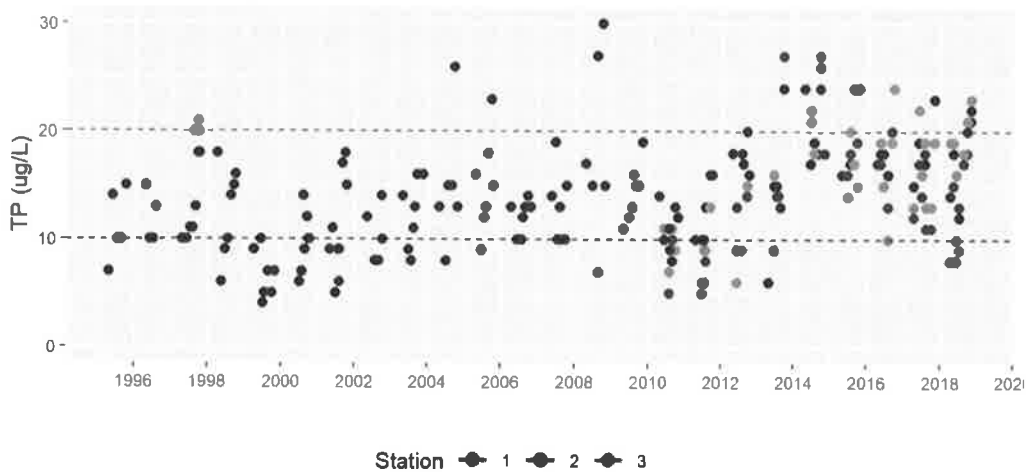
**6A Oscawana 2017 & 2018 Seasonal Surface (1-meter) Total Phosphorus**

**6B Five Year Monthly Average Surface (1m) Total Phosphorus**

**6C Oscawana Long Term Surface (1m) Total Phosphorus**

**Figure 6: Surface Total Phosphorus- (A) 2017-2018, (B) Compared to Five Year Average\*, (C) Long-Term Trend**

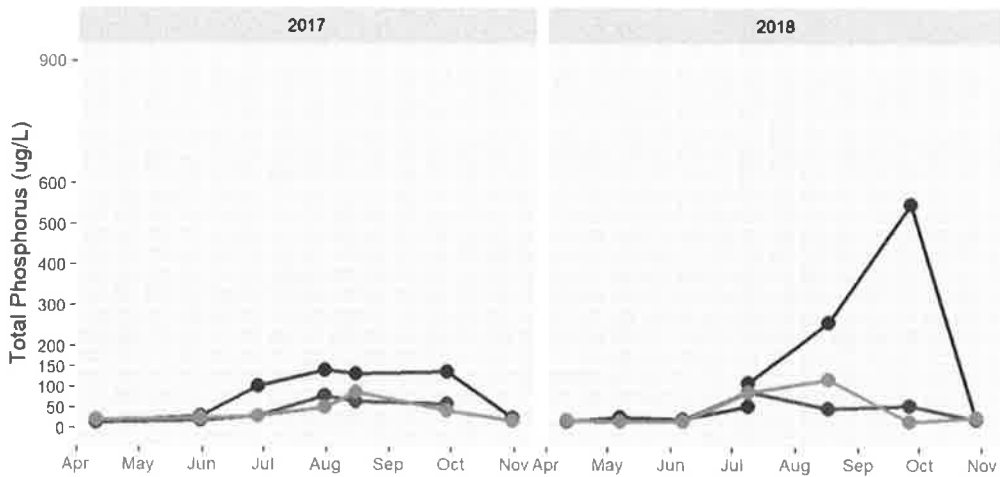
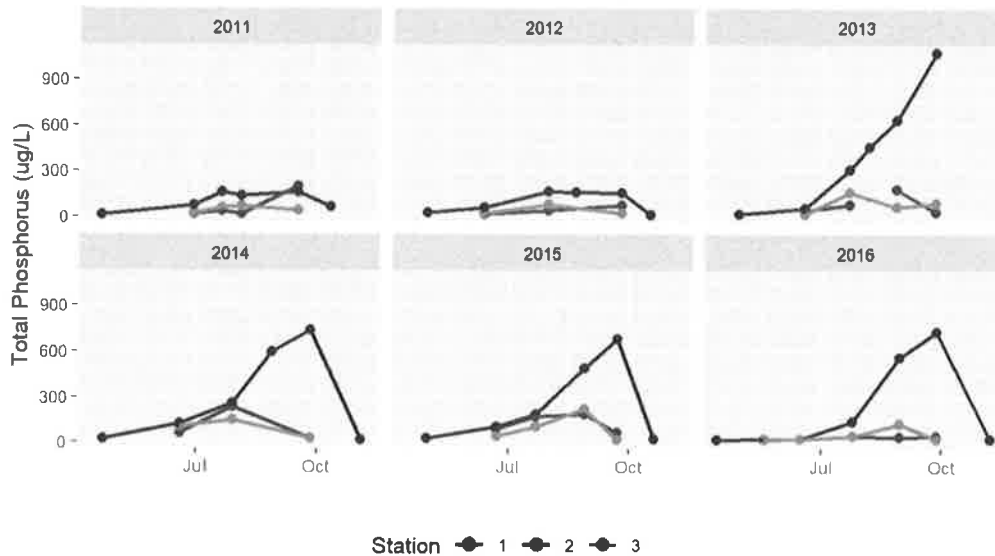
**7A Oscawana 2017 & 2018 Bottom Total Phosphorus**

**7B Comparison: 2011-2016 Bottom-Water Phosphorus**

**Figure 7: Trends in Seasonal Bottom Water Phosphorus (A) 2017-2018 & (B) 2011-2016**

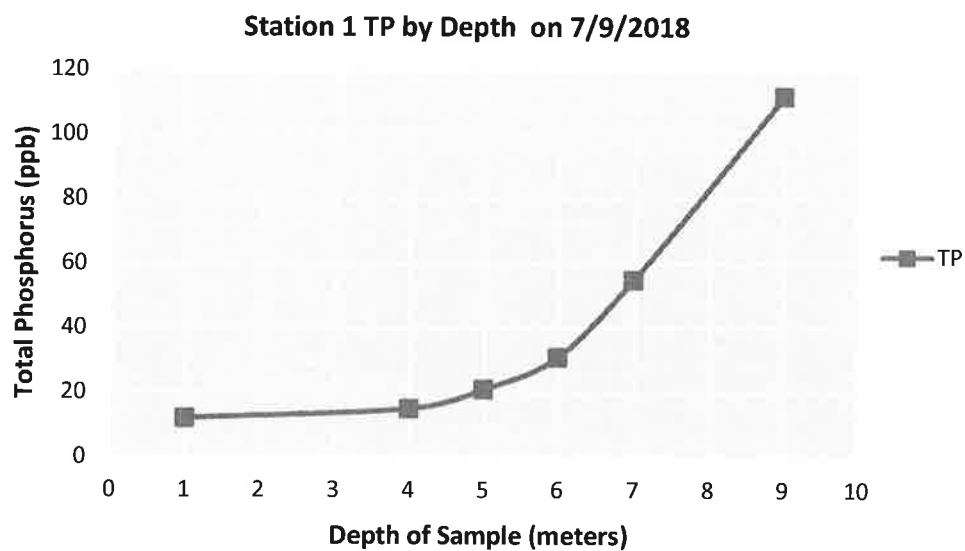
On July 9th, 2018 two extra samples were taken at Station 1, at 5 and 7-meters deep. The purpose of the extra samples was to measure the TP gradient from surface to bottom as another way to assess the impact of bottom water internal phosphorus loading on surface waters. Scientific literature suggests that a linear increase from bottom to surface waters indicates nutrient entrainment from bottom to surface. Yet the trend in July was more exponential than linear, suggesting that the thermocline effectively limited phosphorus at the bottom of Station 1 from migrating to surface waters. As expected, the trend is linear below 6-meters, which is the depth of the thermocline on the July sampling date. With reference to the seasonal increase in surface (1m) TP during the 2018 season, this vertical trend in summer TP demonstrates that surface increases are not entirely a result of internal loading phosphorus accumulation. Other sources of phosphorus, related to weed harvesting and watershed loading, also contribute to summer surface increases.

**Figure 8: Total Phosphorus Extra Depths (July 9, 2018)**

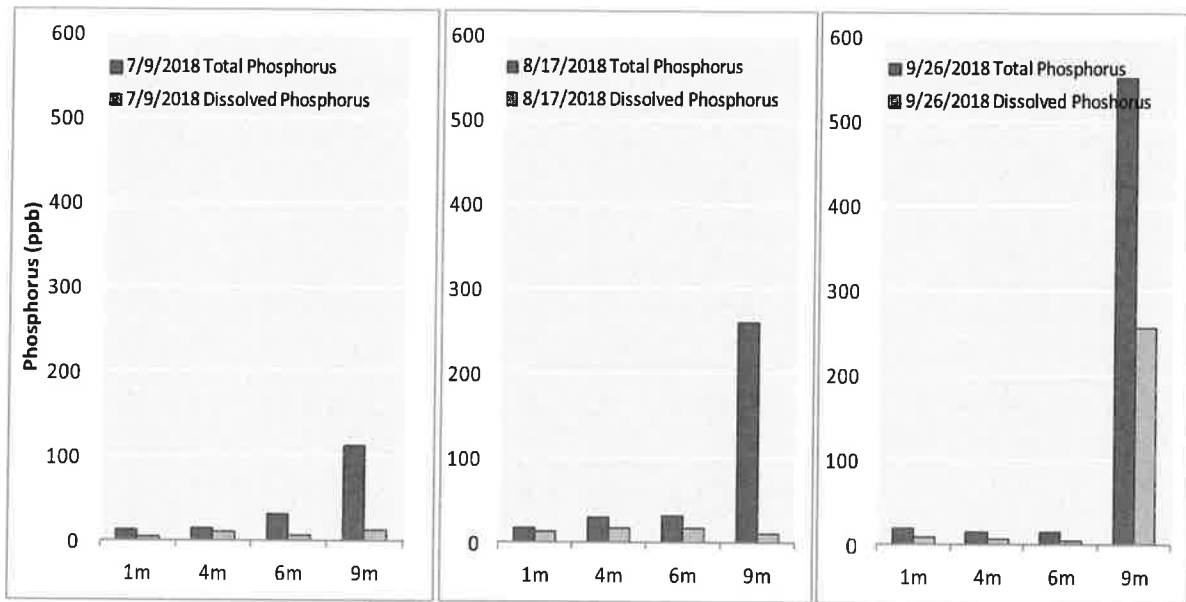
In order to better understand phosphorus in the water column, we also tested summer samples for dissolved phosphorus, which is a fraction of the total phosphorus that is small enough to pass through a 0.45 micron filter. Dissolved phosphorus is typically very close to the amount of ortho-phosphorus, or readily available phosphorus that algae can use immediately for growth. In a bottom-water internal loading situation, one can expect the dissolved phosphorus to increase at about the same rate as the total phosphorus. Dissolved phosphorus will usually make up a large fraction of the total phosphorus in the bottom-waters. However, that was not the case at Oscawana in 2018 (Figure 9). The 2018 season was the first year of testing dissolved phosphorus in bottom waters, so unfortunately there is no historical data for comparison.

**Figure 9: Dissolved Phosphorus of the Total July-September 2018**

Figure 9 demonstrates that the increasing amount of bottom-water phosphorus is comprised of very little dissolved phosphorus through mid-August despite anoxic conditions and apparent release of dissolved P since early June. It isn't until late September when the true internal loading of dissolved phosphorus at 9 meters is seen. Even then, dissolved phosphorus constitutes less than half of the total. Again, this information will become critical in tracking potentially reduced internal loading with new weed management techniques designed to reduce sediment disturbances and particle re-suspension.

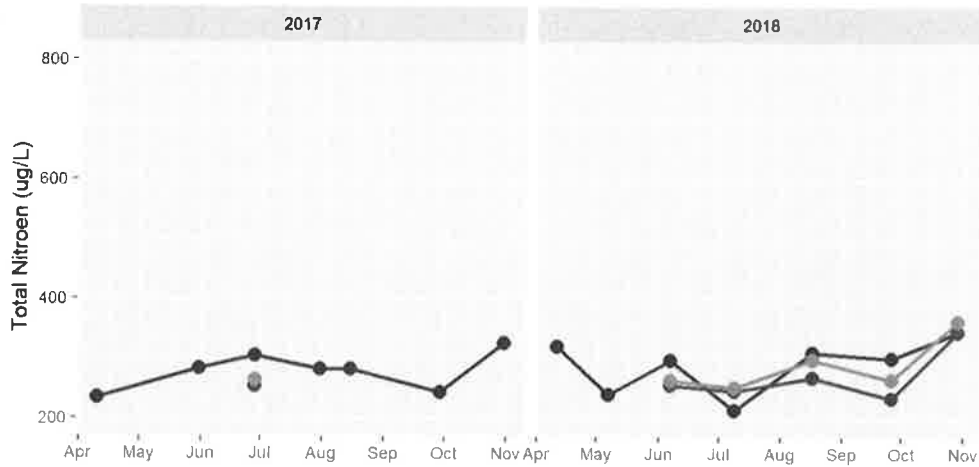
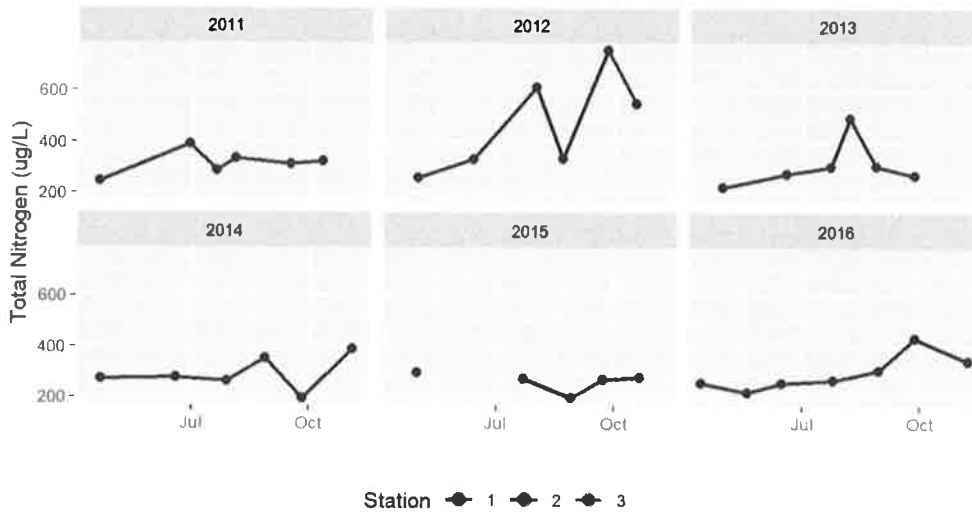
**10A** Oscawana 2017 & 2018 Surface Total Nitrogen

**10B** Comparison: 2011-2016 Surface Total Nitrogen

Note: No Consistent Surface TN data for St. 2 & 3 Prior to 2018

Figure 10: Surface Total Nitrogen 2017-2018 (A) and 2011-2016 (B)

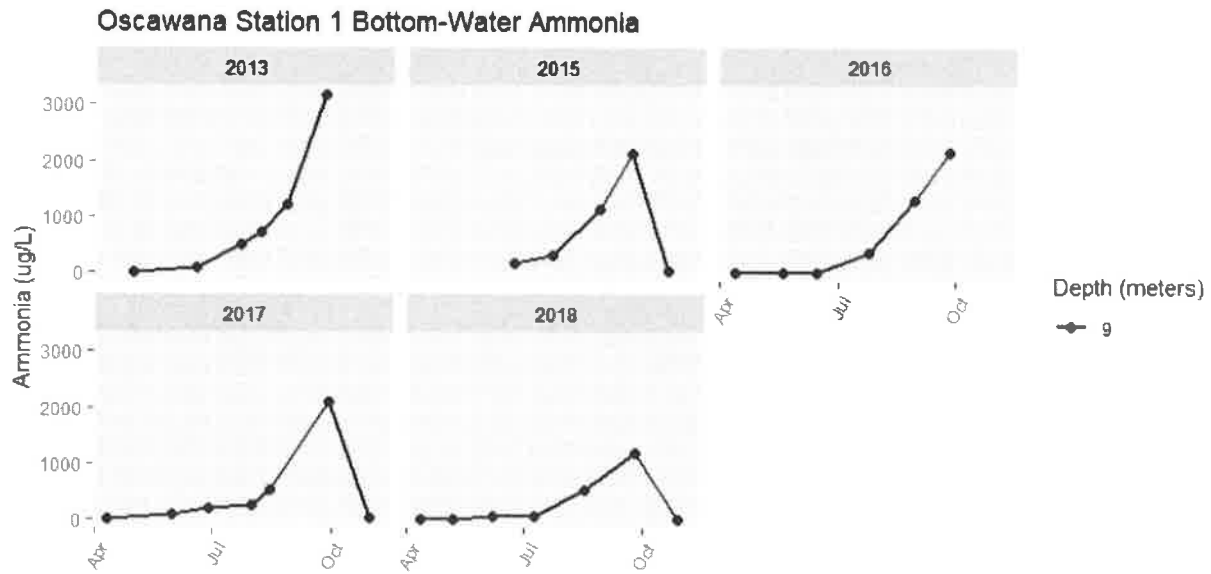
**Figure 11: Bottom-Water Ammonia Accumulation at Station 1 (2013-2018)**

Ammonia nitrogen was tested only on bottom-water samples from Station 1. There is no ammonia nitrogen data from 2014. Ammonia released from the anoxic bottom sediments in 2018 was similar to recent years, drastically increasing over the course of the summer. In comparing the surface TN to bottom-water ammonia in 2018, it is evident that the fall turnover caused an increase in surface nitrogen as bottom-water ammonia was mixed into the epilimnion late in the season. Yet as previously mentioned, surface ammonia nitrogen trends appear more externally driven and not wholly related to the bottom-water ammonia accumulations, which again suggests external sources of nutrient pollution.

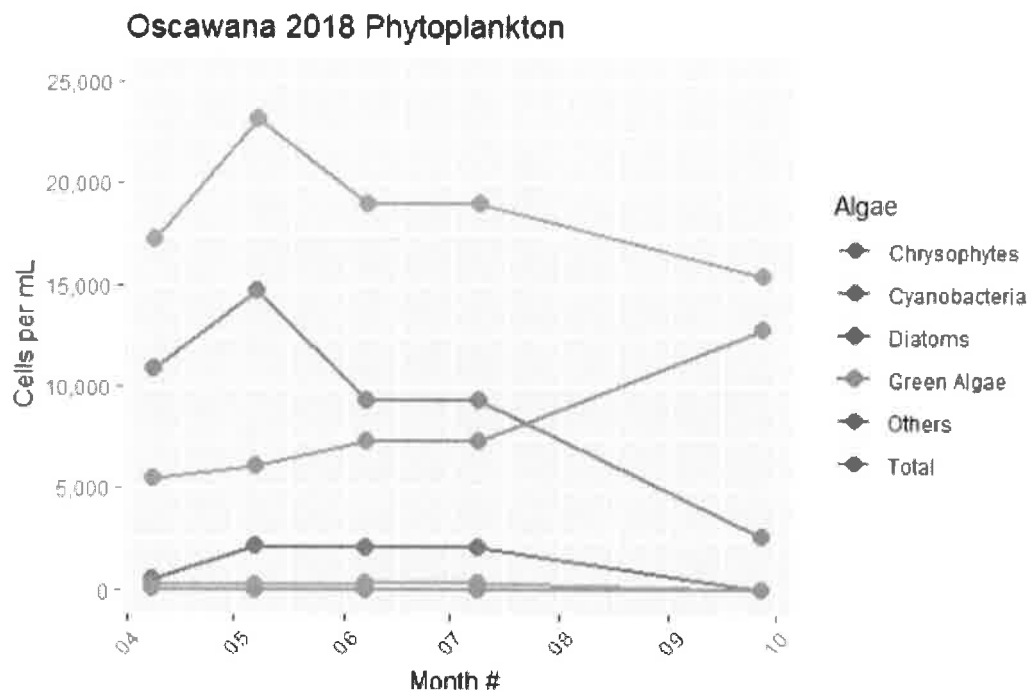
Phytoplankton levels in 2018 ranged from approximately 17,000 to 23,000 cells per milliliter. These levels indicate overall good water quality conditions. Spring sampling did not record a substantial Diatom bloom, as has been documented in years past, yet spring water clarity was still poor. Poor water clarity seen in spring and fall 2018 can also be linked to suspended sediments in the water column, but suspended sediments have never been explicitly measured. The Oscawana phytoplankton assemblage becomes dominated by cyanobacteria, also referred to as harmful blue-green algae, during summer months. Yet cyanobacteria numbers have remained relatively low throughout the season. Cyanobacteria becomes a human health concern once a bloom reaches concentrations greater than 70,000 cells/mL.

Figure 12: Phytoplankton Assemblage 2018

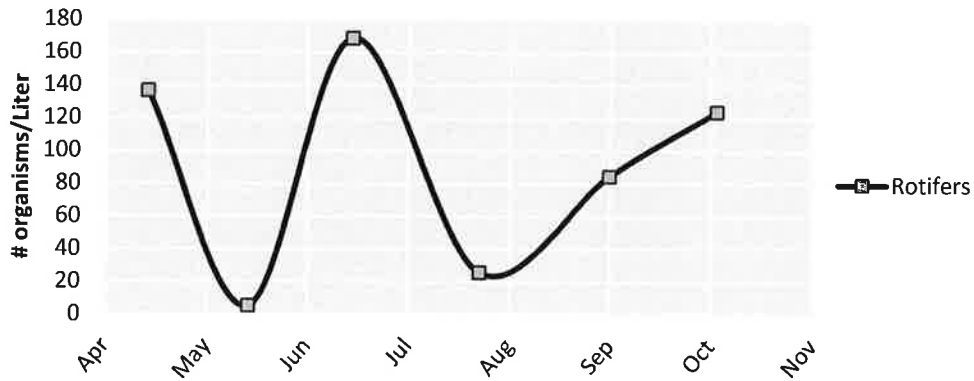
**Figure 13: Rotifer Populations 2018**

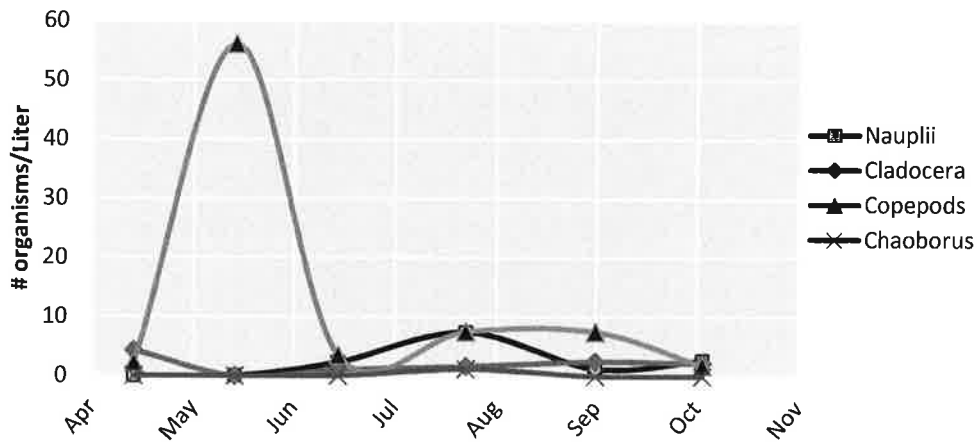
**Figure 14: Other Zooplankton Populations 2018**

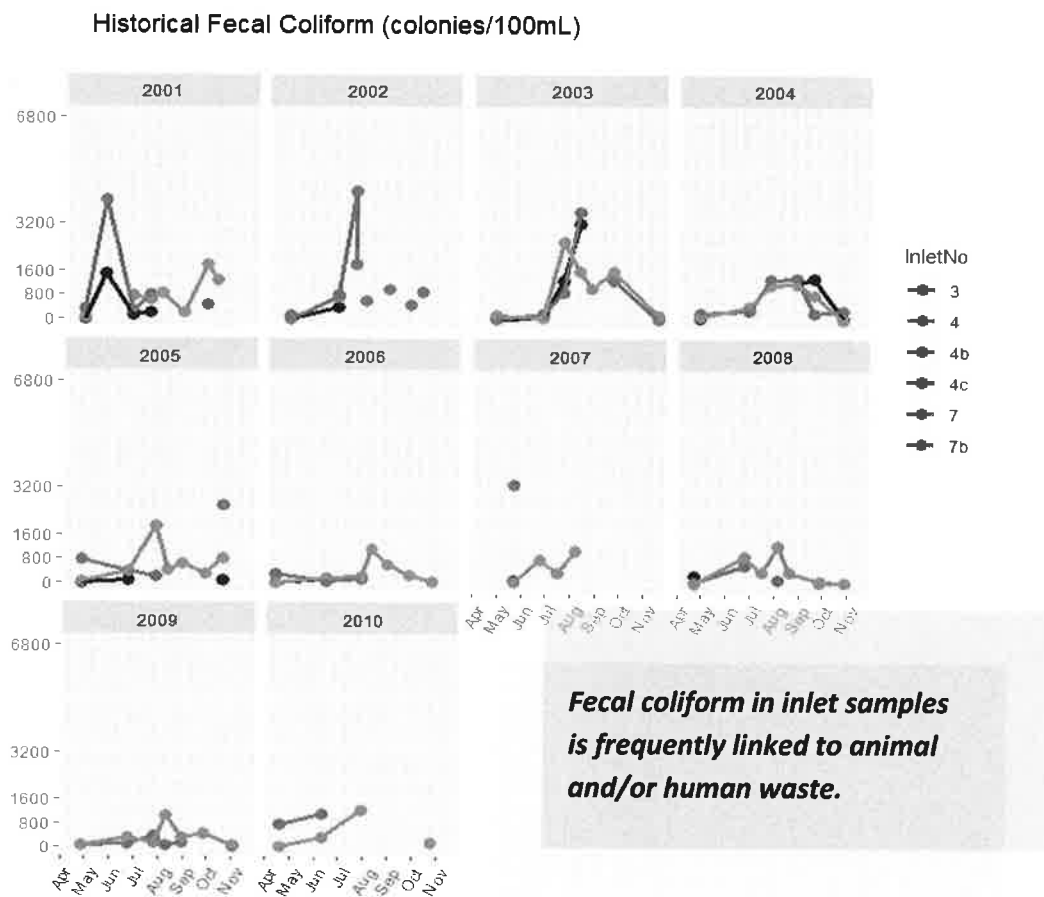
Inlets 4 and 7 are also likely candidates for septic system impairment as they have historically been high in fecal coliform bacteria (Figure 15). The Health Department is aware of these high fecal coliform counts and circa 2003, at least one septic system was replaced near inlet 4. However, since that time, nutrients have remained elevated throughout the seasons. One round of Fecal coliform testing was conducted at inlets 4 and 7 in 2018. Results from September 29, 2018 found 120 and 270 fecal coliform colonies per 100mL sample at inlets 4 and 7, respectively. Further e. coli and fecal coliform testing occurred in 2019. The Health Department was made aware of bacteria and nitrate results. The very high nitrate nitrogen concentrations (**average 2014-2018 inlet 4 nitrate nitrogen = 1,398ppb**) indicates human sources of groundwater impairment. Of the total 20 samples that were taken at inlet 4 from 2014 to 2018, the top 30% all occurred in April and May, which is the period of high groundwater that may interfere with septic system functioning. Unfortunately there are no total nitrogen or ammonia nitrogen values to make better comparisons through the seasons. A discussion of possible remediation actions is included in Section 2.3. Detailed inlet nutrient results are included in the appendix of this report.

**Figure 15 - Inlets Fecal Coliform Historical Data**

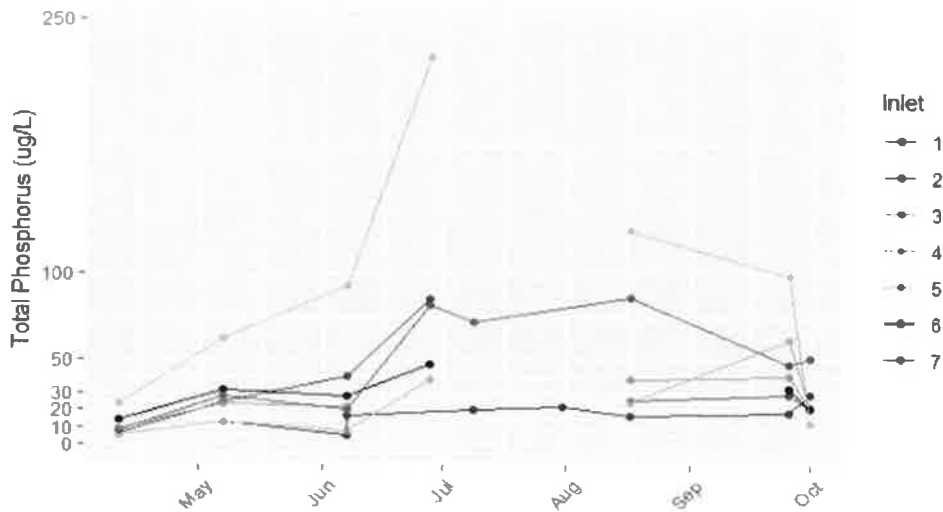
**Oscawana Inlets Total Phosphorus 2018**

**Figure 16: Inlets Total Phosphorus Concentrations 2018**

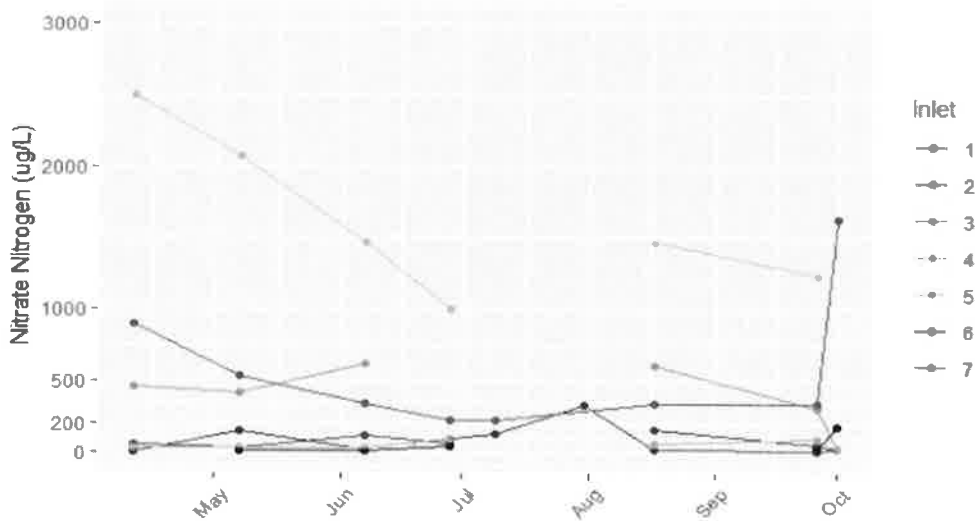
**Oscawana Inlets Nitrate Nitrogen 2018**

**Figure 17: Inlets Nitrate Nitrogen Concentrations 2018**

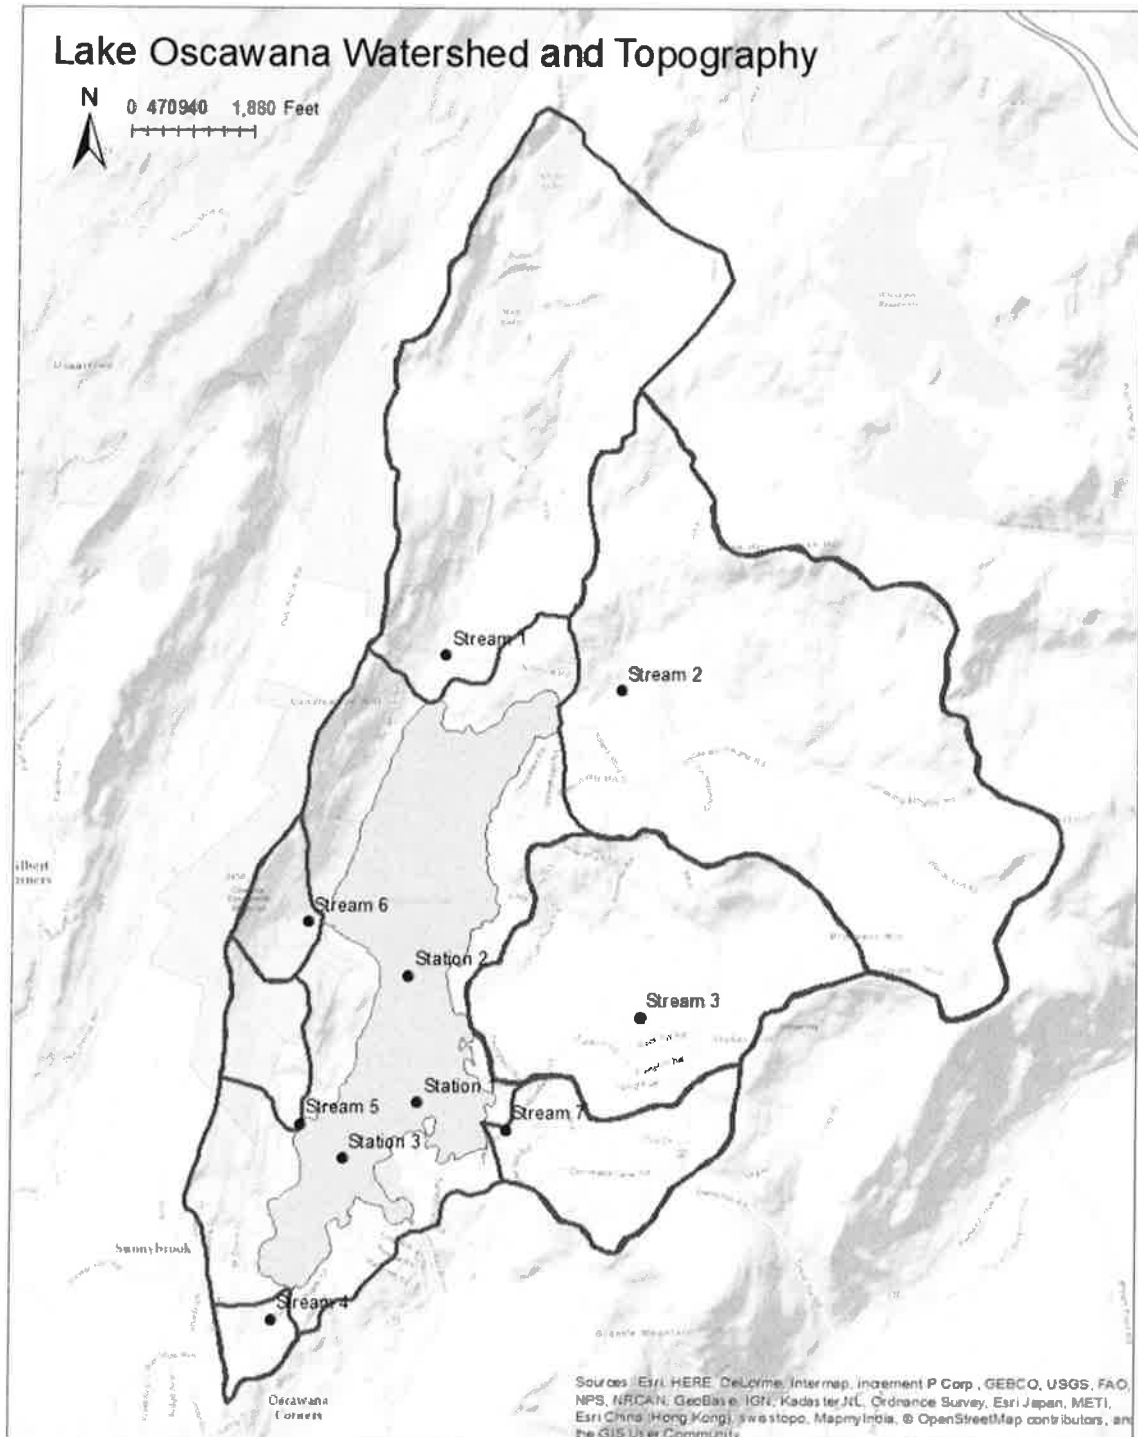
Map 1 Oscawana Watershed and Main Inlets/Sub-basins

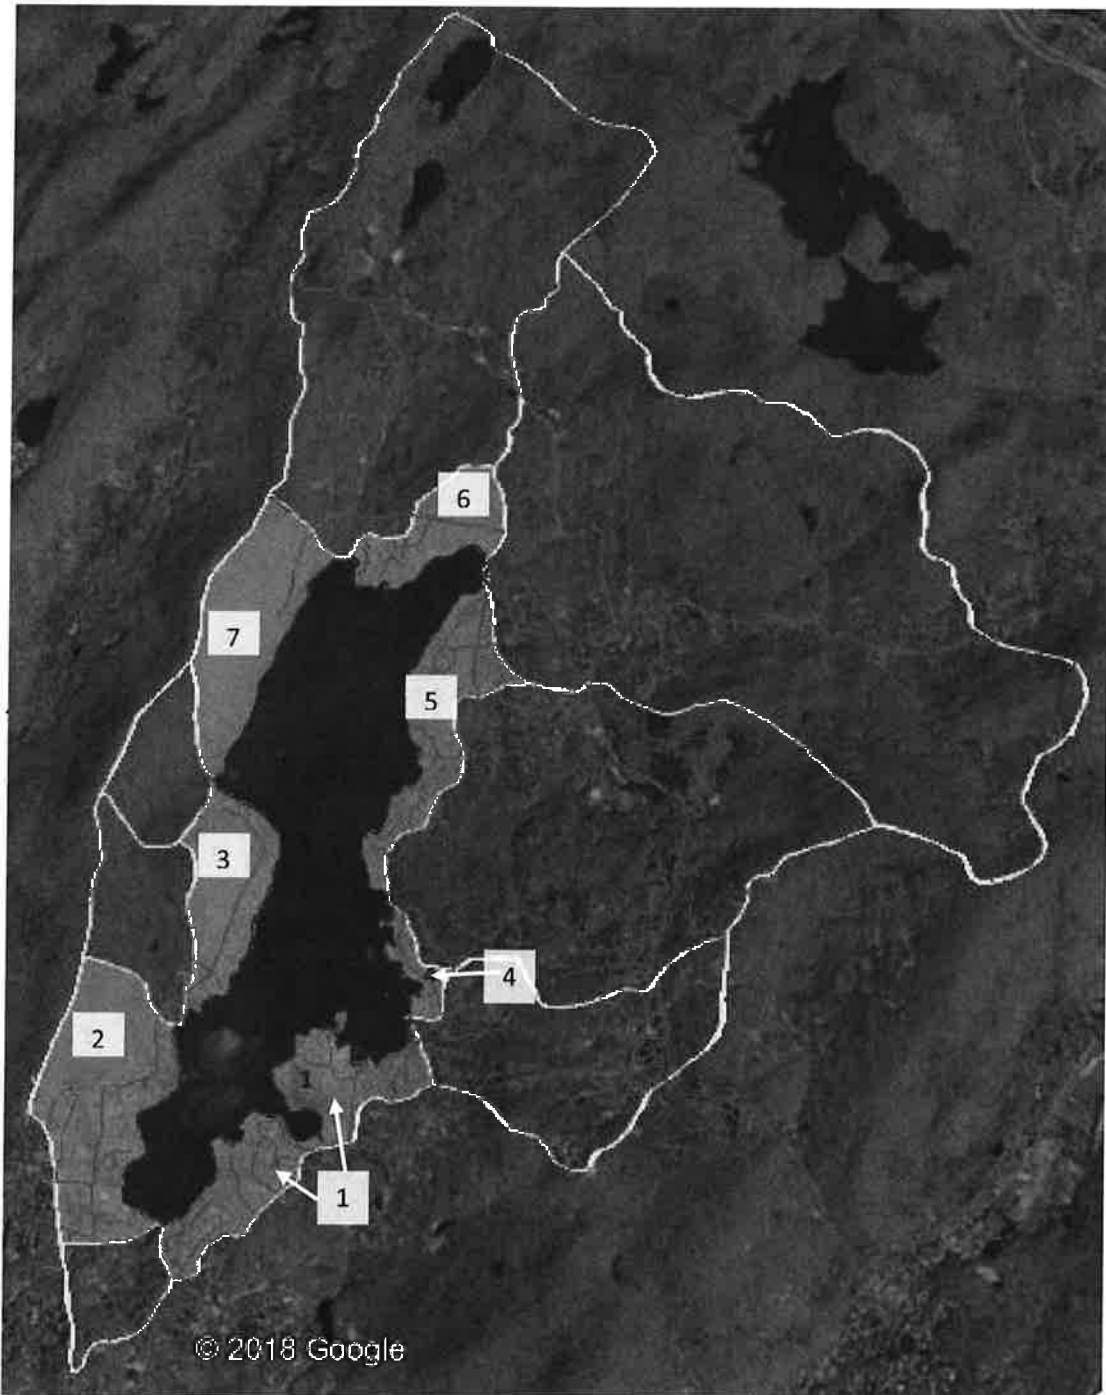
Map 2 Direct Drainage Areas (#D1-D7)

Map 2, above, also demonstrates the measured linear feet of roadways in each of the sub-basins and seven direct-drainage areas (direct-drainage #D1-D7 shown shaded in blue, roadways in red).

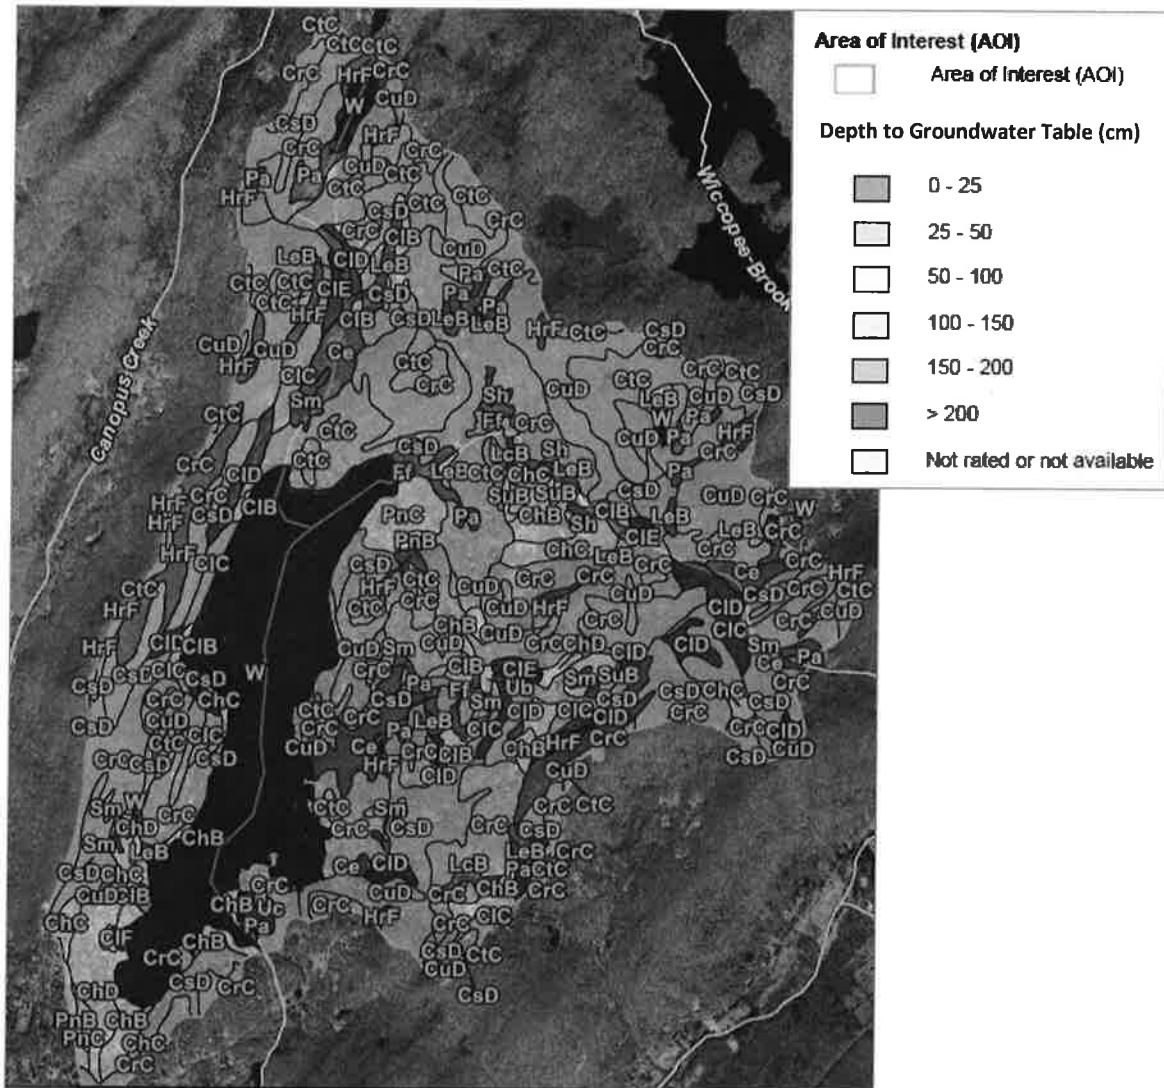
The soils in the Oscawana watershed were determined using the Natural Resource Conservation Service Web Soil Survey Application. The majority of the watershed soils are classified as well drained, very rocky Charlton-Chatfield (CrC) and Chatfield-Charlton (CsD) complexes. The next most common soil types were Chatfield-Hollis-Rock outcrop rock complexes (CtC and CuD), which indicate the large areas of the watershed with exposed bedrock. The map image below displays the various soil types using their three letter code, as well as a color coding to indicate the soil types' depths to the groundwater table. Soil rating colors indicate the number of vertical centimeters to the groundwater table.

The important take-away from this map is that the majority of soils in the immediate shoreline area have a depth to groundwater of 25-50 cm (about 10-20 inches) and high amounts of bedrock. By current New York onsite wastewater standards, the majority of the lake's watershed soils are not suitable for onsite wastewater treatment. The NY Public Health Law, 201(1)(1) Wastewater Treatment Standards for Residential Onsite Systems Section 75-A.4 states that, "Highest groundwater level shall be at least two feet below the proposed trench bottom," meaning that a minimum of 24 inches of usable soil is required for conventional septic system leaching fields.

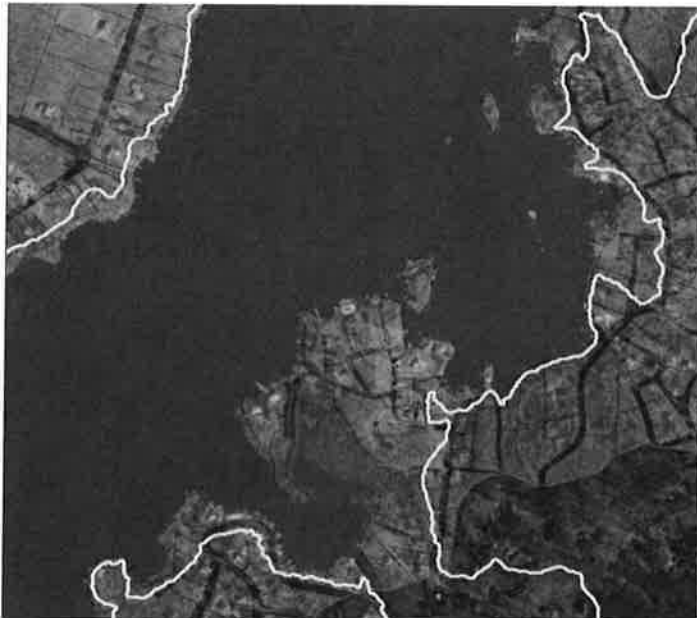
***Current NY Treatment Standards for Residential Onsite Systems Section 75-A.4 states that, "Highest groundwater level shall be at least two feet below the proposed trench bottom," meaning that a minimum of 24 inches of usable soil is required for conventional septic system leaching fields.***

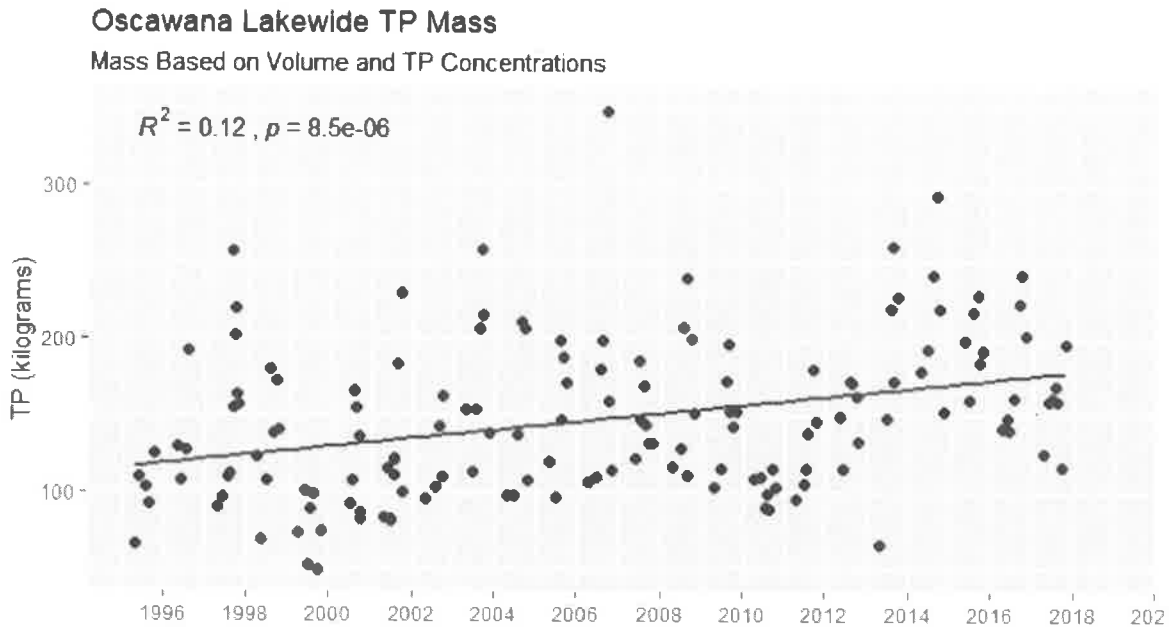
values per date are included in the Appendix. The graph in the Appendix demonstrates a period of reduced in-lake phosphorus mass from 2009 to 2012, followed by a sharp increase in 2013 and a subsequent season-wide decrease in 2017 and 2018. Years 2010 and 2017 were the lowest in-lake phosphorus mass on record since the late 1990s. The 2017 Lake Monitoring Report discussed this phenomenon and how the periods of nutrient reductions coincide with both septic ordinances/pumping and reduced mechanical weed harvesting loads.

Figure 18: Long Term Lake Phosphorus Mass

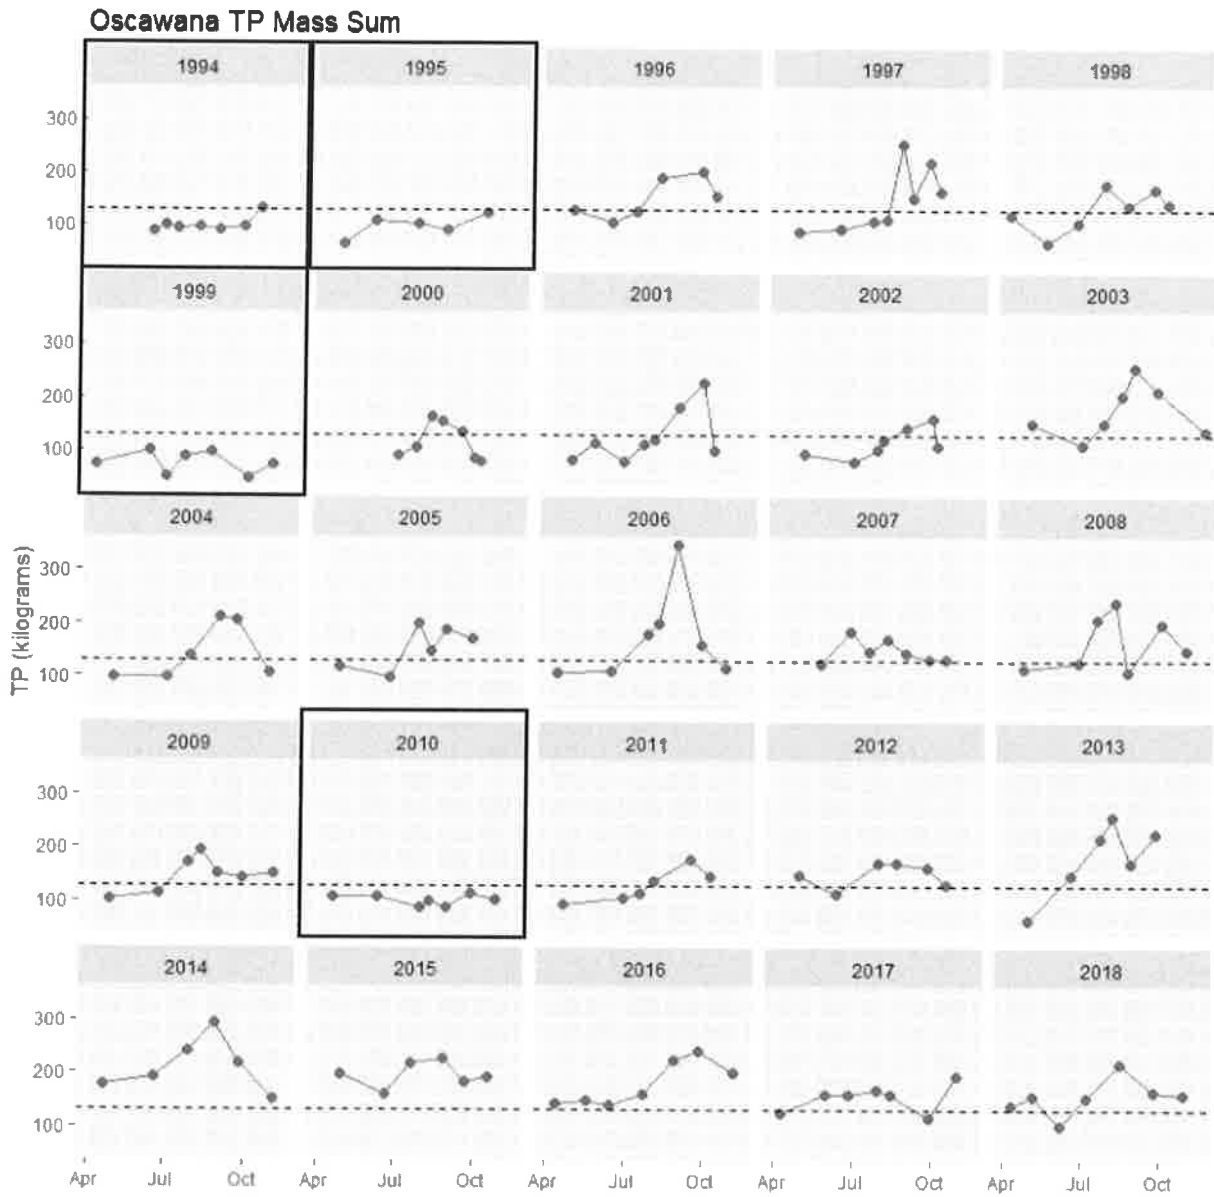
The historical in-lake total phosphorus mass is the foundation to understanding internal loading. Phosphorus mass was further divided and analyzed on a seasonal basis. Figure 19 below demonstrates the seasonal changes in lake phosphorus mass from 1994 to 2018. The horizontal dashed line serves as a **target threshold for Lake Oscawana of 130 kilograms of phosphorus**, which is the quantity of phosphorus present in the lake during most years in early spring. Years where phosphorus mass remained below this threshold for the entire season are outlined (boxed) in navy blue. Readers should also note that the pattern of seasonal phosphorus mass in the lake is not uniform from year to year. There are years where mass loading appears to be higher than others, indicating that suppression of internal loading is possible.

**Figure 19: Seasonal Lake Phosphorus Mass by Year**
