# TOWN OF PUTNAM VALLEY

## Town Board Meeting

# Report Outline

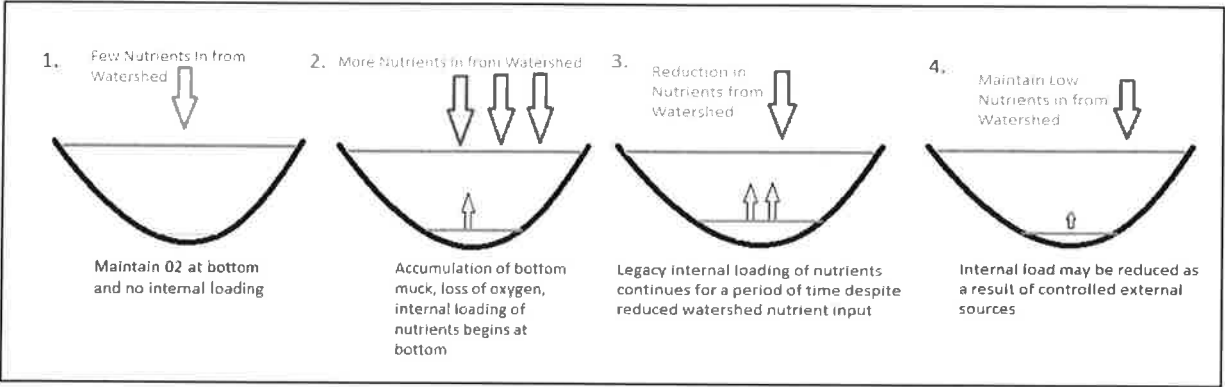
When phosphorus inputs from the watershed are reduced, the lake should respond with suppressed internal loading (Jeppesen, 2005).

**Figure 20: Internal Loading Suppression Diagrams**

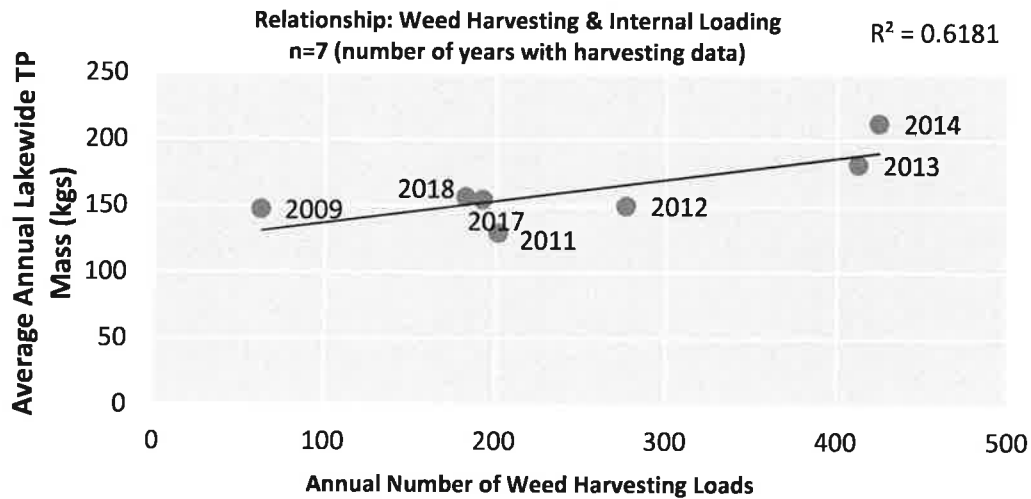
Weed harvesting records of the last decade were tracked by the harvester operators on their respective payment time-sheets. The harvesters record the number of hours, approximate area of weed harvesting, and the number of daily "loads," which is roughly the number of times the harvester becomes full with plant and organic material and has to off-load. Though the "loads" metric is not an ideal way to track the amount of weed harvesting in past years, this was the only information on record. Only seven years of harvesting data has been recovered since 2009, yet a statistically significant correlation was found between the number of harvested loads and total in-lake phosphorus mass ( $r^2 = 0.6435$ ,  $p\text{-value} = 0.029$ ). This correlation is prompting new conversations about weed control, which are discussed further in Section 3.0.

**Figure 21: Weed Harvesting Loads vs. Phosphorus Mass**

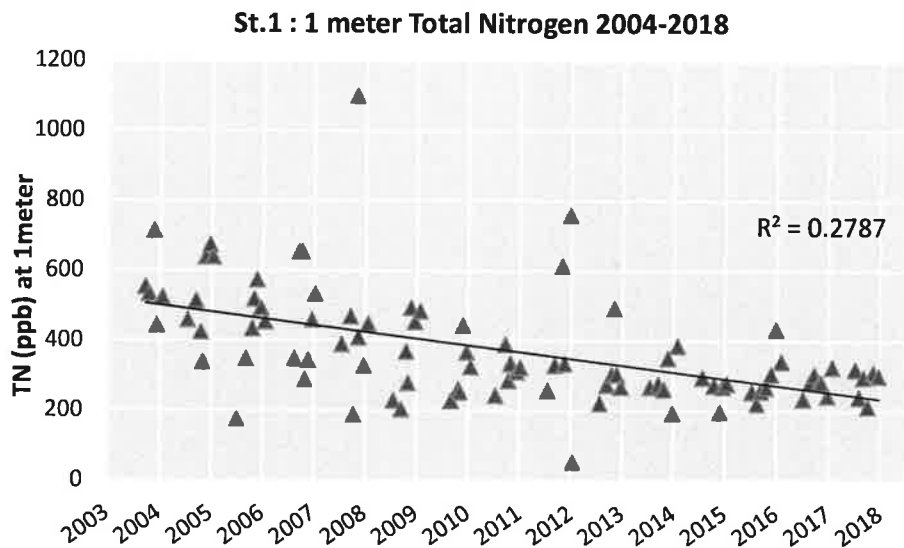
Based on nutrient monitoring it is apparent that there were years with much less internal loading than others. Similarly the surface nitrogen concentrations have been steadily declining since 2004, which may be attributed to onsite wastewater improvements over time. Nitrate nitrogen readily leaches to the groundwater table and impairs downstream water quality by increasing plant and algae growth. If onsite wastewater systems were being updated and more adequately maintained, there would be significantly less nitrogen entering the lake. This trend, as demonstrated in the figure below, would be more apparent than phosphorus changes because phosphorus accumulates in aerated sediments for long periods of time. The very high outliers of nitrogen on this graph are not explainable at this time and may either have been related to concentrated surface cyanobacteria blooms or laboratory error.

**Figure 22: Historical Nitrogen Concentration Trend**

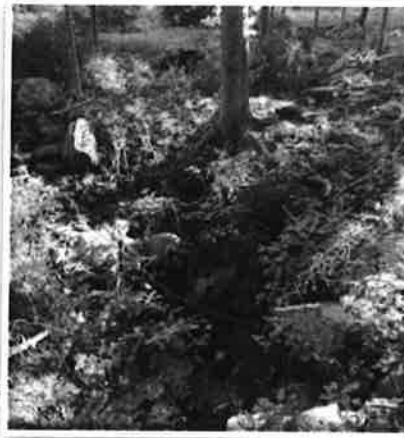
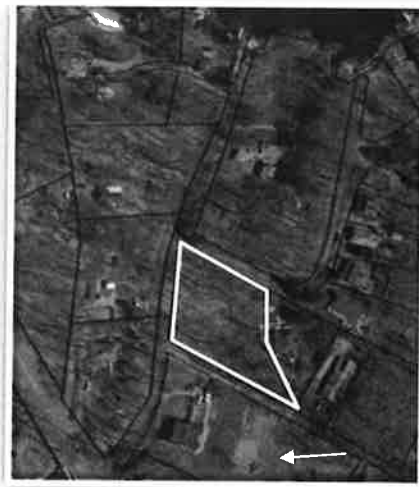
The Inlet 4 samples are collected at the road on the northern side of Lee Ave. This area is notorious for very high nutrient concentrations and frequently tests positive for fecal coliform bacteria. The aerial image shows that water that is sampled comes directly

from an upstream private pond (white arrow), which is frequently full of algae. From the road you can see pipes on private property which appear to drain the front lawn into a private pond. The pond then flows under Lee Ave to the lake through a concrete

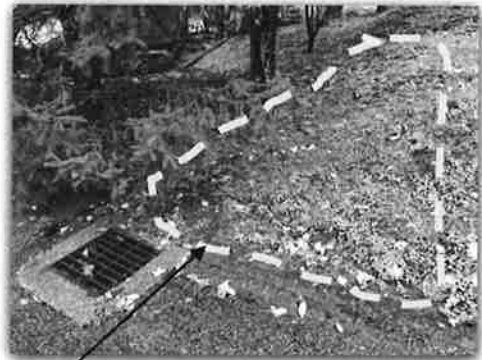
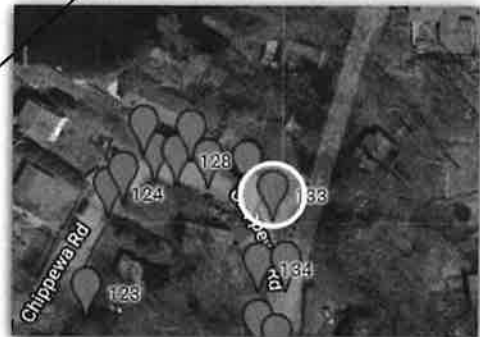
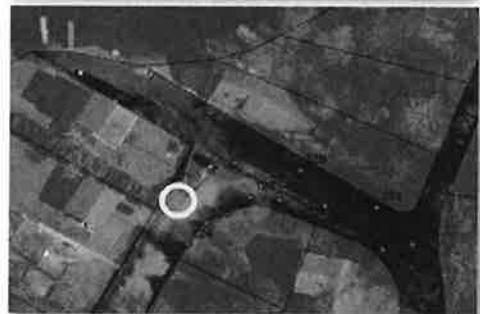
Waypoint 133 marks a catch basin next to a privately owned lot with an open grassy area that could serve as a bio-retention stormwater infiltration basin for small storms (area traced with yellow-dashed line). Additionally, this catch basin would need to be retrofitted with a particle separator unit connected to the bio-retention cell with an overflow mechanism for large storm events. **Estimated cost \$25,000.**

The Town must check the extent of the road easement at this location. The **bottom of the hill is also a Town access site** with a catch basin (Right: WPT#127 circled in yellow) that could be converted to a holding wetland or infiltrative area depending on soil infiltration rates. Local soils are surveyed as well-drained Paxton fine sandy loam, but test pits must be dug prior to stormwater design. **Estimated stormwater improvement costs \$30,000.**

Additionally, all catch basins on Chippewa, Sioux, and Winnebago Road were full of debris, which gets caught above the filter inserts and may prevent proper functioning of the catch basins. On most recent visits in 2018 and 2019, many of these catch basins were flooded and the filters were in need of repair. This whole area is a priority for specialty phosphorus filters. Yet with large amounts of flooding and water stagnation on the corner of Chippewa and Sioux, the Town should consider this a priority for complete roadway reconstruction with innovative stormwater practices in mind. **Estimated costs > \$50,000.**

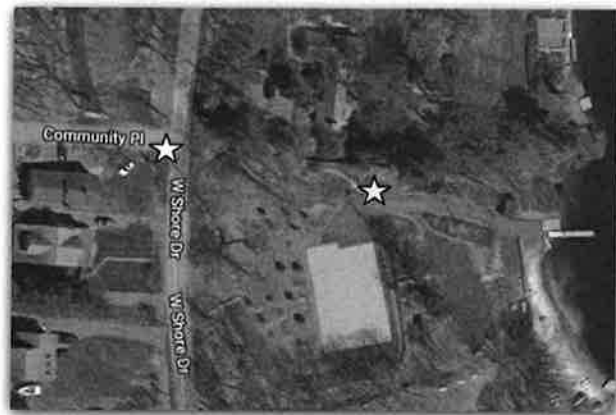
Erosion of Community Place road and large volumes of water flow to two catch basins at the end of Community at the intersection of West Shore Drive - marked as white star. Water then flows under the road and into the Hilltop Park swales / catch basin system. There are a series of failing silt fences in Hilltop Park and very high concentrations of nutrients in groundwater seepage. **High groundwater nutrients are likely related to septic leaching**

from uphill systems; the yellow star indicates seepage flow and sampling point where **Nitrate nitrogen = 4,930ppb (4.9mg/L) and Total Phosphorus = 139ppb**. We recommend testing this site for fecal coliform in 2019 and notifying the local health department if bacteria tests are positive. The Town should also clean the catch basins in Hilltop Park and either replace failing silt fence, or install a more permanent barrier to protect against slope erosion caused by groundwater seepage. **Estimated costs: \$300 for additional bacteria and nutrient testing. Follow up with Health Department.**

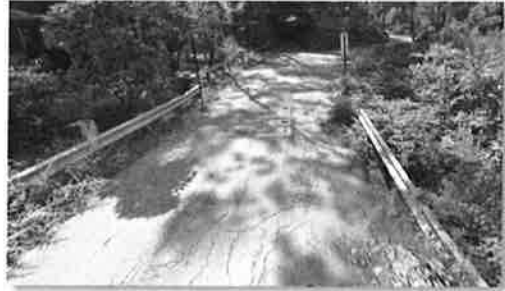
Monitoring at Inlet 7 at the intersection of Lakefront Road suggests that there may be multiple septic systems in this immediate area that are not functioning properly and are leaching high nutrients to the downstream wetland and lake. Fecal coliform tested at this location in 2018 were 270 colonies per 100 mL. Further 2019 E. coli testing revealed **3700 E. coli** colonies per 100mL, which is very high and invoked Public Health Department involvement.

**Estimated costs: \$300** further bacteria and nutrient testing per year.  
**Follow up with Health Department.**

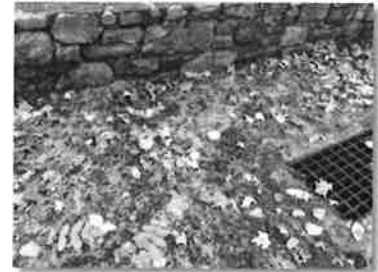
In the area of 59 West Shore Drive (WPT #24 in GoogleMaps GPS file-shared with LOMAC), there is a small white pipe that comes out of a retaining wall. At the time of inspection this pipe and area smelled of sewage. Further investigation is need to ensure that this drainage pipe is not leaking septic effluent into the nearby catch basin during storm events and high groundwater periods. **Estimated costs: \$No Cost**

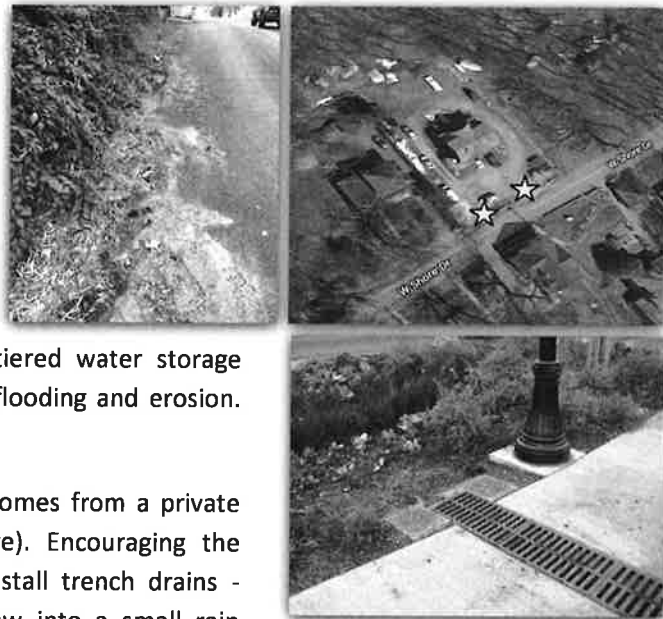
Photo 3 Credit: <https://s-media-cache-ak0.pinimg.com/originals/44/61/7a/44617a40b9ad8c540f00bc6a8c47acd7.jpg>.

However, a primary source of this erosion comes from a private driveway just uphill (153 West Shore Drive). Encouraging the property owner to work with LOMAC to install trench drains - example areas indicated with stars - to flow into a small rain garden at the corner of the property would prevent much erosion. The trench drain could be easily cleaned by the highway department at the time of annual catch basin cleaning. An example of a type of trench drain and rain garden is shown in the third photo. **Estimate costs: \$ 3,000**

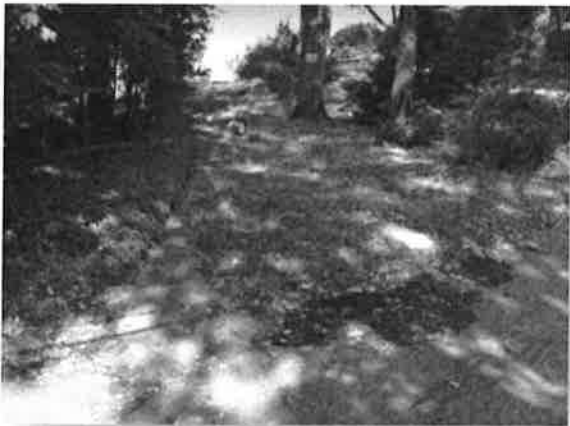
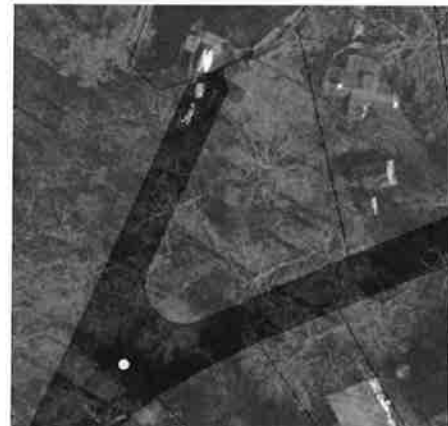
This area is a low point where stormwater accumulates and flows down the footpath. Some Lee Ave stormwater may be directed to a small rain garden at this location, which would be placed on existing Town property. **Estimated costs: \$4,000**

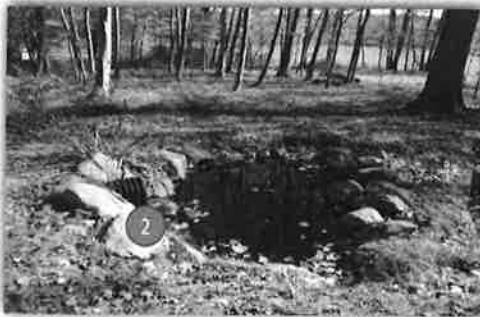
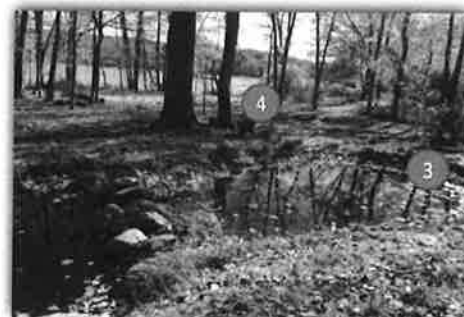
The West Shore biofilter is included in this list in order to explain the functioning and to ensure proper maintenance in years to come. The biofilter, which is adjacent to Inlet 5, serves as a stormwater retention pool and wetland filtration system. Residents were long under the misunderstanding that the biofilter was intended to purify the Inlet 5 water, however, the primary function of the biofilter is to receive stormwater from West Shore Road. Stormwater runoff enters a culvert and mixes with the Inlet 5 water during high-flow periods, spilling into the biofilter. Testing at the biofilter in 2018 revealed that there was no major decrease in nitrogen or phosphorus from the inlet compared to the outlet of the biofilter. Samples were taken at four sites. The first sampling site was a groundwater seepage point from the West Shore drive hillside across the road from the biofilter. Sites 2-4 are indicated on the images below and nutrient test results are shown in Table 11.

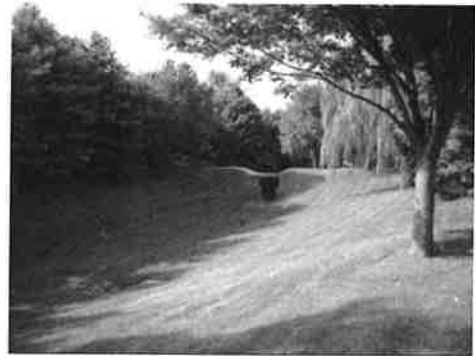
Photo 1 Dry Detention Basin  
(<https://sustainablestormwater.org>)

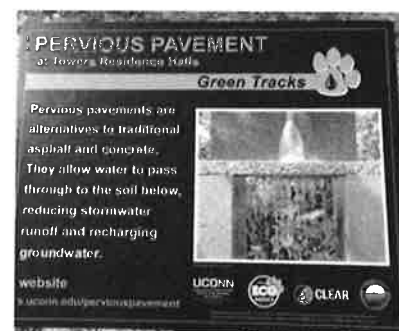
Photo 2 UCONN Center for Land Use Education and Research Pervious Pavement Demonstration

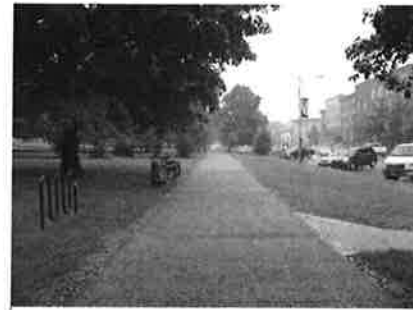
Photo 3 Saint Albans Vermont (EPA <https://www.epa.gov/soakuptherain/soak-rain-permeable-pavement>)

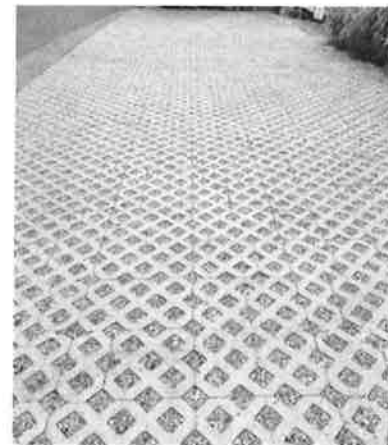
Photo 4 Oscawana watershed interlocking pavers filled with pea-gravel

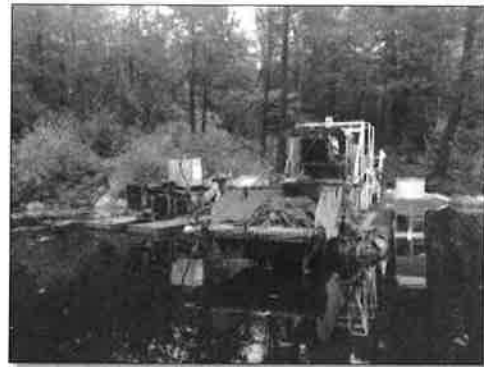
Mechanical weed harvesting involves the cutting and ripping of aquatic plant stems at a certain depth beneath the surface. The mechanical harvester used at Lake Oscawana is capable of cutting plant stems to approximately 3ft below the surface. While the harvester is able to clear paths in milfoil beds that would otherwise grow to the surface, the milfoil will always re-grow from cut stems. Presumably, cutting stems also has a similar effect to pruning garden plants: allowing the plants to grow fuller and more dense.

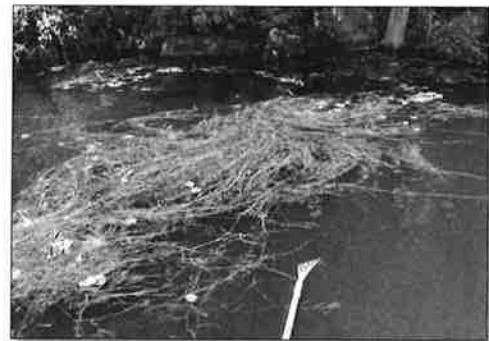
In the last two years, increased scrutiny in the operation and whereabouts of the mechanical harvester have prompted two main concerns. The first concern is that when the harvester operates in dense plant beds, the fragmentation of milfoil is so much that the harvester operator must then spend many hours cleaning up the mess of floating plant stems. The second photo on the right was captured in Wildwood Knolls Cove and represents one of many large floating fragment rafts seen throughout the lake. A review of the plant harvesting logs from the 2018 season showed that approximately 10% of the harvesting loads were skimming floating fragments. And because it takes longer to collect a full load from just skimming fragments, it's expected that the time percentage dedicated to cleanup is much higher.

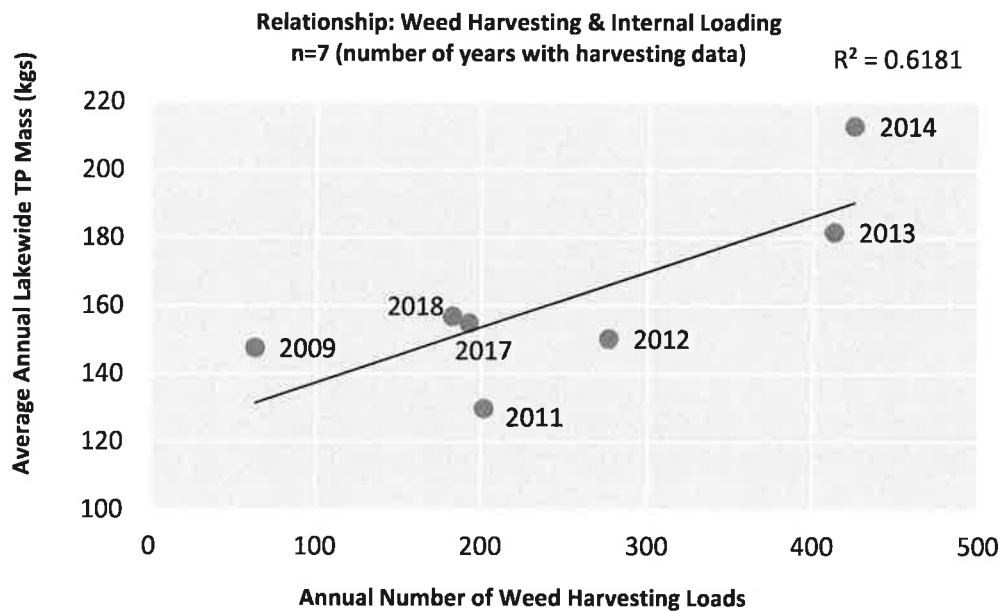
**Figure 23: Weed Harvesting vs. Total Phosphorus Mass**

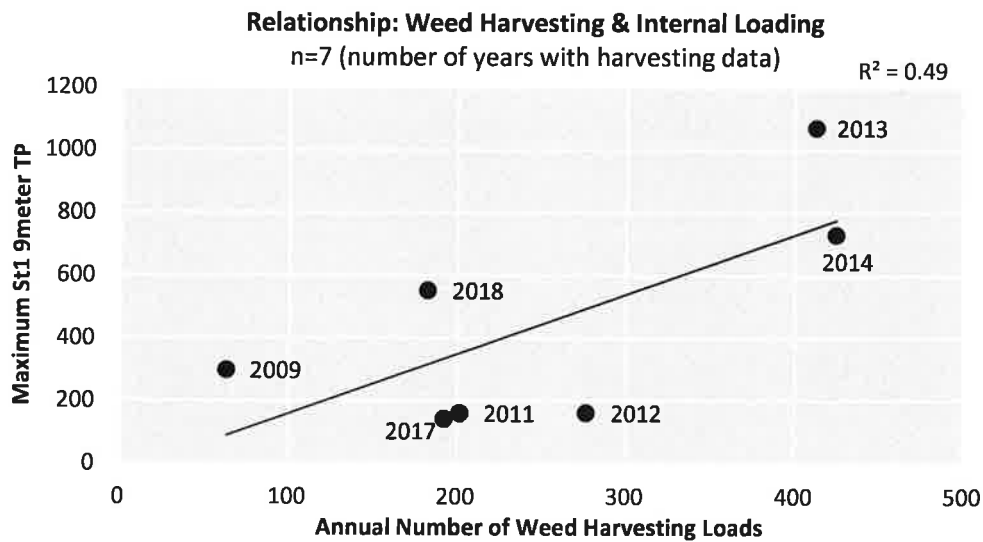
**Figure 24: Weed Harvesting vs. Maximum Bottom Phosphorus (Metric of Internal Loading)**

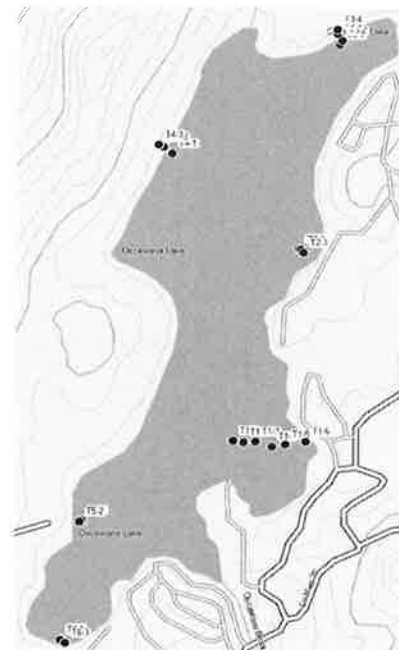
**Figure 25: Plant Survey Transects**

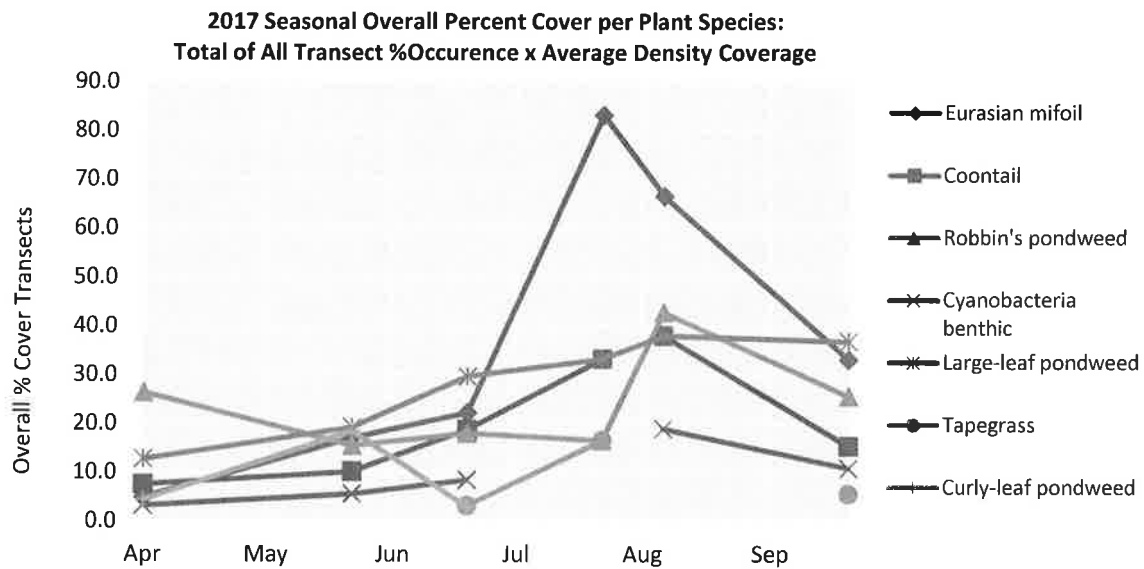
**Figure 26: Seasonal Plant Coverage at Transects 2017**

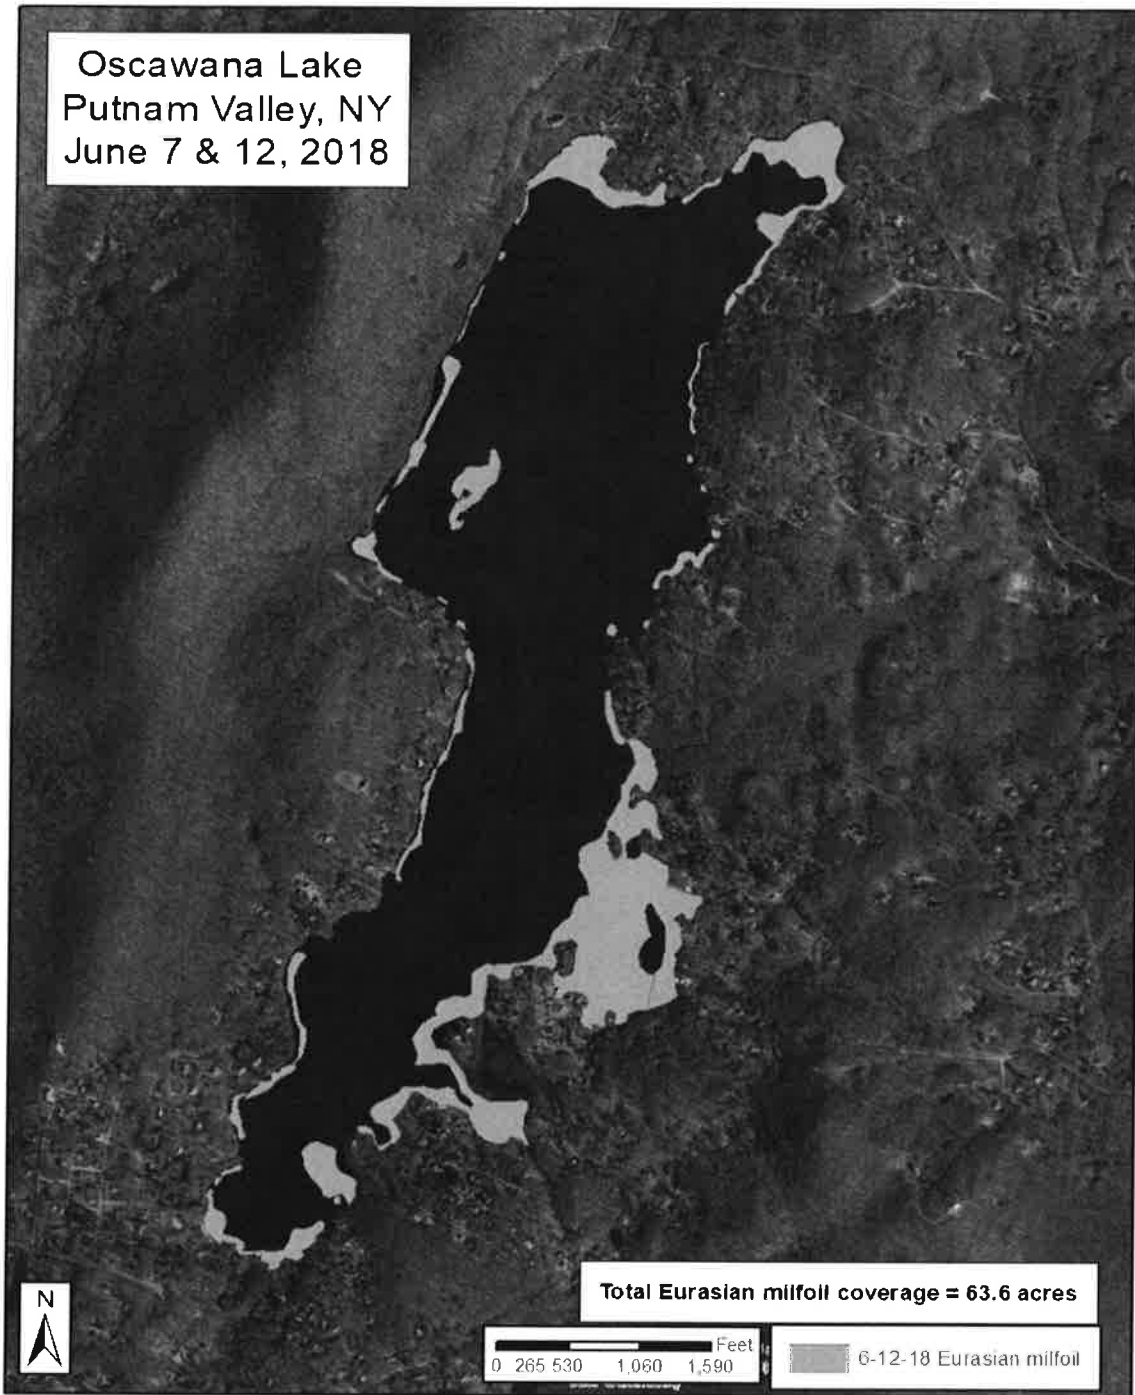
Map 3: 2018 Eurasian Milfoil Coverage

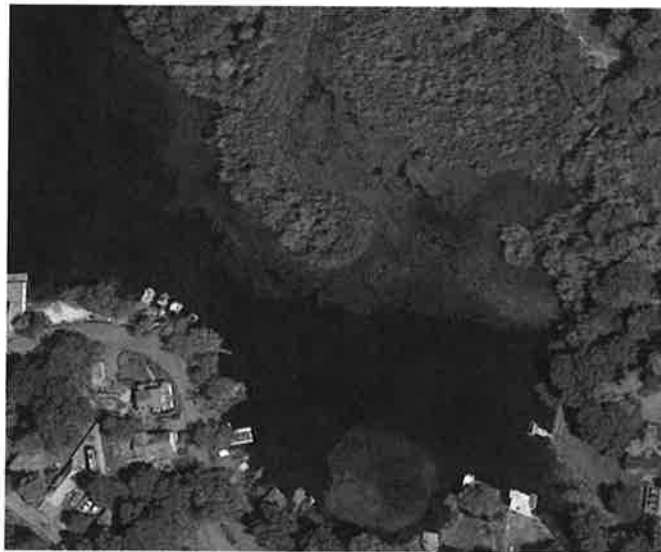
Image 1: Abele Cove 2015 Aerial View (latest GoogleEarth image)

In Abele Cove, where shallow nutrient-rich sediments are easily disturbed by the weed harvester, mechanical harvesting should be minimized. Better Eurasian milfoil control may be achieved by using aquatic herbicides. If an herbicide treatment is to be performed, it should be conducted during a period of low water levels so that appropriate concentrations can be achieved close to the spillway. The cove totals about 6 acres, not including the areas of dense Water-lily coverage. A test case herbicide treatment using ProcellaCOR or SONAR can target Eurasian milfoil. SONAR has been approved for use in New York for decades, yet ProcellaCOR is a new product that was approved in 2018. ProcellaCOR herbicide is considered a faster-acting product perfect for small coves like Abele near an outflow. SONAR is considered a systemic herbicide and takes much longer to impact milfoil plants, but there is typically more years of control.

A 6 acre treatment is considered very small and can serve as a test case to determine if herbicide use is appropriate in lieu of mechanical harvesting. The treatment should cost in the range of \$6,000 and should offer two years of Eurasian milfoil control for ProcellaCOR and 2-3+ years of control if SONAR is used. LOMAC should gauge public opinion of herbicide use at Oscawana.

Further conversations will be necessary between NEAR, residents, and LOMAC if an herbicide treatment will be considered in 2019 or 2020. We recommend trying an herbicide treatment in Abele Cove first and waiting to evaluate further impacts of Grass Carp in Wildwood Knolls and the Northwestern Cove before attempting any treatments.

Again, we recommend a test case spot herbicide treatment in Abele Cove if residents agree that would be appropriate in the next few years. Mechanical harvesting in Abele Cove appears to be negatively impacting the overall water quality of the lake and we hope to see lower phosphorus concentrations and better clarity with lessened harvesting in shallow areas. The mechanical weed harvester will continue to serve as the primary plant control method in 2019-2020, but harvesting Abele Cove should not be permitted unless absolutely necessary. The mechanical harvester is also in need of continued repairs in 2020, which presents a window of opportunity for LOMAC to explore alternative plant management options.

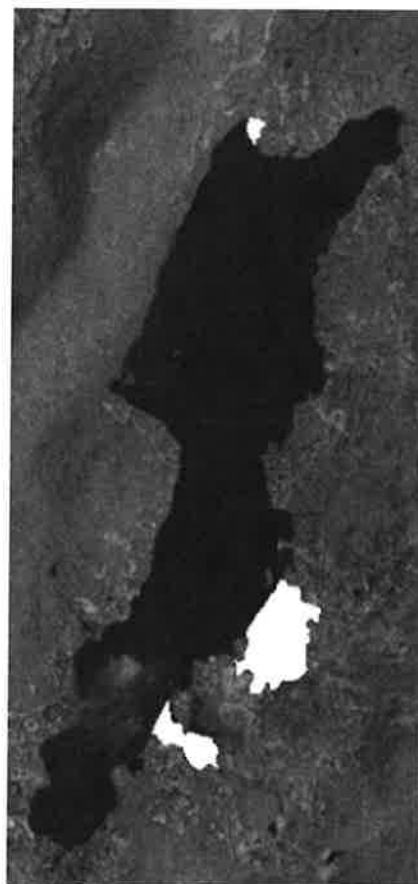
**Image 2: Potential Locations for Test Herbicide Treatments**

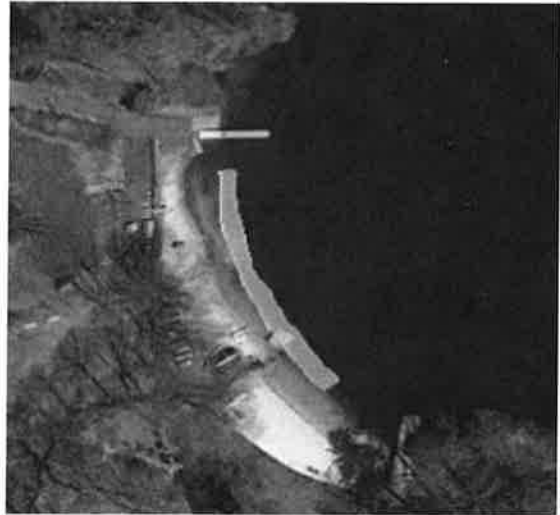
**Image 3: Beach Benthic Barrier Potential Site, Southern Cove**
