2019 Sonar Scan and Water / Sediment Testing Results for Lake Peekskill

Prepared for: Town of Putnam Valley 265 Oscawana Lake Road Putnam Valley, NY 10579

Prepared by: Clean-Flo International / SIS.bio 827 Lincoln Avenue West Chester, PA 19380 On October 8th 2019, the most recent sonar scan was conducted on the lake, while water samples and sediments were collected from sampling sites in the lake. Dissolved Oxygen and temperature readings were also taken at each of the sampling sites. The purpose of the scan and sampling was to provide this progress report of the system and treatment of the lake.

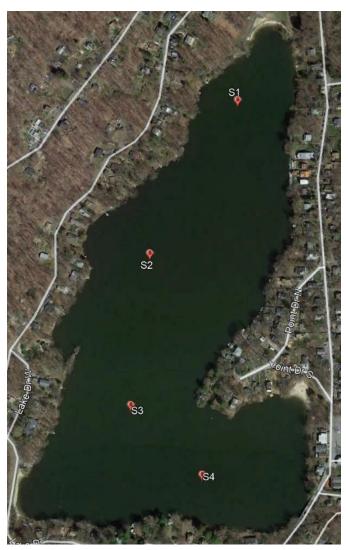
Figure 1. Sampling locations on Lake Peekskill

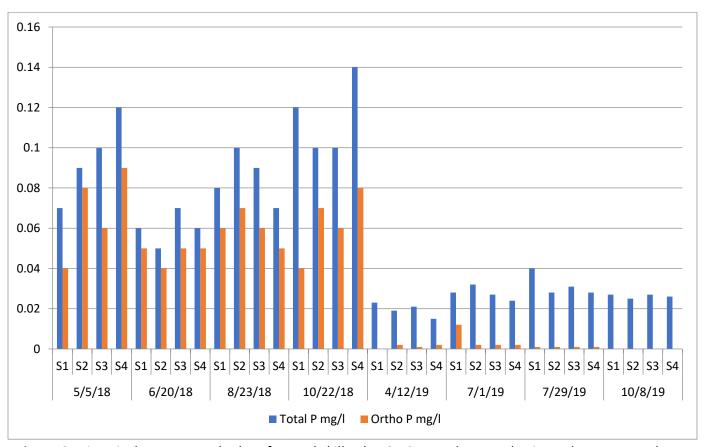
Figure 2. Historical water sample data for Peekskill Lake. S1-S4 are the sample sites. The orange columns are ortho-phosphorus levels while the blue columns are the total phosphorus levels.

Water samples are a snapshot in time and can be greatly affected by rain events and other weather-related activities. Water samples were analyzed for total phosphorus, ortho phosphorus and algal community by independent laboratories. Total phosphorus levels should generally be 0.02 mg/l or less to avoid nuisance algae growth. As can be observed in table 3 below, total P was higher than 0.02 mg/l for 3 of the 4 samples. Orthophosphate is the form that is bioavailable. There has been a significant downward trend in phosphorus levels in 2019 compared to 2018, and even more so in orthophosphate levels, which is shown in Figure 2.

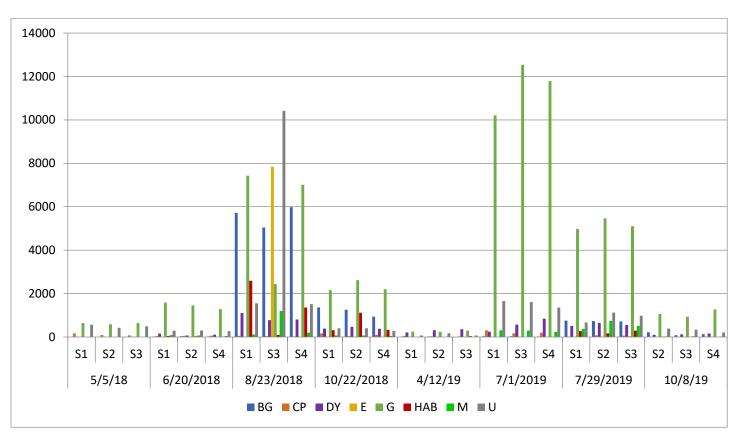
Below is a graph of all the algal population data organized by sample site and date sampled. Across the board, HABs were almost invisible and green algae species that indicate good water quality were the largest part of the overall algae population. Based on this data, the HABs have been reduced to almost 0% while the overall algae levels (Total Cells) have also decreased significantly from 2018 to 2019. The drop in population of other algae species has resulted in green algae, which are indicative of good water quality, filling the population void left by the other algae.

Figure 3. Total Algae Cell count data from 2018 to 2019. Vertical axis is in cells per milliliter.

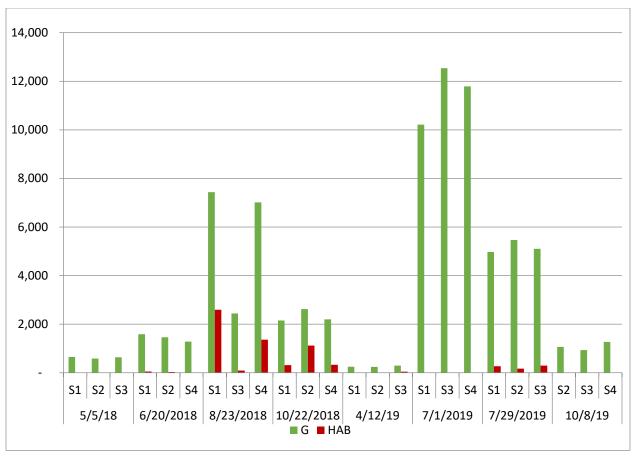
For a more simple analysis, a graph displaying only the HABs and the Chlorophyte (green) algae levels (figure 4) can be found below. HABs levels have consistently dropped from 2018 to 2019 and green algae levels have increased.

Figure 4. Harmful cyanobacteria and chlorophyte (green algae) level comparison.

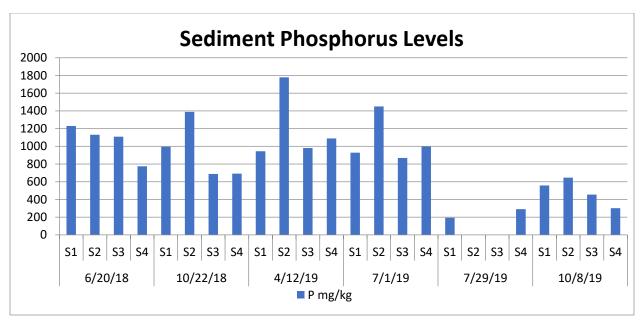
Based on the analysis of the sediment samples displayed in Table 6, the phosphorus (P) in the sediment has a consistent downward trend and has ultimately dropped below 1000 mg/kg. This means that phosphorus is being used up more by the ecosystem than previously. This is an indication of increased nutrient uptake and metabolism by organisms in the lake. Overall, the data demonstrates that the ecosystem is processing the nutrients more quickly, and consistently reducing muck. Figure 5 gives a big-picture view of phosphorus levels in the lake sediments since 2018. There is a consistent downward trend in the concentration of phosphorus across the 2 years the Clean-Flo / SIS.bio system has been in operation.

Figure 5. Historical comparison of phosphorus levels in Peekskill Lake sediments. (S2 and S3 are blank for 7/29/19 because samples were ND)

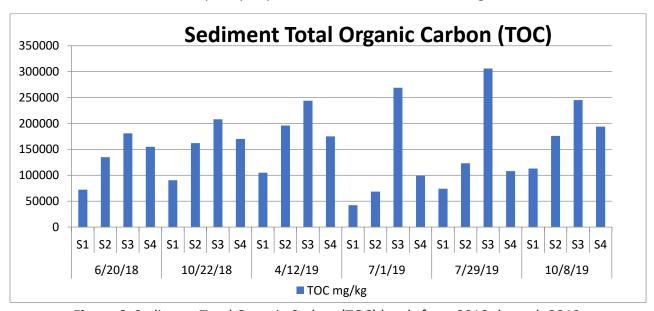
The TOC data indicates that there is plenty of potential for further sediment digestion in the future.

Figure 6. Sediment Total Organic Carbon (TOC) levels from 2018 through 2019.

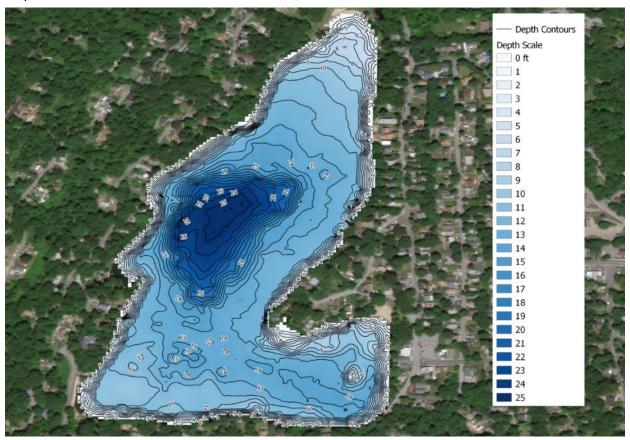
Contour Map (4/24/18) – The deepest reading obtained in the lake was 26.3 feet. We recorded only a handful of readings over 26 feet. This indicates that the area over 26 feet was very small.

The contour maps for the lake along with a color-coded scale are shown below. The 2018 map shows the lake depth increasing in virtually all areas of the lake, meaning the soft organic sediments are being biodegraded. This organic sediment is likely years of dead and decaying weed and algal growth that contains a lot of nutrients to fuel future growth. By reducing the organic sediments, nutrients are also being reduced and converted into food for aquatic insects and fish.

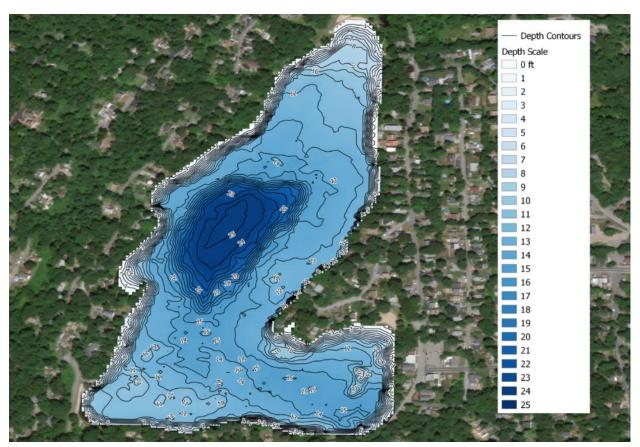
Contour Map (10/8/19) – Comparing this contour to April 2018, you will see the deep contours have all increased in size. This indicates the lake is getting deeper due to organic sediment reduction.

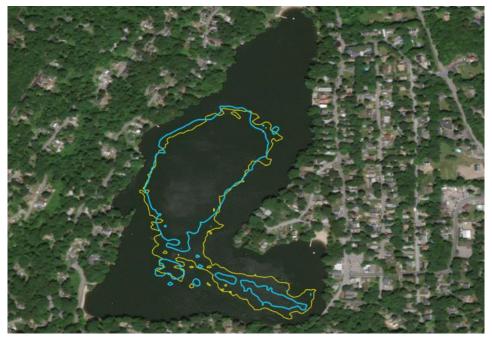
The contour that has seen the most notable growth is the 14 foot contour. The figure below (figure 7) shows the comparison of the 14-foot contour from April 2018 and from the most recent scan. The light blue line represents the contour in 2018 while the yellow line represents the contour from 2019. The contour grew from encompassing a 14-acre area to an 18-acre area.

Figure 7. Comparison of 14-foot contour from 2018 and 2019. The light blue contour is from 2018 and the yellow contour is from 2019.

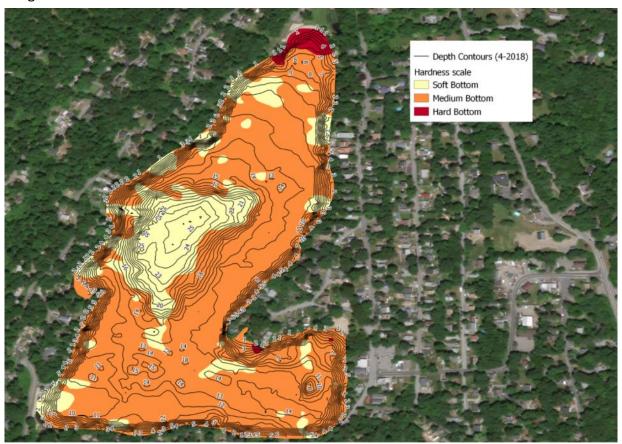
Bottom Composition Map 4/24/18 –As you can see on the map above, lighter colors are associated with greater soft sediments and the darker orange and red colors are associated with less soft sediments.

The bottom composition maps for the lake, along with a color-coded scale, are shown in the maps below. The scale goes from light tan (softest) to red (hard bottom). The softest areas contain large amounts of loose organic sediment. In areas where there is less organic sediment, the color changes to orange and ultimately red if there is no soft organic sediment.

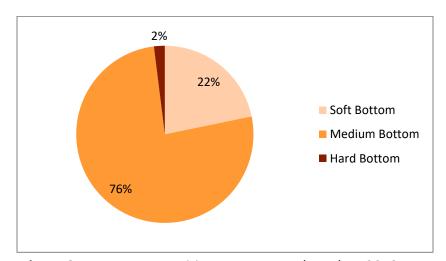
The pie chart below shows the amount of soft, medium and hard bottom sediments in April 2018. This chart indicates 22% soft bottom, 76% medium bottom and 2% hard bottom.

Figure 8. Bottom composition percentages based on 2018 scan

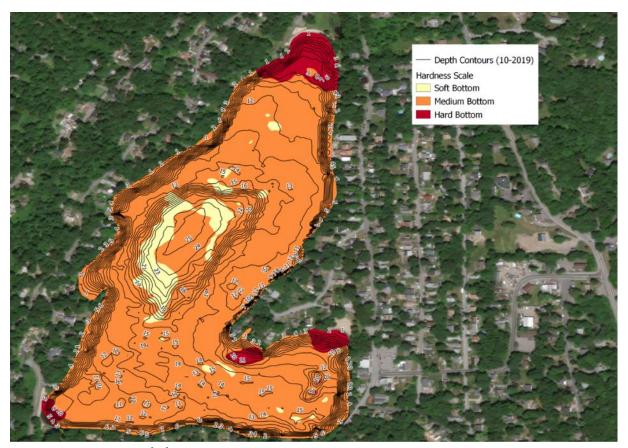
Bottom Composition Map 10/8/19 – Comparing the 2019 map to the 2018 map, there is an obvious change in bottom composition from soft to harder sediments around the entire lake.

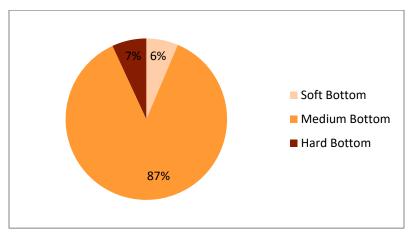
The pie chart below shows the amount of soft, medium and hard bottom sediments in October 2019. This chart indicates 6% soft bottom, 87% medium bottom and 7% hard bottom. The key parameter is the increase in red, or hard bottom since this means that organic sediments have been completely digested. The red hard bottom has increased from 2% to 7%. A comparison to the scan in April 2018 shows a 16% reduction in soft sediments. The medium bottom areas have increased due to the soft sediments reducing to medium hardness because of the system & treatments. The ratio of soft to medium is not critical as long as hard bottom gradually increases.

Figure 9. Bottom composition percentages based on 2019 scan

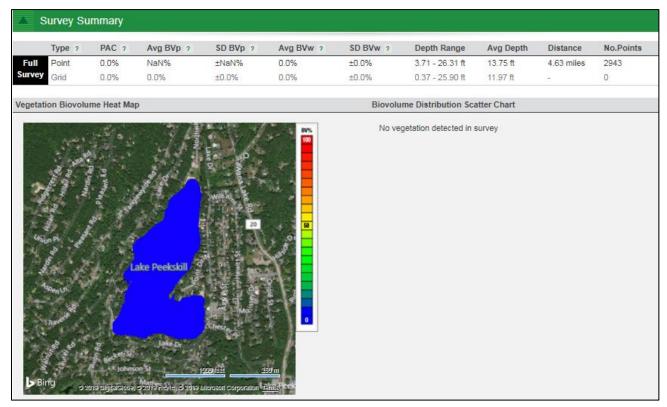
Vegetation Biovolume 4/24/18 – The vegetation biovolume details above shows areas of vegetation and density of the vegetation. The measurement scale shows that red is the highest density of biovolume followed by yellow, green and then blue. At the time of the scan in April 2018 there was no vegetation detected in the lake.

Comparing these reports shows that minimal vegetation has grown over the time the system has been in operation. Some natural vegetation is beneficial for aquatic life and provides habitat for fish. Natural vegetation will also utilize nutrients that would otherwise be utilized by algae. The progression of aquatic plant growth will be monitored with future scans.

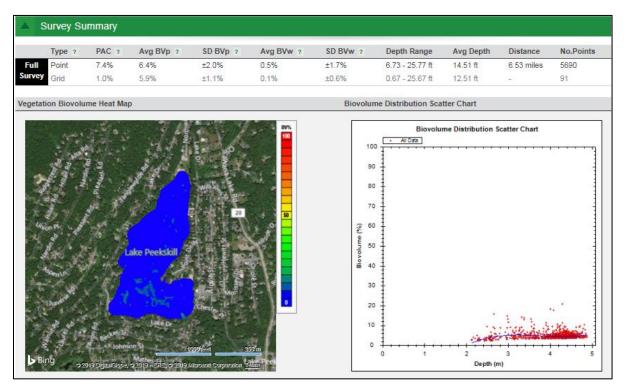
Vegetation Biovolume 10/8/19 – The vegetation biovolume details are shown above. At the time of the scan, some vegetation was detected.

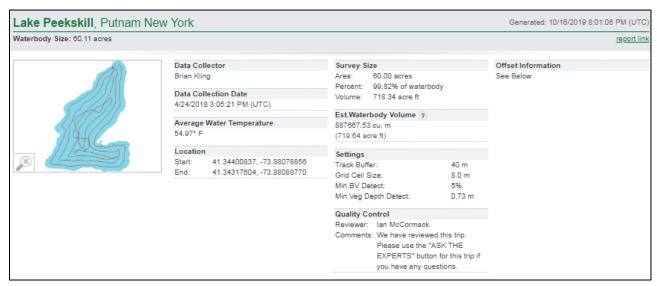
Scan Details 4/24/18 – Additional details of the April 2018 scan are shown above. The water body was 718.34 acre-feet in volume with an average depth of 11.95 feet.

Based on the scans, the lake has gained 33.57 acre-feet due to digestion and elimination or organic sediments. This amount is equal to 54,159.6 cubic yards.

NB: It should be noted that the water level of the lake was 42 inches below the spillway in 2019 but at the level of the spillway in 2018. This difference is an input into software algorithm so that the water volume calculations are all computed back to the same equivalent water level in order to ensure that they are comparable.

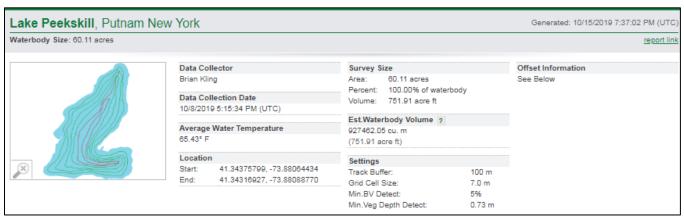
Scan Details 10/8/19 – The scan details above show the volume of water in October 2019 is 751.91 acre-feet with an average depth of 12.5 feet.
