Lake Peekskill 2021 Annual Report

Town of Putnam Valley
265 Oscawana Lake Road
Putnam Valley, NY 10579

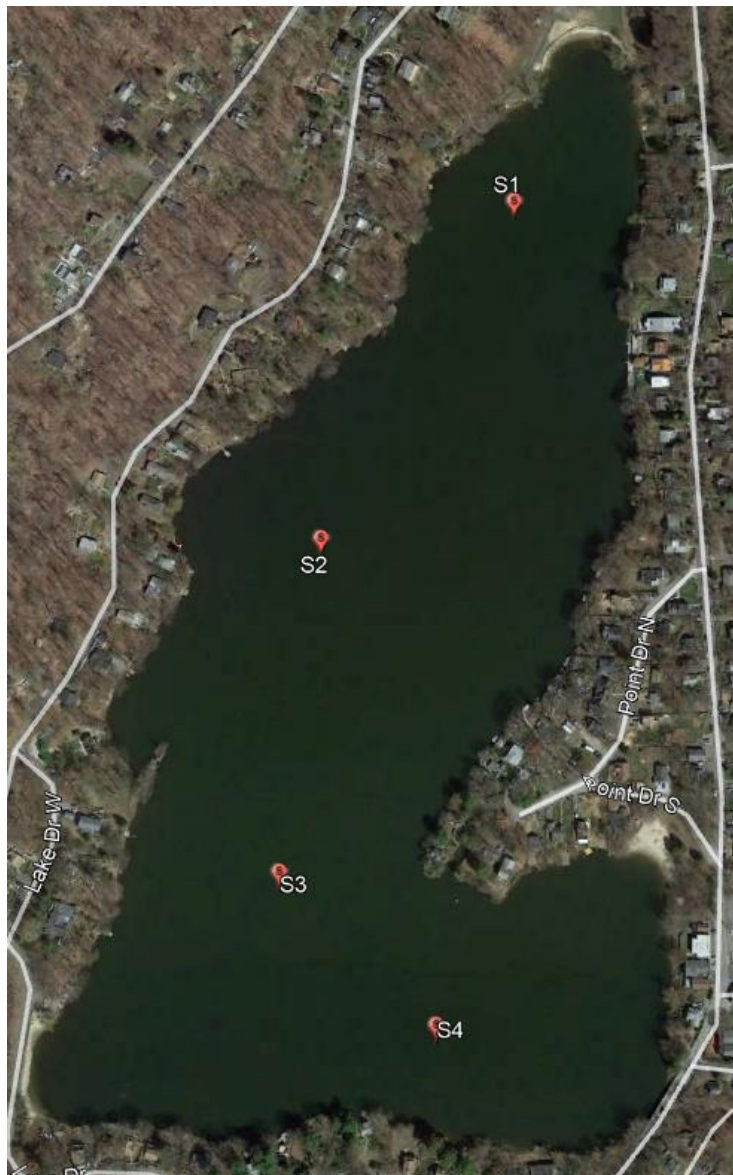
Figure 1. Sampling locations on Lake Peekskill

Water samples were taken on April 29th, May 25th, and July 25th, 2021. Samples were analyzed for total phosphorus (TP), orthophosphate, and algae. Samples were taken at four locations, with the exception of algal community, which were only taken at S1, S2, and S3, in accordance with the contract. Sediment samples were also taken at all four locations to analyze total organic carbon (TOC) and phosphorus levels in the sediment. The sample locations in the lake are shown in Figure 1 below. The sample results and analysis are illustrated in the following sections.

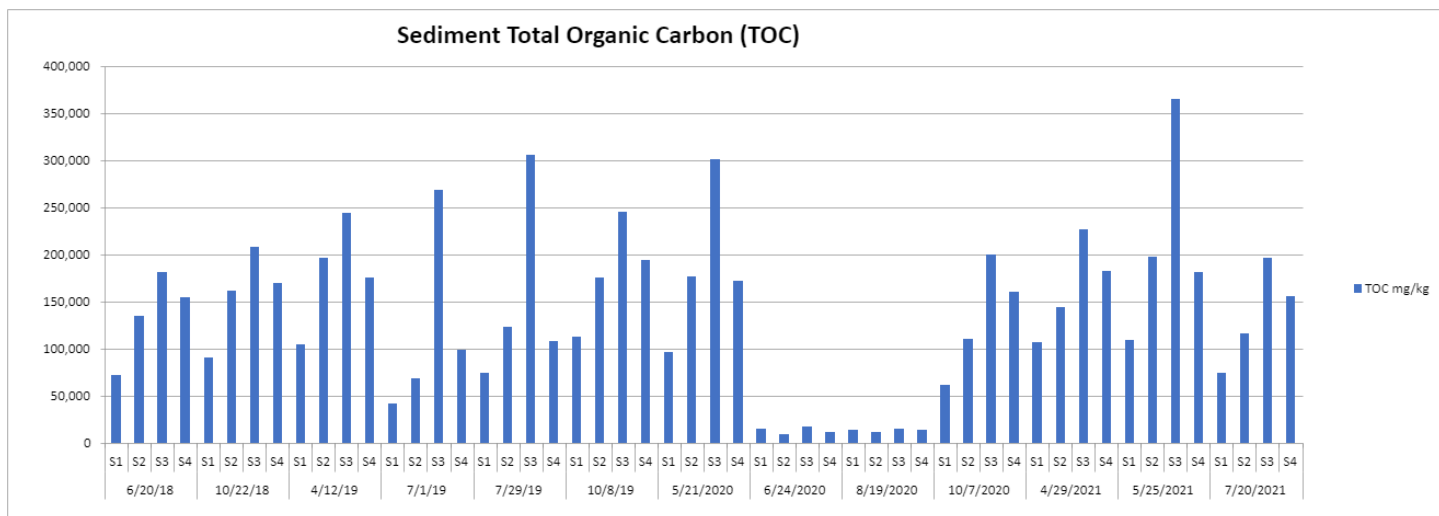
Figure 5. Total Organic Carbon (TOC) in Sediment 2018-2021

The TOC data presented in Table 9 and in Figure 5 indicate that there have been relatively consistent concentrations of organic matter in the sediment since the project began, with the exception of a substantial dip in the summer of 2020. This was likely due to the performance of the Clean-Flo oxygenation-inversion system and Clean & Clear™ applications – which prioritize muck reduction – in the 2020 season. TOC results are not an indication of organic muck removal. Instead, they indicate that the organic content of the muck has remained relatively constant and that therefore there remains considerable amounts of organic matter still to remove. This is born out by the continued depth and volume increases that have been observed annually.

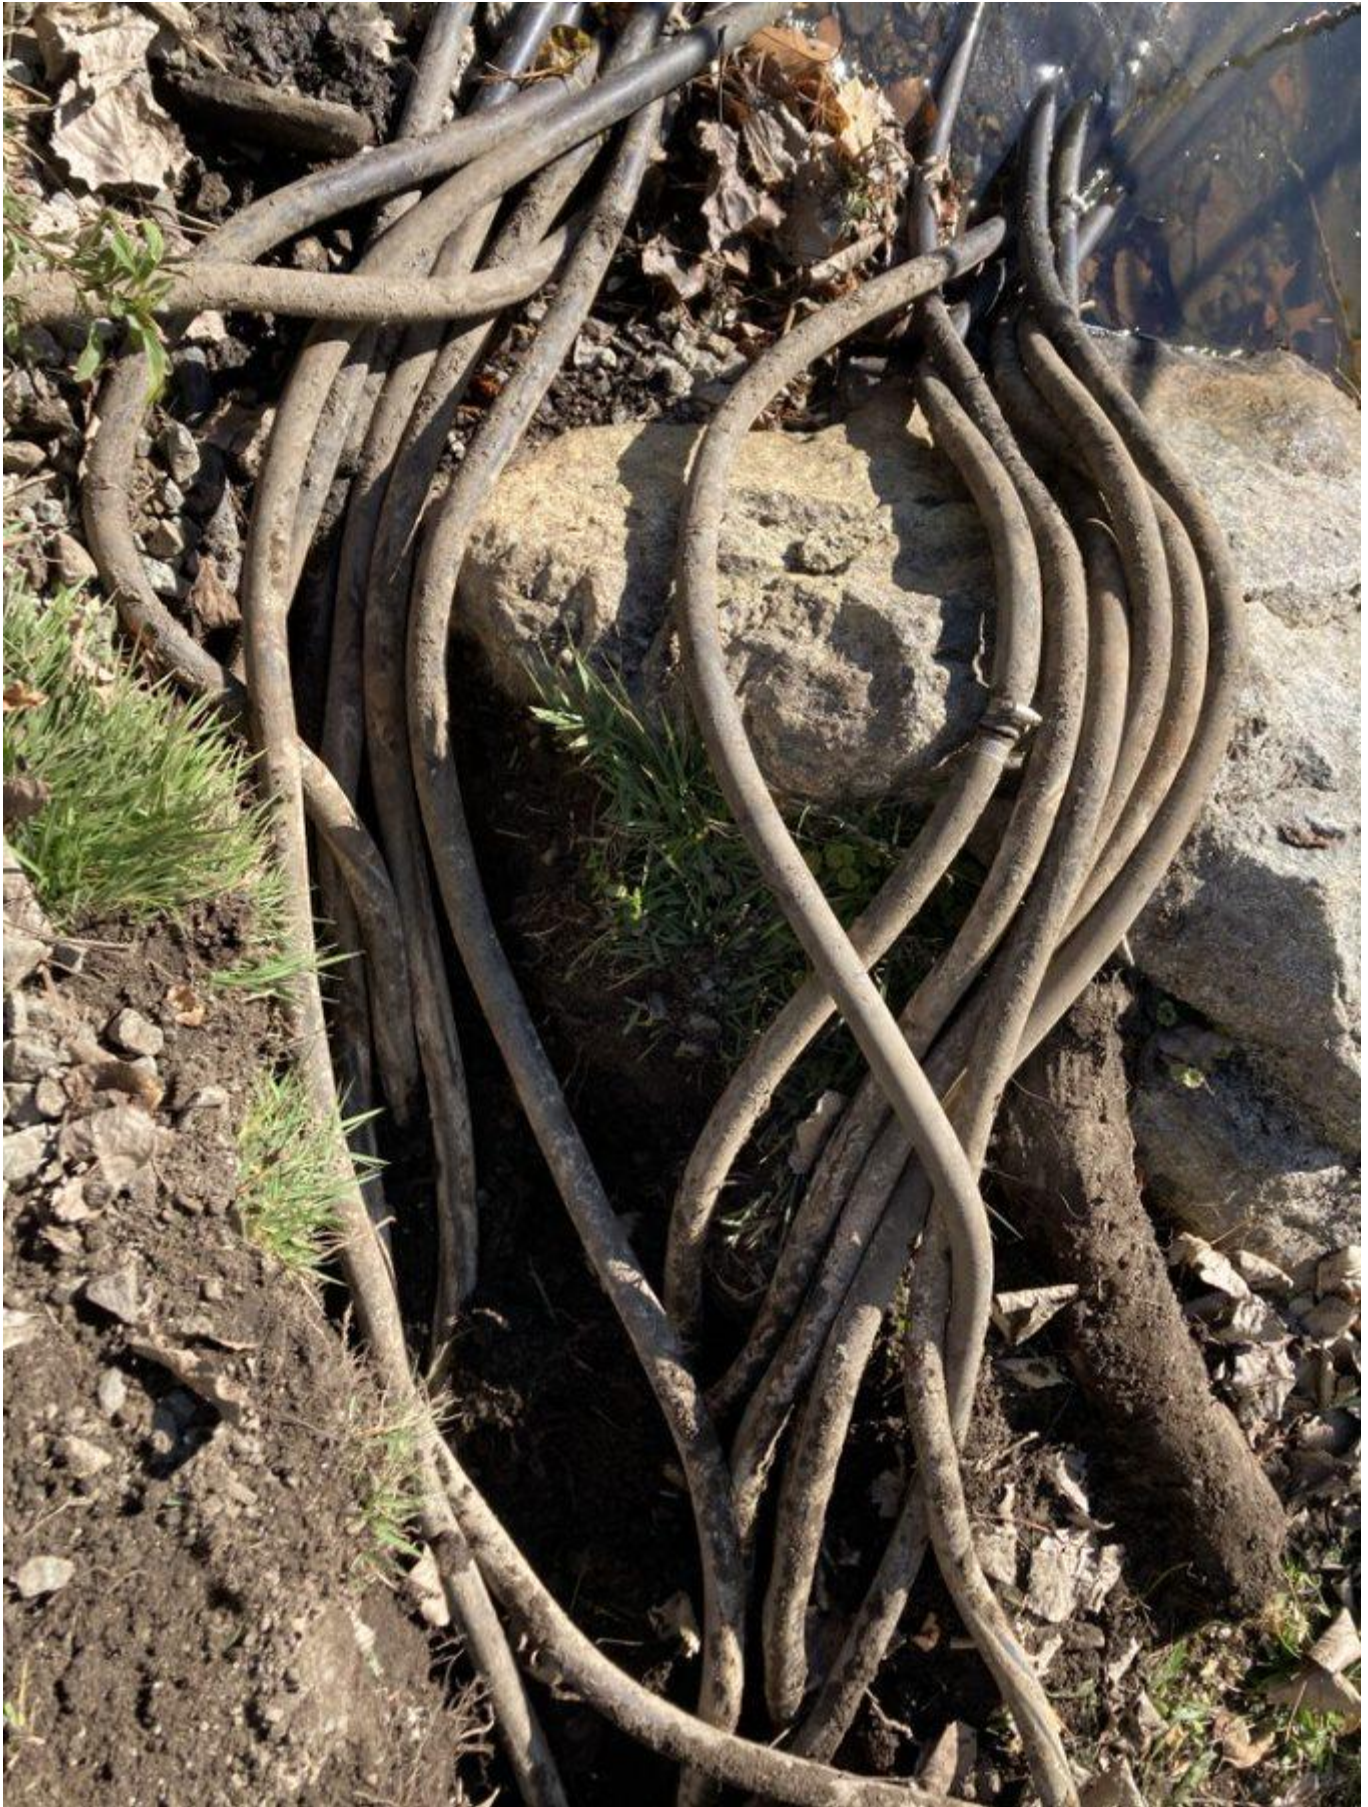
In consulting with town personnel, it became apparent that some of the airlines near the shoreline had cracked and were releasing air. Clean-Flo concluded that UV radiation from sunlight had weakened and cracked the airline, which resulted in the insufficient air supply to the diffuser closest to S2. In response, Clean-Flo replaced the airline between the shed and the lake and installed corrugated piping to cover it. After testing DO levels just after repairs (see data at S2 on 10/20/21 in Table 2), the system was back to full operation and was oxygenating the deepest area of the lake as designed. We expect that further monitoring will indicate that a healthy oxygen level is being maintained in the deepest parts of the lake.

Image 1: Airlines between the shed and the shoreline were excavated to locate break in airline to deepest diffuser. Airlines for all diffusers were replaced in this section with high-temperature airline.
