LAKE PEEKSKILL 2022 WATER QUALITY AND MACROPHYTE REPORT

TOWN OF PUTNAM VALLEY, PUTNAM COUNTY, NEW YORK

PROJECT NUMBER: 0075.017
JANUARY 2023

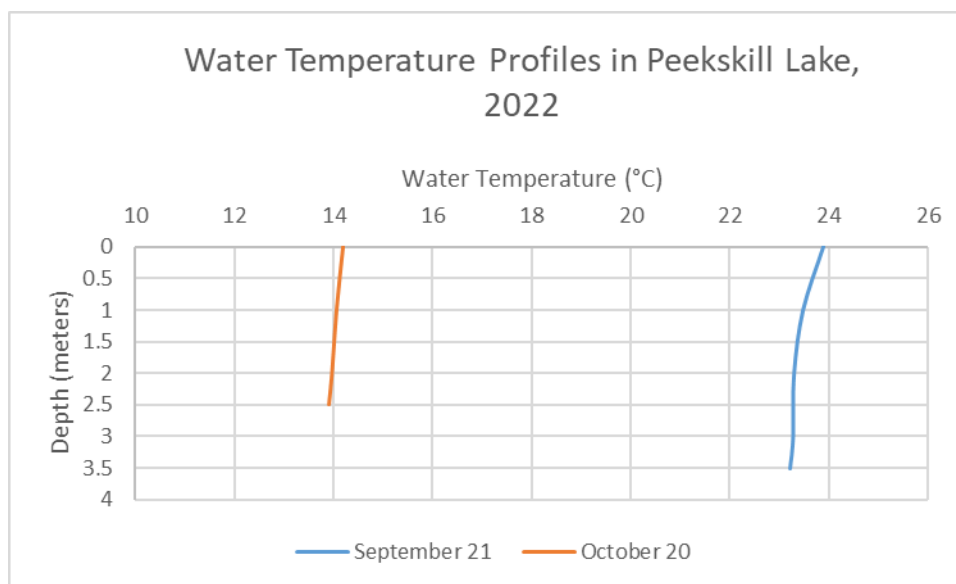
During both of the water quality events, Lake Peekskill was measured to be well-mixed thermally. The lake’s aeration system likely contributed to this, as likely did decreasing fall air temperatures. Dissolved oxygen concentrations were sufficient throughout the water column during both events. During the September event, dissolved oxygen was measured at somewhat supersaturated concentrations (>100%); this likely was contributed to by the cyanobacteria bloom that was observed to be occurring on the lake during this date. Increased amounts of cyanobacteria, algae, and/or plants can often add larger concentrations of dissolved oxygen into the water column through photosynthesis.

Figure 1. Temperature profiles at the south station at Peekskill Lake during two dates in 2022.

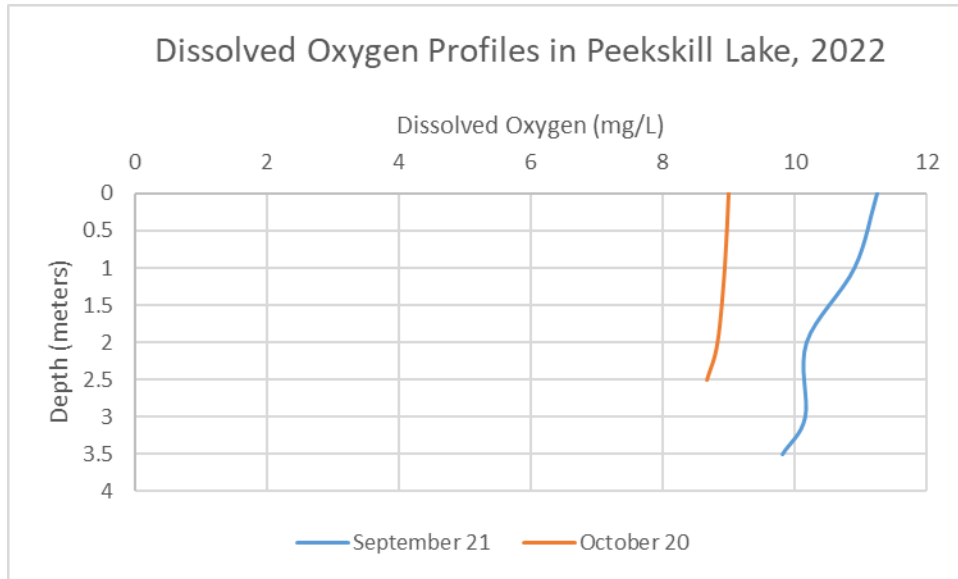
Figure 2. Dissolved oxygen profiles at the south station at Peekskill Lake during two dates in 2022.

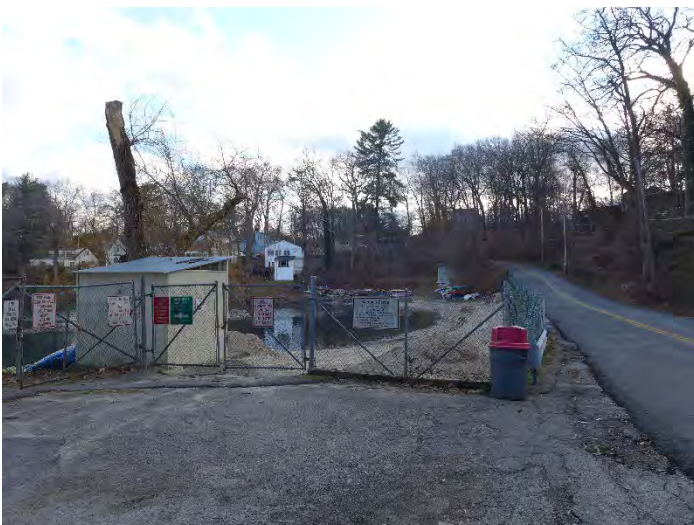
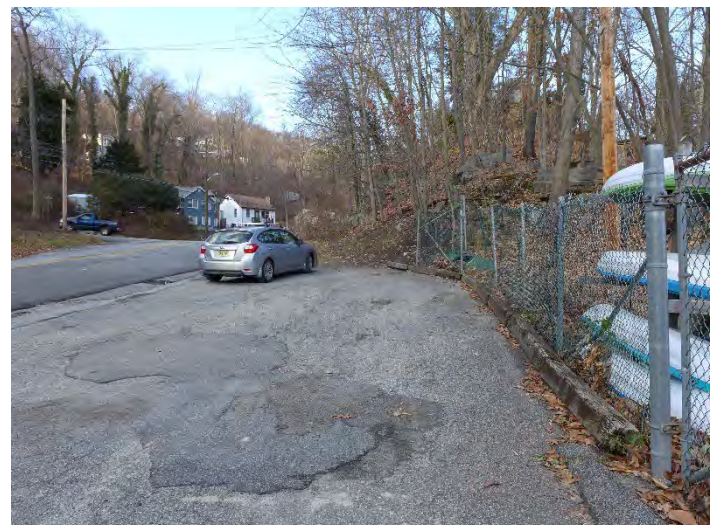
Carraras Beach is in the southwestern corner of Lake Peekskill and the asphalt lot and shoulder lead to the gates that allow vehicular access to the sand boat launches. There are stored boats, a small structure, and a swimming beach within the cove. A portion of the stormwater from Lake Drive flows into inlet grates above and below the paved lot near the lake edge. The discharge point for these inlets was not observed due to lack of access to the gated area near the water's edge. Stormwater that does not get captured by these drainage structures appears to sheet flow or pond and flow from the roughly paved parking area onto the beach. Several timber curbs and rolled asphalt curbs have been placed assumably to prevent this runoff and/or define the limits of the paved lot. Sand looks to be brought in to relieve the erosion on the beach, notably where there is a drop in grade where the paving meets the sand at gates perpendicular to Lake Drive. Refer to Photos 1 and 2 to see the parking area and drainage structures. The drainage area to the potential BMP is paved roadway/shoulder, paved lot and an area of eroding slope that bounds the paved lot.

Photo 1: Access lot at Carraras Beach (looking north)

Photo 2: Access lot at Carraras Beach (looking south)

Recommendation Site 1A: The recommended Best Management Practice (BMP) would be to disconnect the impervious surface via a pavement conversion of portions of the access lot coupled with connecting the existing vegetated areas for potential conveyance, storage, and filtration of the runoff. The asphalt lot area could be partially converted to either a vegetated or a porous pavement system, which allows for filtration of stormwater prior to entering the lake or other drainage system thus reducing the total amount of sediment and excess nutrients discharged into the lake. The conversion of paved surfaces will also reduce stormwater velocities, ponding of stagnant water, provide filtration, and general enhancement to the public space. Vegetated pavers or porous pavement may require underdrains and have outlet structures connected to the existing stormwater collection system via piping under the lot.

Estimated Costs Site 1A: The approximate cost for design, permitting, and implementation of this BMP recommendation is anticipated to be between \$100,000 and \$200,000 the cost could vary based on the area of the improvements and potential infrastructure.

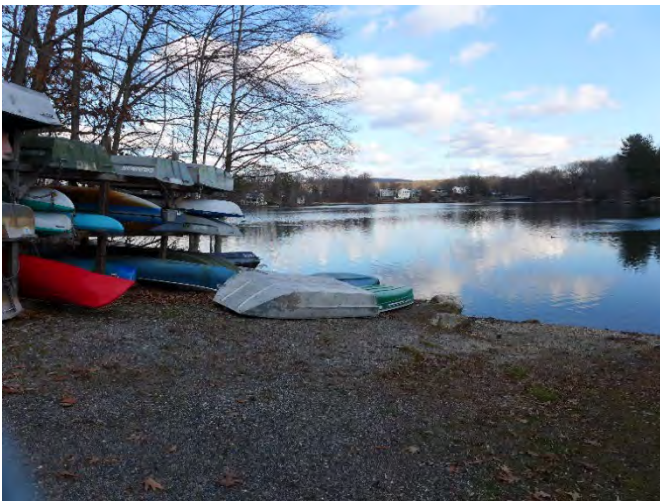
The Carraras Beach lakeshore occupies the areas from the paved edge of Lake Drive and wraps the southwestern corner of the lake. There is a swimming beach, a northern boat launch with storage area, and a southern boat launch with storage area. The northern boat launch and storage area consists of a loose gravel and soil mix to the water's edge while the southern launch appears to be sand with the boat storage being on heavily compacted soil on a terrace built up with boulder facing. Areas of high use become compacted and impermeable over time.

Photo 3: Carraras Beach waterfront northern boat launch

Recommendation Site 1B: Converting the two existing boat ramps to vegetated pavers will filter the surrounding impervious surface runoff into the ground before the sediment and pollutants contained within it flow completely into the lake. In addition, portions of the beach shore could benefit from the introduction of native aquatic plants, potential regrading, and a vegetated buffer to provide increased nutrient uptake by the lake ecosystem and reduce additional nutrient loading from entering the lake. The lake would also benefit from increased aeration within the water column in this area with other in-lake measures such as Floating Wetland Islands or Biochar to increase the removal of nutrients from the pool's water column.

Estimated Costs Site 1B: The approximate cost for design, permitting, and implementation of this BMP is anticipated to be between \$200,000 and \$450,000. These recommendations may be implemented separately or as one larger improvement project. The costs assume implementation as a single project.

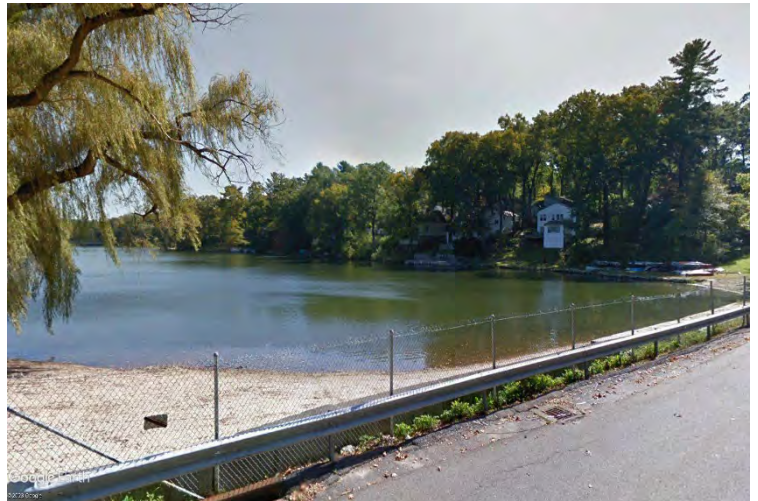
Photo 4: Carraras Beach lakeshore looking south to southern boat launch.

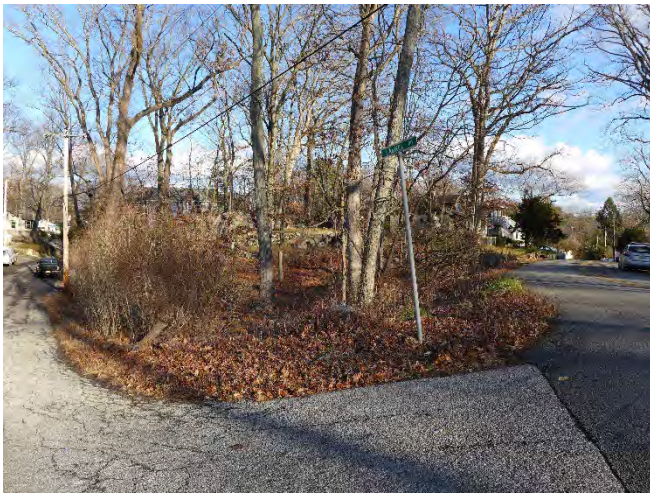
Site 2 is the wooded lot at the northeast corner of the intersection of Becker Street and Laurel Road. Both Laurel Road and Becker Street have no observed stormwater inlets immediately above or below the lot. The asphalt surfaces from the centerline in both directions appear to drain toward the lot. The wooded lot has a significant depression compared to the surrounding area and was observed to have evidence of receiving runoff drainage in the recent past, though no piped outfalls were observed. In its current state the vegetation is a mixture of trees, areas of exposed rock outcrops, native and invasive shrubs and vines with little to no visible understory at the time of site visit in December. Refer to photos 5 and 6 for existing conditions.

Photo 5: Sheet flow condition at pavement edge

Recommendation Site 2: The recommendation for this site is to take advantage of the natural low point in the woodlot and create a vegetated filter strip, bioswale or other bioretention area. This location already has a gradually sloping vegetative buffer between the impervious area and the recommended best management practice. Creating a bioswale at the edges and populating it with multi-stress tolerant perennial plants could be an additional beneficial use of this wooded lot. Any runoff from the residential houses that enter the roadway adjacent to this lot would also be slowed and filtered in addition to flow from the roads themselves. It is not recommended at this time to remove existing healthy trees for the purposes of stormwater management interventions. Property ownership and depth to bedrock/soil conditions would also need to be assessed and found suitable in order to utilize this area to further manage stormwater.

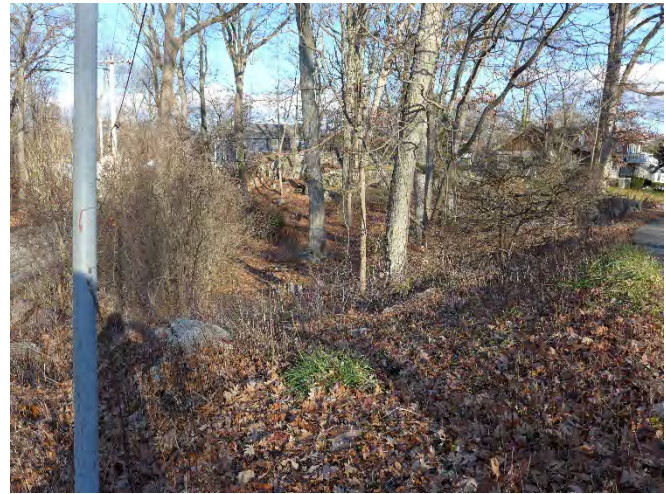
Photo 6: Existing depression and vegetation in wooded lot

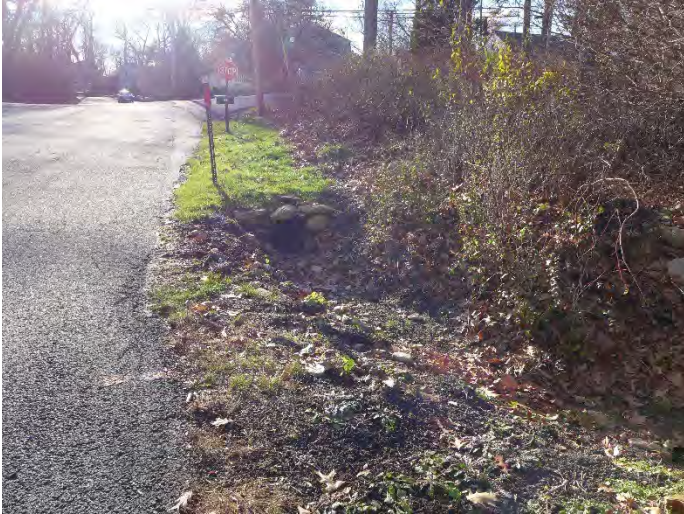
seen at this location on a dry weather day. The site is currently vegetated with trees and shrubs and was seen to have a grassy, weedy perennial layer from Google Earth imagery from the summer months. Refer to photos 7 and 8 for existing conditions.

Photo 7: Sheet flow condition at pavement edge

Recommendation Site 3: The recommendation for this site is to enhance the existing stormwater capture and retention function in the wooded lot by regrading the existing eroded and incised swale to a stabilized, vegetated stormwater conveyance and enhanced bioretention area. This location has a reasonable vegetated buffer between the impervious area and the recommended best management practice. Dense plantings and creating energy attenuation using stones at outfalls and at points along the swale would add to the ability of this site to filter sediment and absorb energy to reduce erosion from the discharge points during heavy flow events. In addition to providing scour protection, the stones will spread out the flow of water, thus increasing the treatment time. Due to the nature of this site, invasive plant species removal and treatment is also recommended. It is not recommended at this time to remove existing healthy trees or unnecessarily disturb their root zones for the purposes of stormwater management interventions. Property ownership and soil conditions would also need to be assessed and found suitable to utilize this area to further manage stormwater.

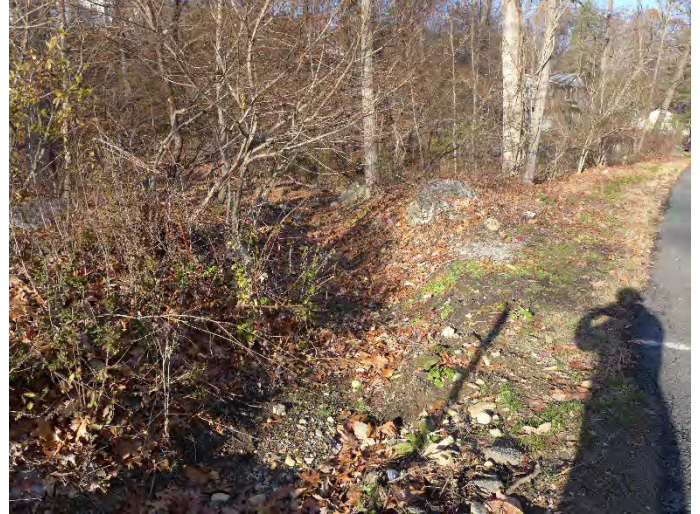
Photo 8: Existing depression in wooded lot

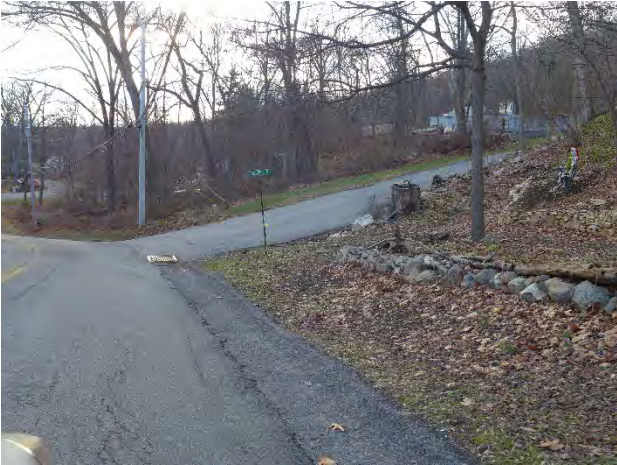
This section of Tanglewylde Road is paved with an asphalt drainage swale that runs along the northwest side of the road and ends in an inlet at the northwest corner of the intersection with Reichert Street. Photo 9 shows the location of the inlet and the asphalt drainage swale. The swale borders approximately 350 linear feet of road with a portion of the road runoff draining into it and is bordered by residential landscaped areas and/or weedy, gravel verge on the non-roadside. The impervious area of the road combined with the surrounding drainage of the sloped and thinly planted landscape areas add excess sediment and nutrients to the drainage system. The existing conditions do not filter the stormwater runoff before conveying these excess pollutants into the overall drainage system and ultimately the lake.

Photo 9: Tanglewylde Road existing asphalt ditch with potential for conversion to bioswale prior to entering drain.

Recommendation Practice 4: Convert the approximately 350 linear feet of existing asphalt ditch with vegetated conveyance that drains to the existing inlet to reduce sediment and nutrient loading into the piped drainage system. Excavating existing compacted soils and replacing with a porous media and underdrainage in addition to and replacing the sparse vegetation with dense native vegetation will promote infiltration, utilize nutrients, and reduce runoff volumes through evapotranspiration. Note that the existing width of the ditch may need to be expanded to properly grade a proposed vegetated conveyance and discussions with private property owners may be necessary depending upon the width of any town right-of-way.

Estimated Costs Site 4: The approximate cost for design, permitting, and implementation of the recommended BMPs assuming they are completed as a single project is anticipated to be between \$300,000 and \$600,000.

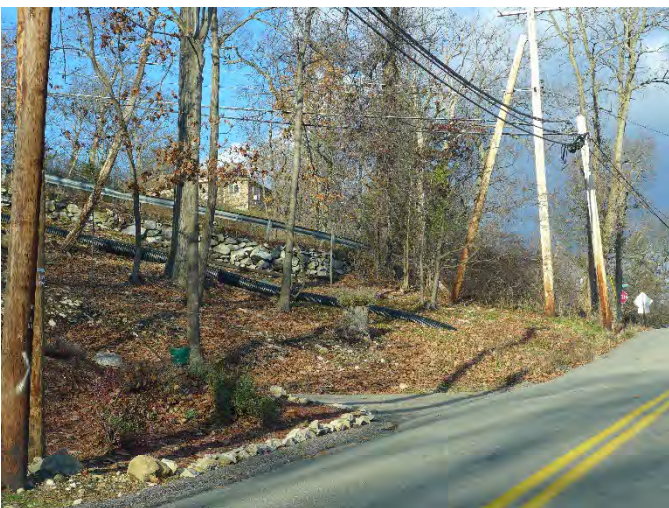
An existing 12-18" diameter HDPE pipe runs down the steep slope along the guardrail at Aspen Lane and is piped under Tanglewylde Road. The originating drainage areas that are collected into this pipe were not observed, but it is assumed that the source(s) are stormwater inlets in the right of way above the pipe possibly including portions of Pleasant and Nardin Roads. Given the steep slope that the pipe length travels, it can be assumed that the storm water that enters the pipes beneath Tanglewylde Road moves at a high velocity. Stormwater with high velocities can carry sediment and nutrients while also being an erosive force.

Photo 10: Tanglewylde Road existing overland piped conveyance potential for conversion to stabilized vegetated conveyance system.

Recommendation Practice 5: The recommended Best Management Practice (BMP) for this location would be to construct a stabilized, vegetated conveyance swale in lieu of the existing pipe. Given the steepness of this site, a series of step structures and pools would also be needed to sequester water. This would provide the reduction in stormwater velocity flowing down the steep slope as well as sequestering nutrients and sediments before they enter the culvert and eventually discharge into the lake.

Estimated Costs Practice 5: The approximate cost for design, permitting, and implementation of this BMP recommendation is anticipated to be between \$200,000 and \$300,000.

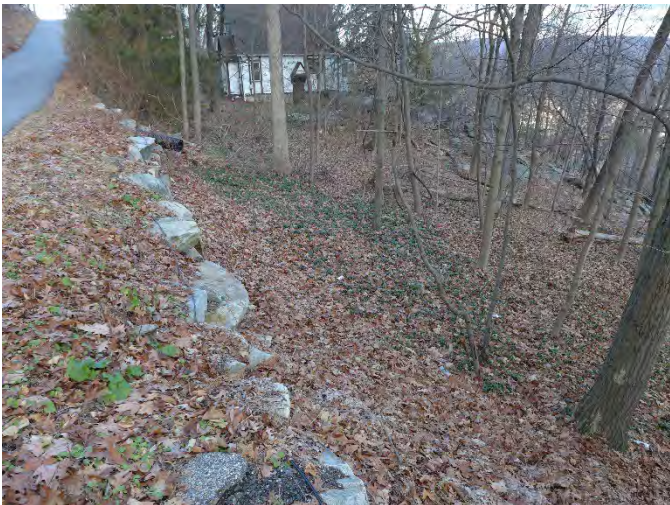
Pleasant Road is a residential street upslope of and on the western side of Lake Peekskill. A 12" HDPE pipe is seen in photos 11 and 12 that collects water and routes it under the paved road and discharges into a steeply sloped wooded lot that slopes downward to the lake. This pipe conveys assumably unfiltered sediment and nutrients from areas above and before conveying them onto the wooded slope. During heavy rainfall events, this concentrated zone of flow can lead to erosion and additional sediment deposition that can potentially end up in the lake or other intermittent water bodies in addition to destabilizing trees and soil upslope of existing structures.

Photo 11: Site 6A Culvert discharge point draining to steeply sloped wooded area.

Recommendation Site 6A: Discharging this section of piped conveyance to a stone-lined scour hole would slow water flow as it travelled down the slope and provide increased time for infiltration before it is discharged further down the slope and ultimately into the lake. Treatment for existing invasive plant species may be needed prior to planting the slopes and perimeter of the scour hole practice. Depending on available area, property ownership and suitable subsurface material, this intervention could be replicated at multiple locations where piped culverts outfall to open ground.

Estimated Costs Site 6A: The approximate cost for design, permitting, and implementation of this BMP recommendation is anticipated to be between \$150,000 and \$300,000 depending on size of bioretention area.

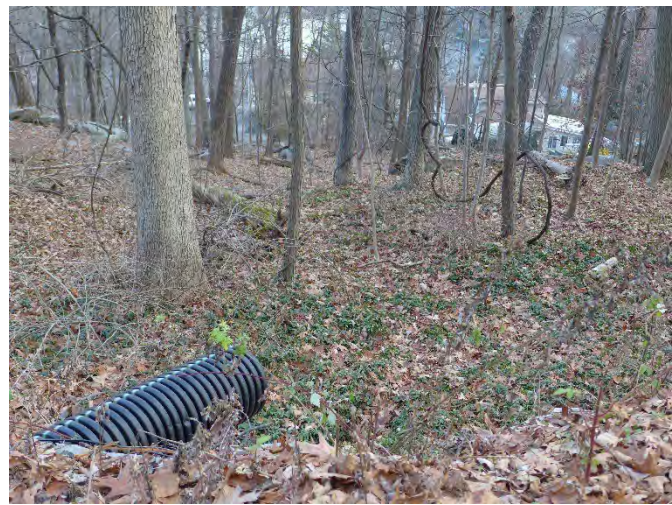
Photo 12: Site 6A Discharge Location of 12 in. HDPE pipe

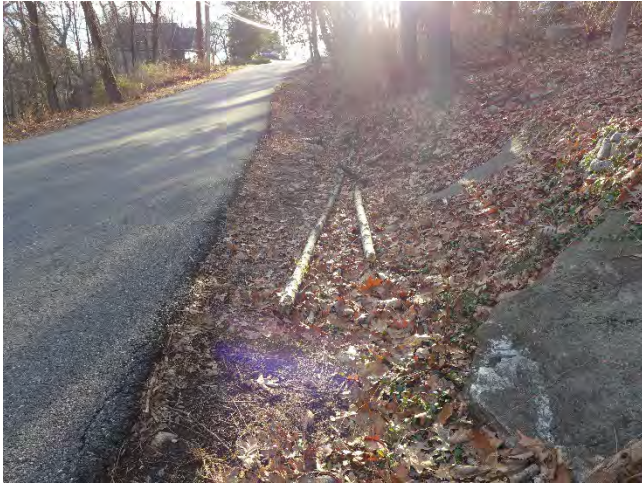
vegetated and weedy in the warmer months with shallow-rooted vegetation. Bare soil and gravel are visible indicating signs of past erosion. This ditch conveys semi-filtered sediment and nutrients from road surfaces and other runoff downstream and ultimately into the lake. During heavy rainfall events, increased flows can lead to erosion and additional sediment deposition that can potentially end up in the lake or other intermittent water bodies in addition to destabilizing the road shoulder and the root zones of roadside trees creating potential fall hazards.

Photo 23: Pleasant Road existing ditch and culvert pipe; looking south.

Recommendation Site 6B: The recommendation for this site is creating a stabilized vegetated conveyance system along the sides of the road upstream and downstream of the culvert with additional bioretention area at the culvert discharge point. The use of stone check dams within the vegetated conveyance would reduce gravel and debris from washing downstream. Increased vegetation with deep root systems would also allow water to be taken up through root structures, which could assist in slowing and filtering the flow.

Estimated Costs Site 6B: The approximate cost for design, permitting, and implementation of this BMP recommendation is anticipated to be between \$150,000 and \$400,000 depending on the width and length of the conveyance system being addressed.

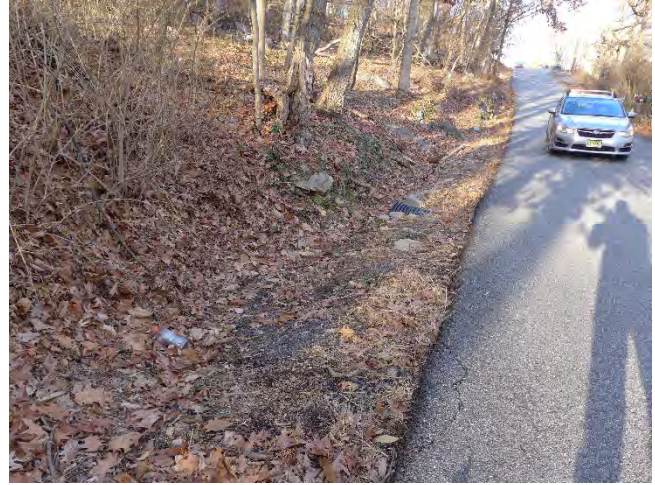
Photo 14: Pleasant Road existing ditch with bare soil; looking north.

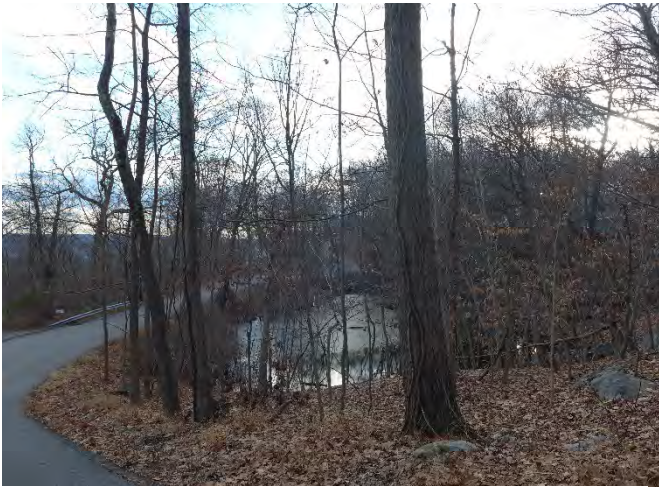
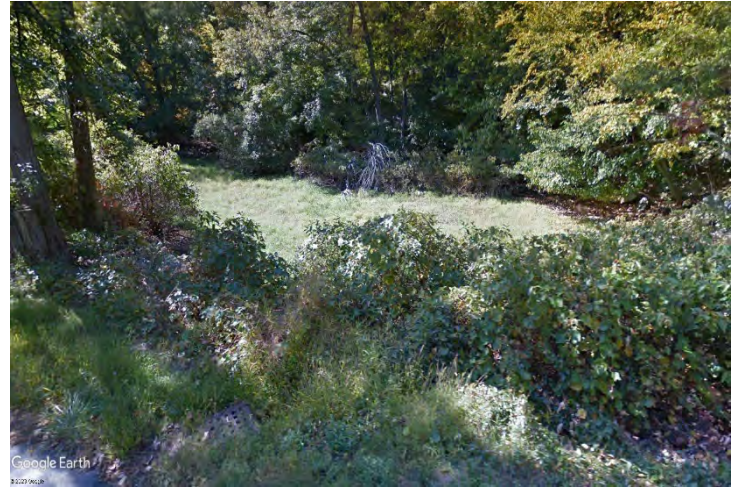
The northernmost site along Pleasant Road is an intermittent pond just off the asphalt shoulder and otherwise bordered by trees and shrubs. The source of the pond was not observed other than what appears to be sheet flow from the road and possibly piped drainage received from upslope areas. There is what appears to be an outlet structure that is piped under Pleasant Road and discharges to the east. Though this pond is observed to be intermittent, it could be a source of nutrient input to the lake and more investigation would be needed prior to implementing any recommendation and estimating nutrient removal efficiencies.

Photo 35: Pleasant Road intermittent pond, winter

Photo 46: Pleasant Road intermittent pond, summer

Recommendation Site 6C: The conversion of this pond to a constructed wetland to more effectively treat water entering the greater drainage system as well as enhancing the vegetated buffer between the pond and the road will add to this feature's function. See Figure 5 below for proposed practice. Some ecological improvements can be made by adding native emergent vegetation to provide additional nutrient assimilation before the water is discharged downstream. The stabilization of the accumulated material in the existing pond and potential use by vegetation can also serve to reduce the nutrient load to the lake.

Minor regrading, treatment of existing invasive plant species and potential replacement of the existing outlet structure may be required. Soil modification may also need to be investigated to achieve desired retention times. The combination of ecological activity improvement along with the stormwater drainage improvements described above will not only increase the water quality of the lake but improve the climate resiliency of this location.

Estimated Costs Site 6C: The approximate cost for design, permitting, and implementation of this BMP recommendation is anticipated to be between \$250,000 and \$500,000.

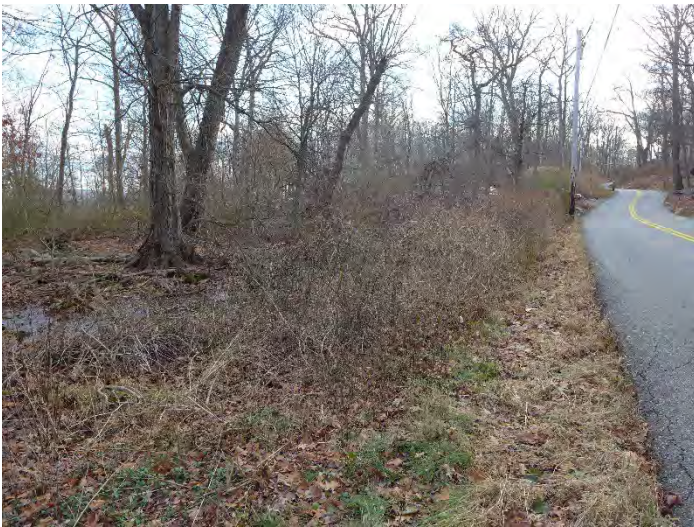
The open parcel spanning from the east side of Nardin Road through to Pleasant Road collects both sheet flow from a portion of the roads as well as piped discharge from a set of twin storm inlets on the west side of Nardin Road. Evidence of channel flow along the east side of Nardin Road in the grassy area as well as some evidence of past water movement from the Pleasant Road side are also indicative that the depression in this wooded parcel receives flow from road surface runoff. There was visible surface water in the center of the parcel at time of visiting in December as well as summertime Google imagery that may be an existing stream or wetland. The conditions of the site are shown in Photos 17, 18 and 19. The edges of the site are bordered by areas of invasive shrubs and vines, deciduous trees and an area of lawn on the Pleasant Road side. The presence of groundwater on this site would need to be assessed as part of further pre-design investigation.

Photo 17: Site 7 Vegetation and visible water on the east side of Nardin Road.

Recommendation Site 7: The recommended BMP for this location would be to install a vegetated conveyance system along the eastern side of Nardin Road and to increase the riparian buffer plantings around the conveyance and the existing wet areas. Should the area be found to contain an existing wetland, a further wetland enhancement planting using native plants adapted to these conditions for filtration function. The

Estimated Costs Site 7: The approximate cost for design, permitting, and implementation of this BMP recommendation is anticipated to be between \$500,000 and \$1.2 million.

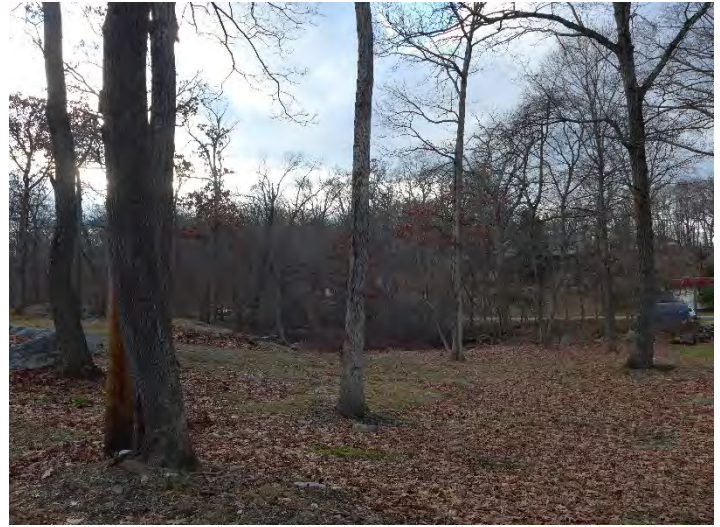
Photo 58: Site 7 Entrance Area and Discharge Inlet

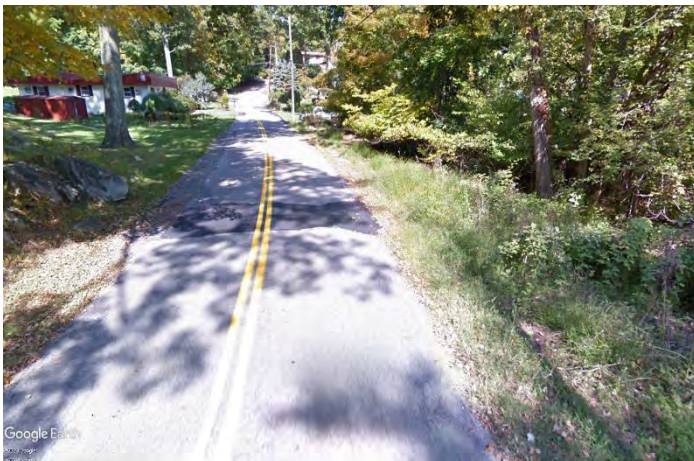
Photo 19: Site 7 Twin stormwater inlets piped across Nardin Road to site.

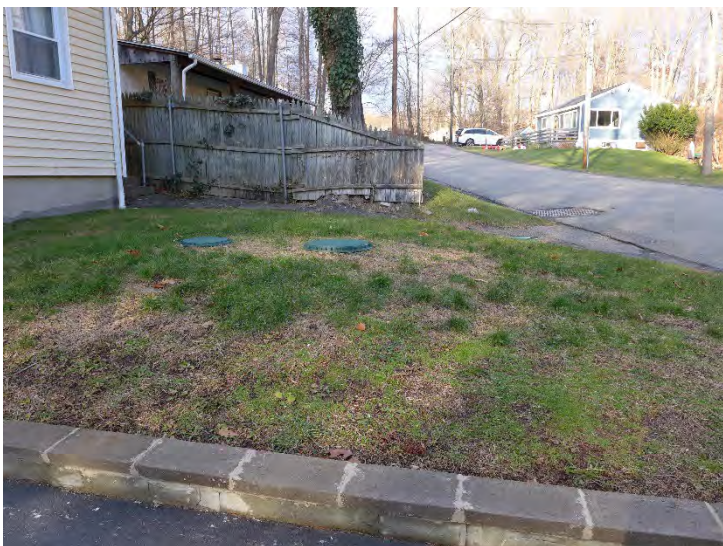
Site 8 is the Lake Peekskill Community Center building and grounds at the south end of Northway and adjacent to the beach and associated parking lot. This site consists of asphalt paths, lawn areas (one of which contains the septic tanks) and roof leaders that drain to the street. From past Google Earth imagery, many large shrubs have recently been removed from the front lawn areas. The contributing drainage area to the storm sewer is primarily from the area below the storm inlet that sits just above the property on Northway, an uncurbed road that is steeply sloped toward the lake and the building's roofs, paths and compacted lawns. The catch basins here and in the parking further south all presumably drain to the retention basin (Site 9B) located to the southeast of the site. See photos 20 and 21 of the existing conditions.

Photo 20: Grassed area with septic, upstream storm inlet and small existing asphalt path.

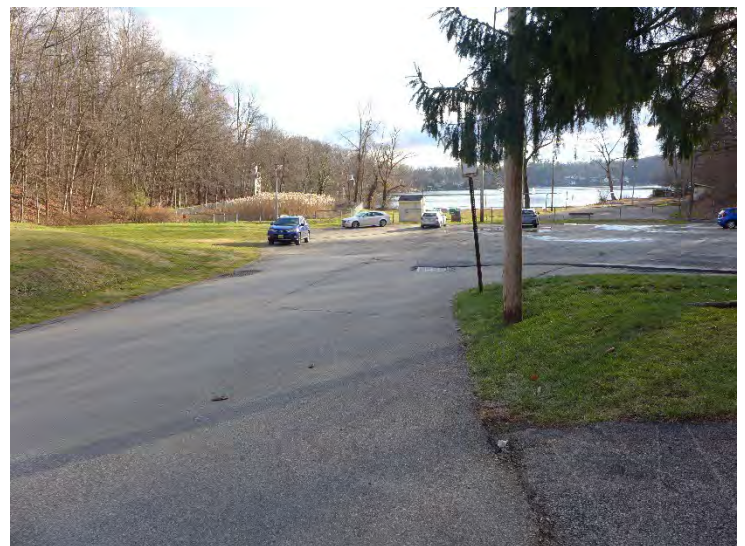
Photo 21: South grassed area for potential rain garden and downstream storm inlet.

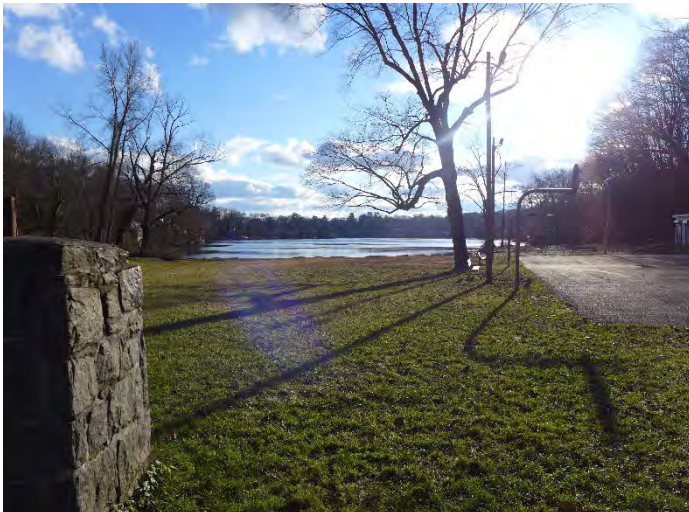
Site 9A is located within the fenced enclosure for North Beach and focuses on the grassed recreation areas adjacent the lake and the asphalt paths that run from the basketball court and to the south. The parking lot that is directly to the north of this site will be addressed separately as part of site 9B, as it has its own inlets that capture runoff and bring it to the retention basin. For recreation area itself, there were no observed stormwater management measures in place thus these impervious areas sheet flow untreated into the Lake.

Photo 22: Site 9A Compacted lawn and basketball court

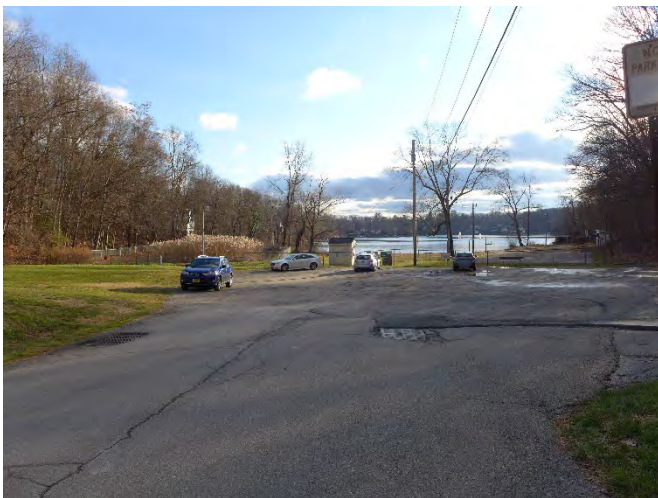
Photo 74: Looking south at parking lot and wet basin with grass area to the left.

See Figure 6 below for reference. Converting the parking area to a permeable or vegetated paver will allow runoff to be infiltrated and filtered prior to entering the conveyance as well as reducing ponding by creating a more consistently graded surface. Daylighting the piped conveyance and existing stream channel where they join and empty into the grassed area to create an extended flow path for water to remove nutrients and sediments as it moves toward the wet basin will serve both to visually enhance the site by using natural materials

and attractive native plantings. Retrofitting the existing wet basin to increase flow path may also be an option to enhance filtration capabilities and overall function of the feature. Finally, given the vegetative cover on the surrounding steep slopes, it is not thought that they are a significant contributor of sediment, however nutrient-rich leaf litter that falls downslope should be kept from entering the lake in large quantity. This can be achieved by planting a dense, shade-tolerant buffer that will retain some of the leaf-litter upslope.

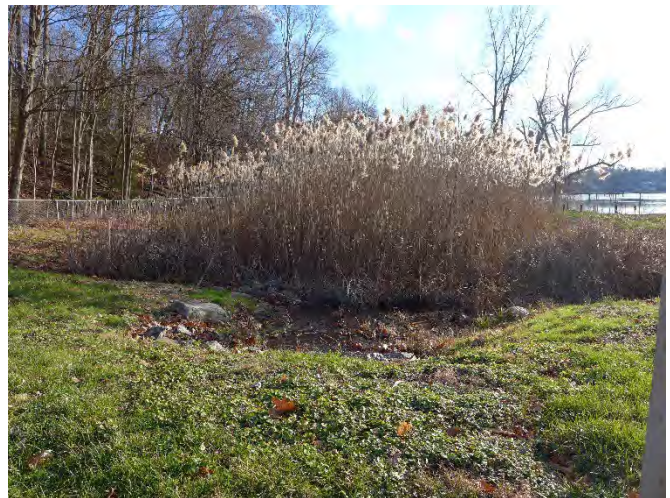
Photo 65: Entry of piped flow to existing wet basin.

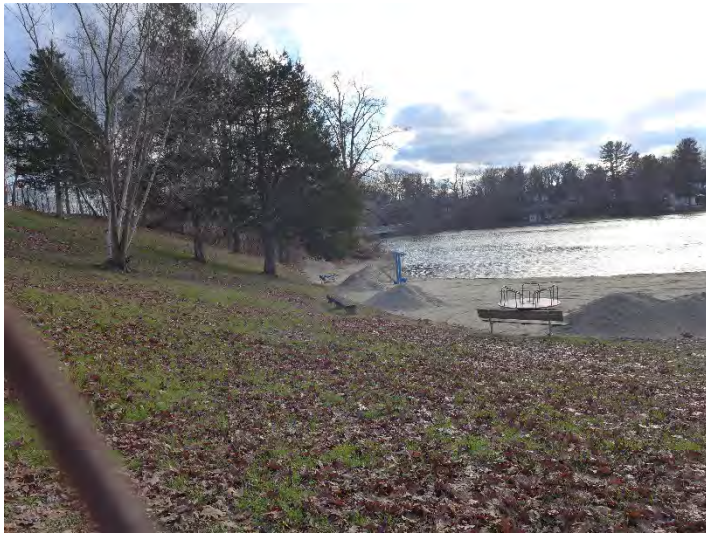
Singers Beach consists of a sand beach, small, shed structure, paved drive, and grass slope that surrounds the beach to the north and east. Only a portion of Point Drive is curbed along the beach boundary with the remaining portions sheet flowing from the road onto the compacted grass area, onto the beach and ultimately into the lake. No formal stormwater infrastructure exists on the site nor the adjacent roads. Runoff is conveyed along the roadway that is curbed and then is a concentrated discharge. At the top of the slope on Lake Drive between Morrissey Drive and Point Drive South, there is a flat area with several spruce trees that is extremely compacted and drains to the sparsely vegetated slope behind it down to the recreation area and lake.

Photo 107: Singers Beach sparsely vegetated slope.

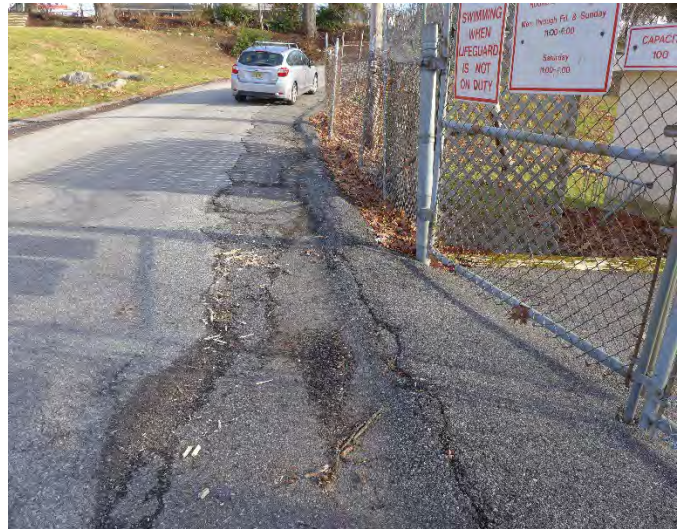
Photo 98: Curbed portion of Point Drive and paved drive at gated entry; no storm inlets.

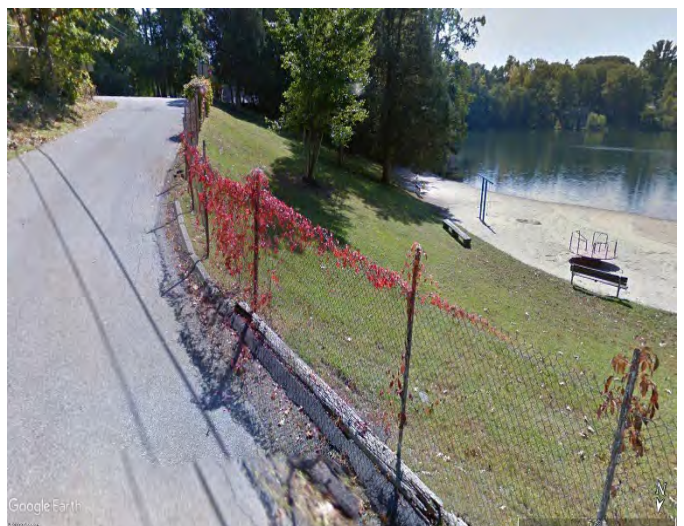
Photo 30: Location of proposed vegetated conveyance along fence line.

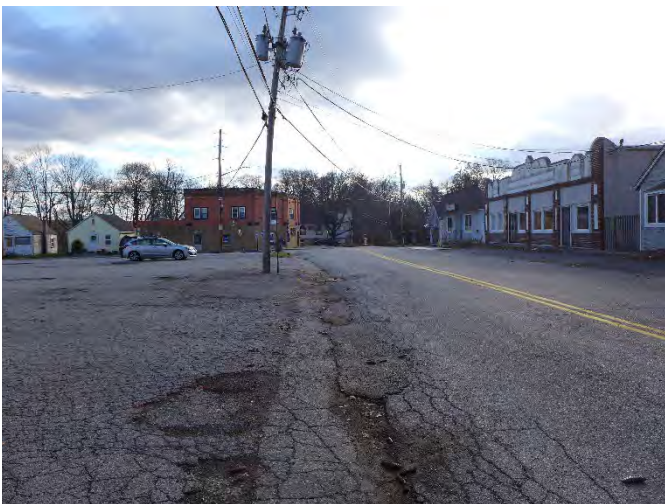
Photo 31: Parking Lot, Looking south

This large, asphalt parking lot is located at the intersection of Lake and Morrissey Drives and appears to serve the businesses and facilities at that intersection as well as possibly serving Singers Beach in the summer months. The lot is roughly 16,000 square feet of asphalt pavement with no observed storm drainage structures within its area. Inlets at the perimeter are on both bordering streets and the lot is graded to drain out to the street. The lot appears to be oversized at the time the site visit. Further investigation and understanding of the seasonal use of the parking will be necessary to make a more specific recommendation.

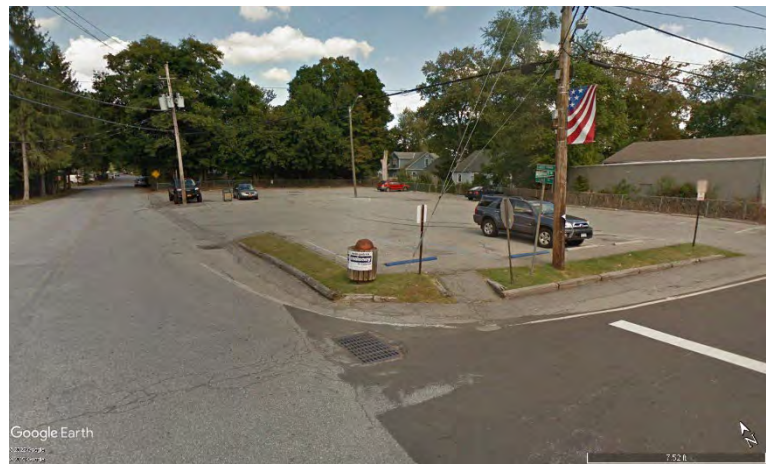
Photo 32: Outlet of parking lot drainage

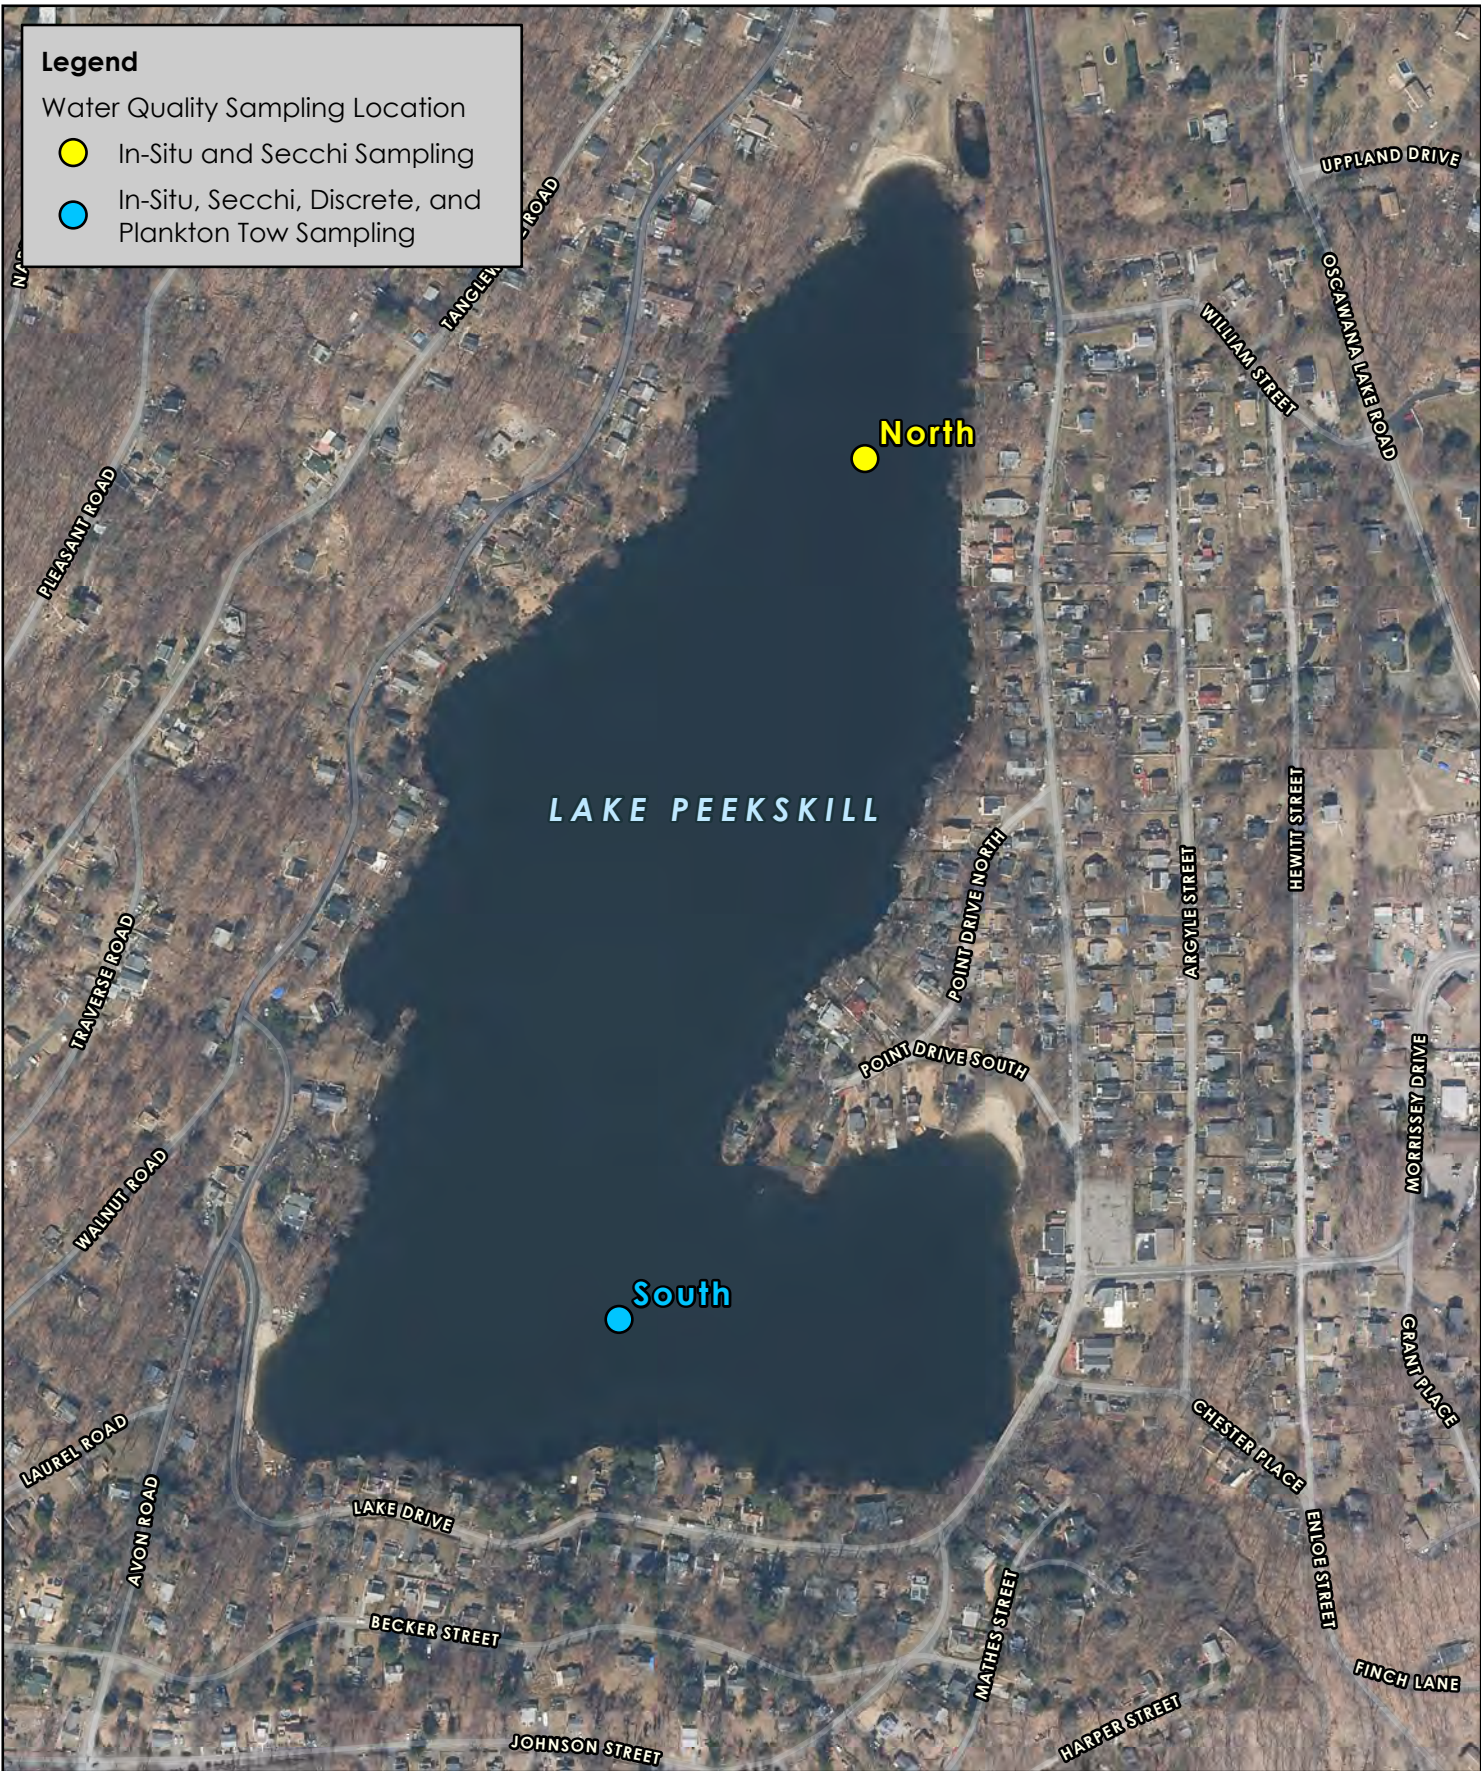
Water Quality Sampling Location
