LAKE PEEKSKILL 2022 WATER QUALITY AND MACROPHYTE REPORT

TOWN OF PUTNAM VALLEY, PUTNAM COUNTY, NEW YORK

PROJECT NUMBER: 0075.017
JANUARY 2023

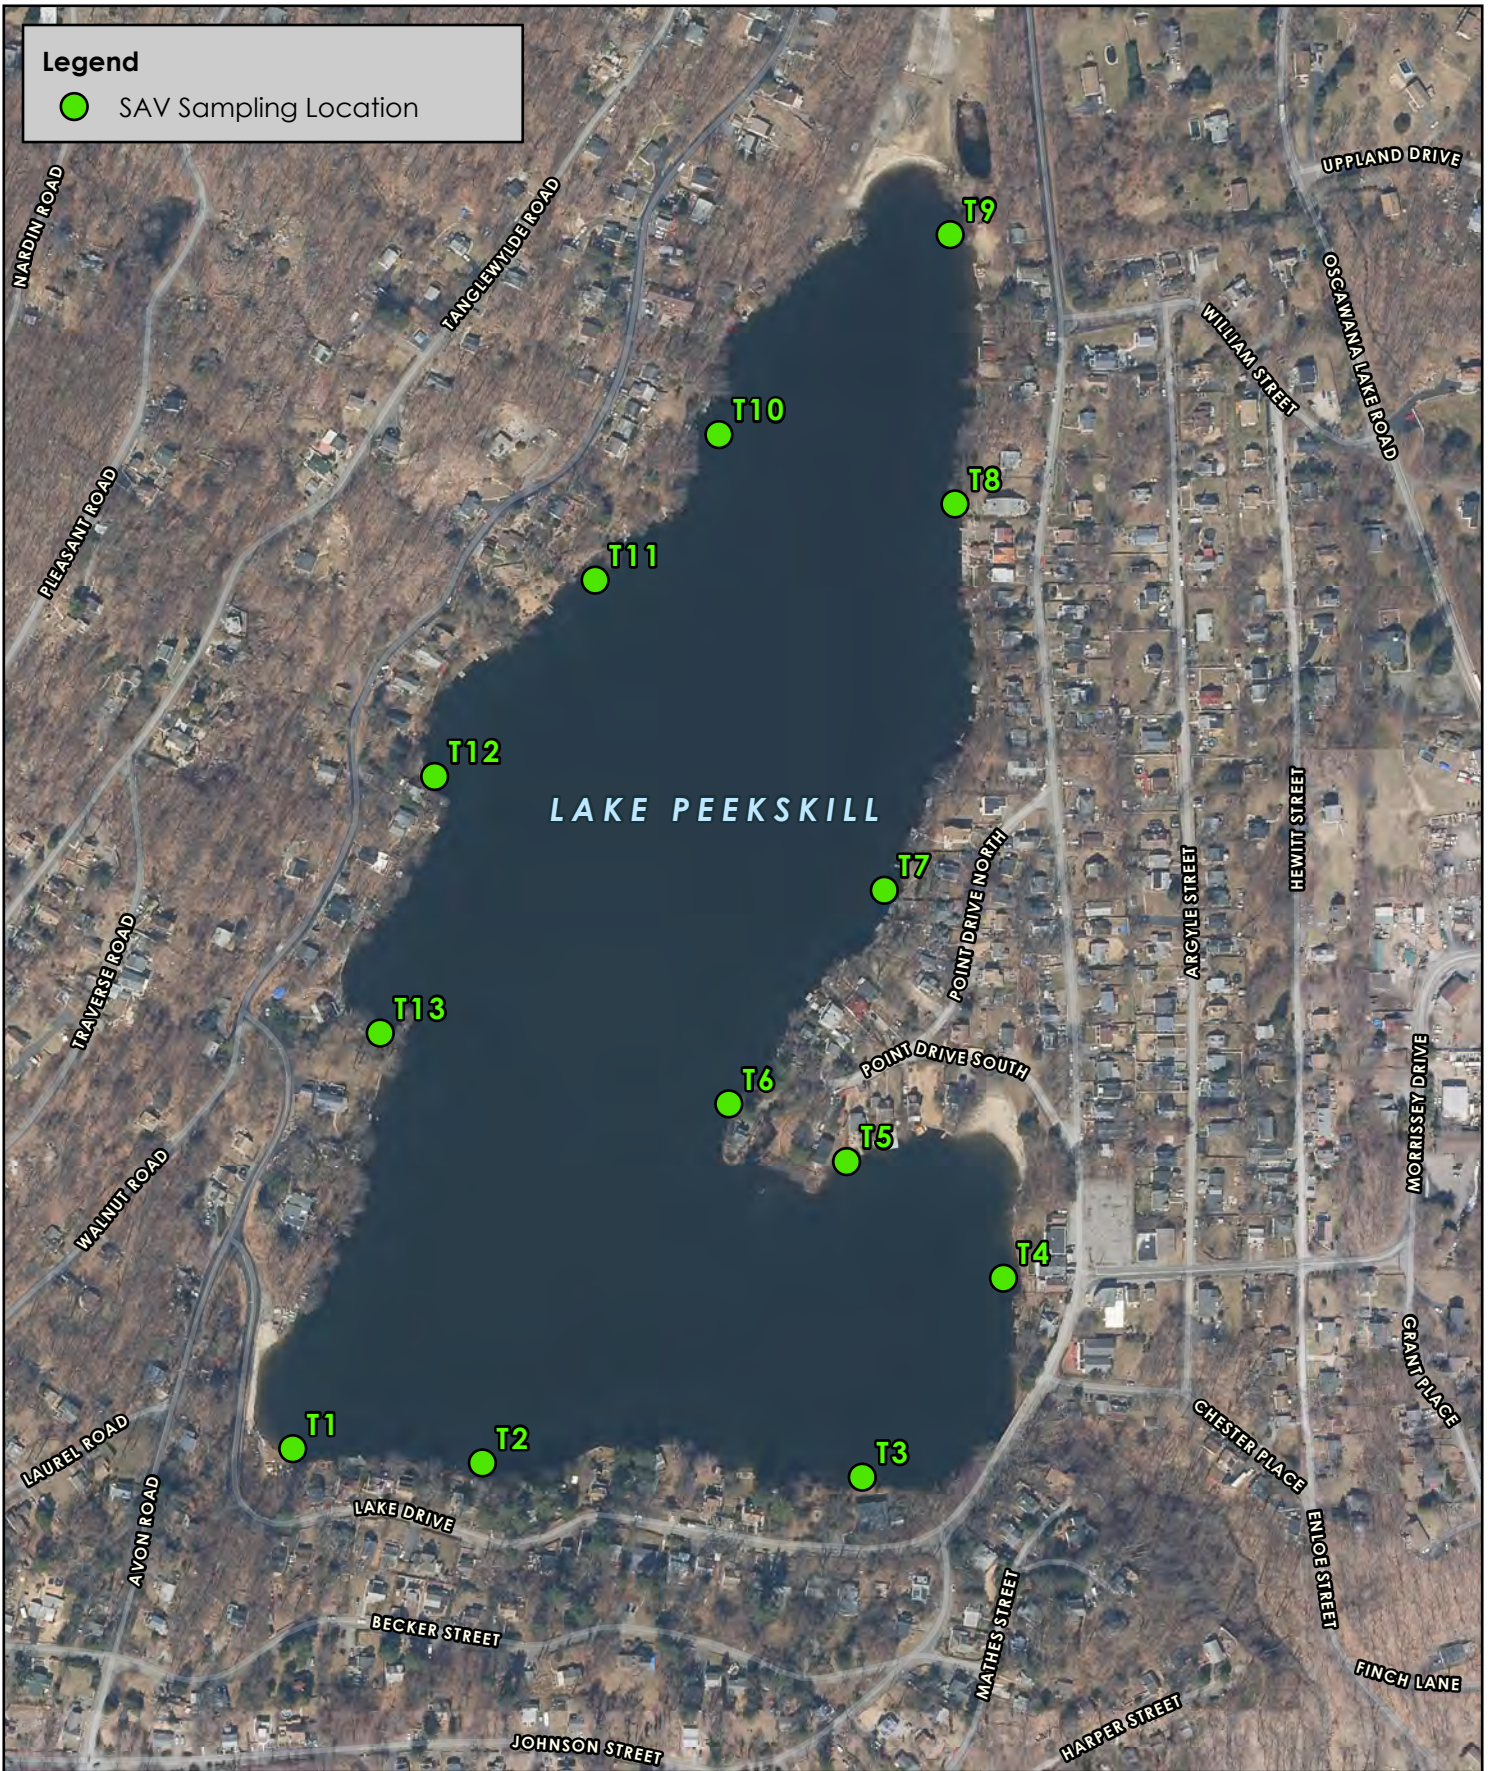
NOTES:
 1. Submerged aquatic vegetation (SAV) sampling locations are approximate.
 2. 2022 orthoimagery and roads obtained from the New York State GIS Clearinghouse: gis.ny.gov
