# Data Scorecard and Action Plan

**To:** Ms. Jacqueline Annabi  
**From:** Alejandro Reyes, CLM and Project Manager  
**c:** Luke Gervase, CLM  
**Date:** May 2023  
**Re:** Roaring Brook Lake Data Scorecard  
 Town of Putnam Valley  
 Putnam Valley, NY  
 GEI Project No. 2204698

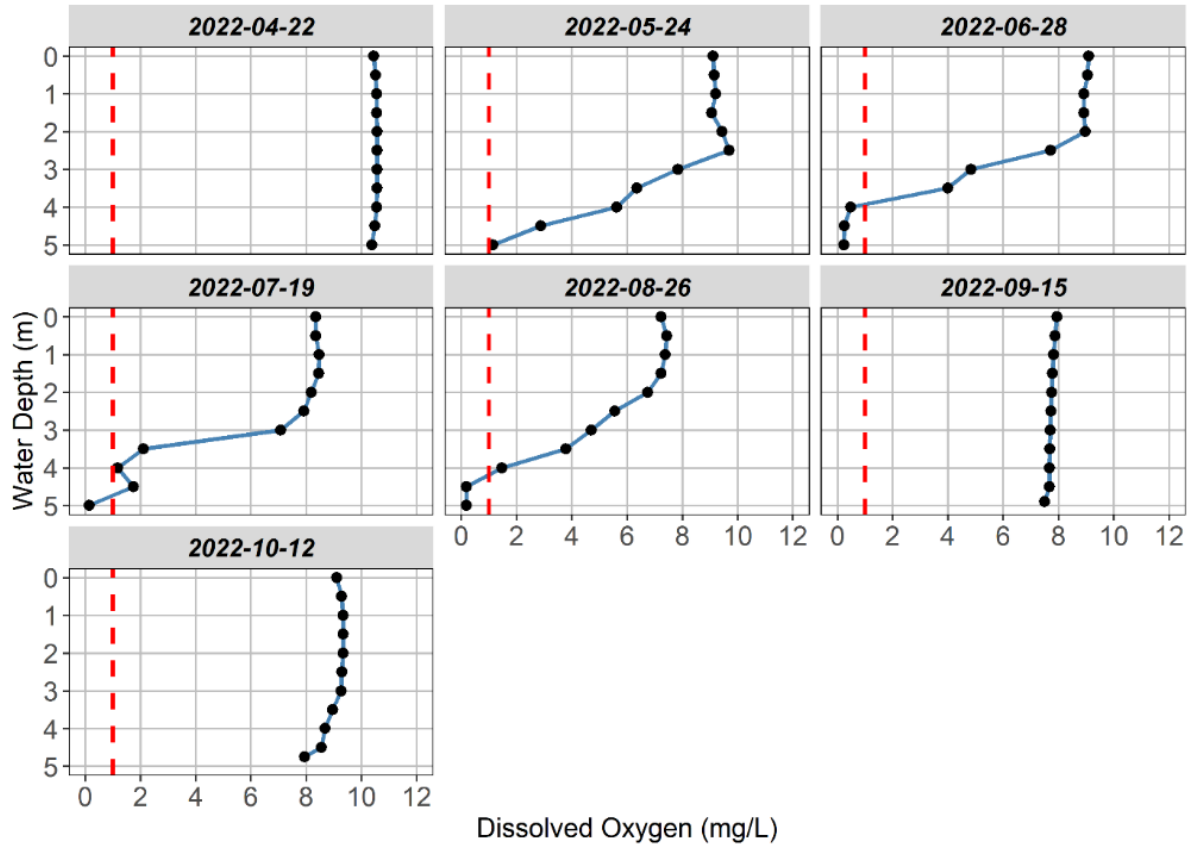
**Figure 4.** DO profiles from Station 1 in 2022. Values left of the red dashed line indicate anoxic (less than 1 mg/L conditions).

Higher surface and bottom dissolved oxygen (DO) concentrations were observed at Station 1 in 2022 (8.8 and 3.9 mg/L, respectively) as compared to 2021 (8.6 and 2.9 mg/L, respectively; Fig 4). Station 2 had slightly lower surface and bottom DO concentrations in 2022 than in 2021. All surface concentrations were higher than the 5.0 mg/L minimum daily average standard set by the New York State Department of Environmental Conservation (NYSDEC). Bottom DO concentrations in 2022 were anoxic (less than 2 mg/L), particularly during June, July, and August, which has been noted in previous years.

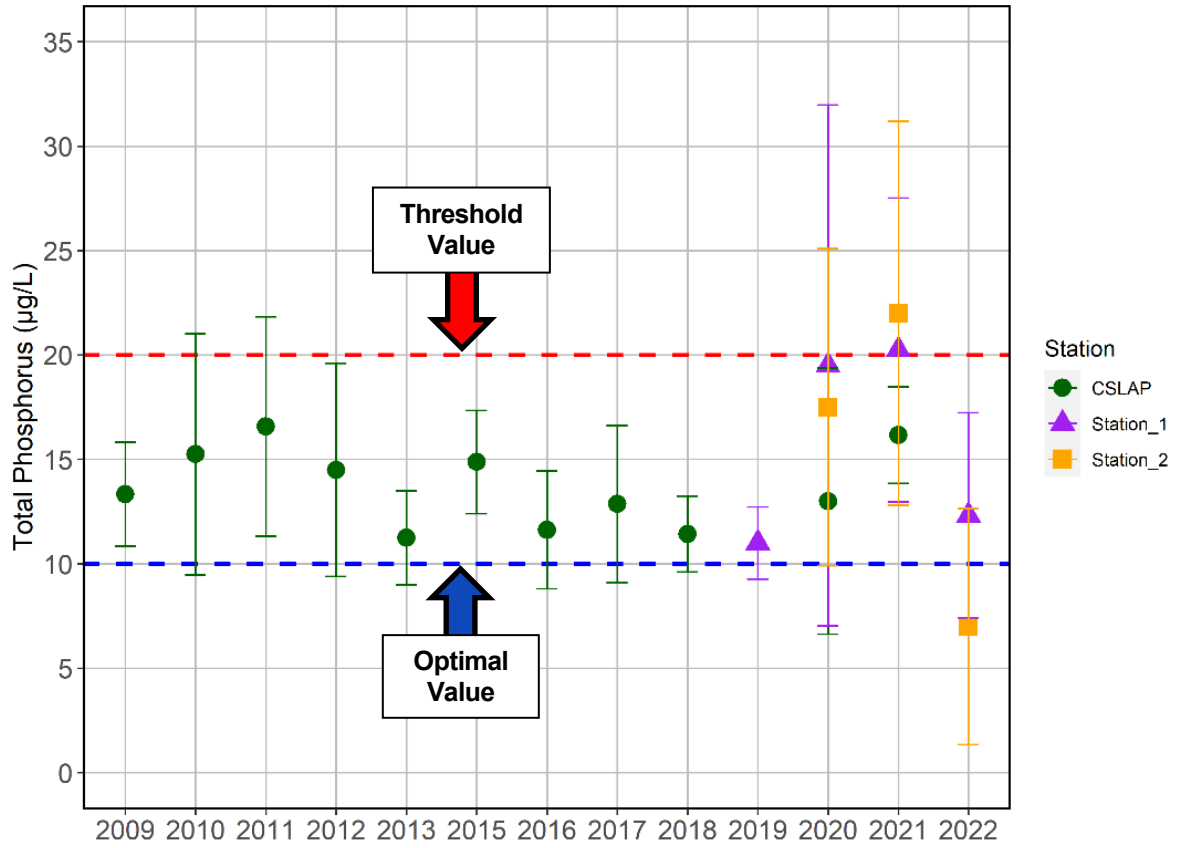
**Figure 6.** Surface TP for all historical data collected on Roaring Brook Lake during the summer season (June through September). Data sources include CSLAP Data (green circles), NEAR Station 1 (purple triangles), and Station 2 (orange squares). Red dashed line indicates the threshold limit (20 µg/L), and the blue line indicates the optimal value (10 µg/L). Error bars represent one standard deviation.

In 2022, surface TP concentrations were lower than in 2020 and 2021, averaging 10.3  $\mu\text{g/L}$  (Fig 6). Station 2 TP concentrations were much lower than what was observed at Station 1 with the average concentration being 7  $\mu\text{g/L}$ . Surface TP concentrations over time have varied between 10 and 20  $\mu\text{g/L}$  with recent years having concentrations over 30  $\mu\text{g/L}$ . The low TP concentrations observed over the past few years makes it difficult for the lake to sustain thick, lake wide algae blooms as seen in other local lakes. Cyanobacteria can still grow and proliferate in Roaring Brook Lake, as evident by the infrequent shoreline algae scums that are reported. Low phosphorus concentrations in the surface waters are likely the difference between the scum showing up and going away in a few hours versus sustained, lake-wide blooms that will close swimming for the entire season.

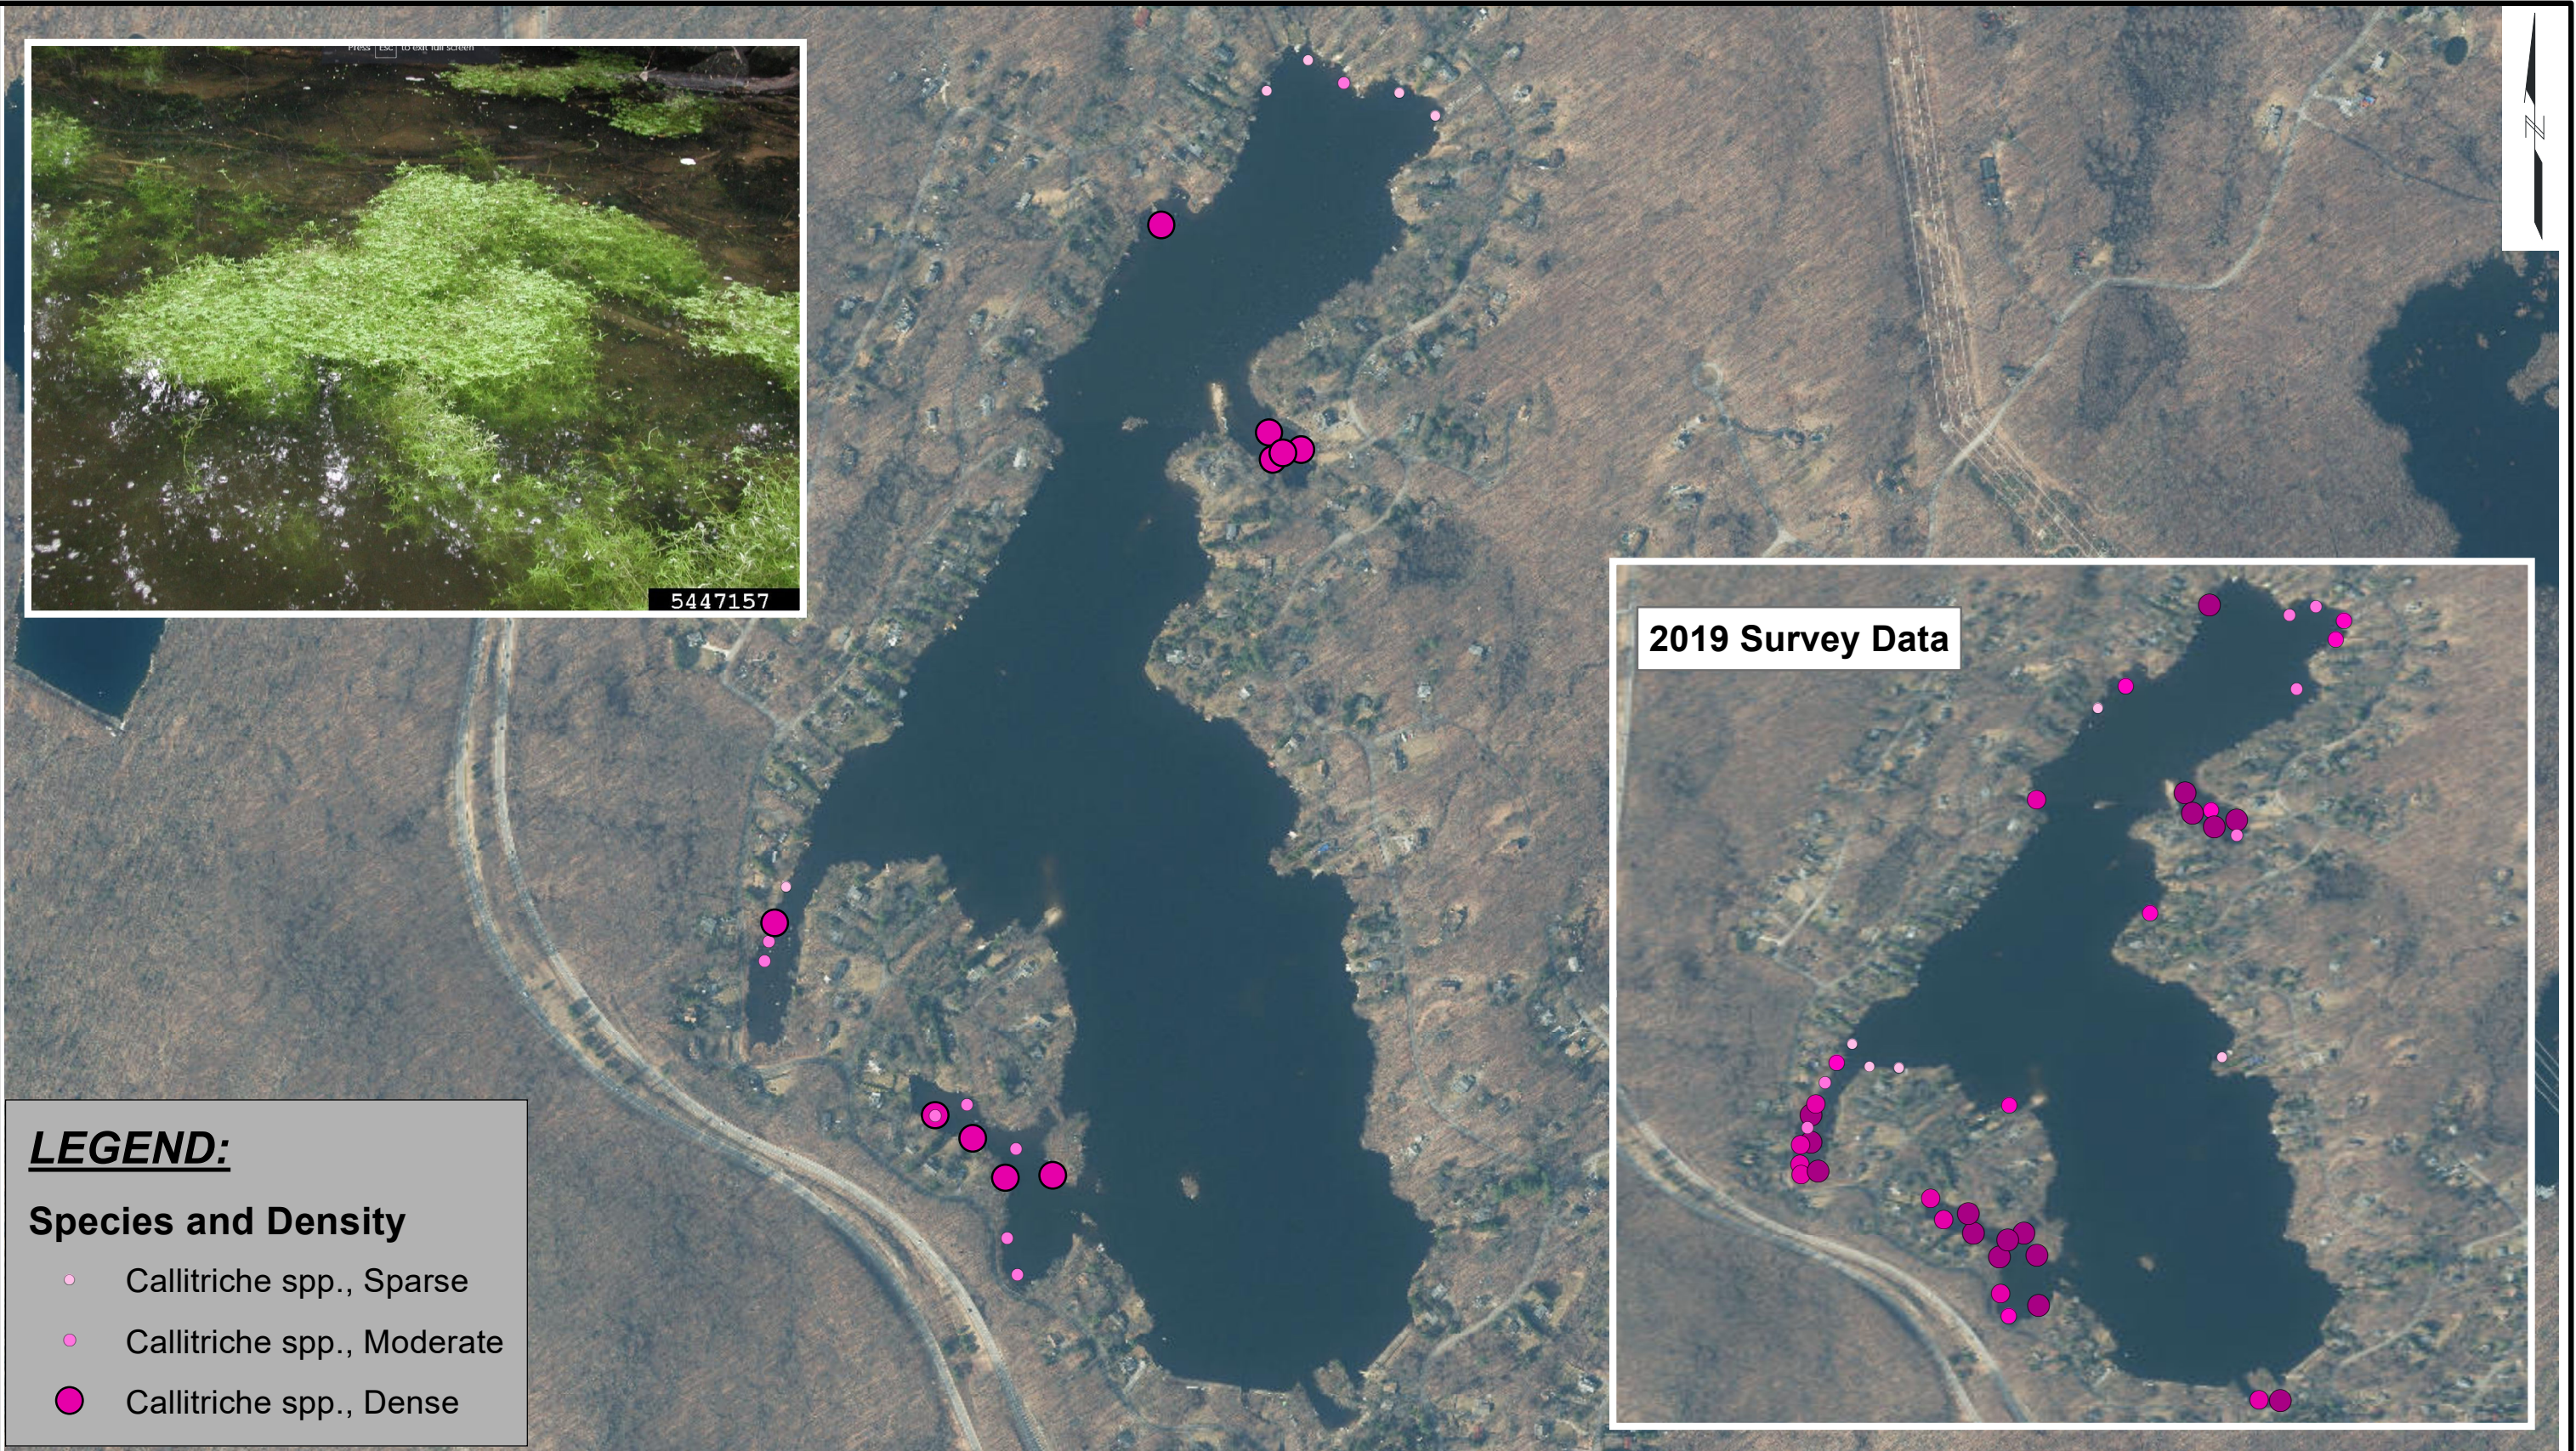
**2022 Plant Distribution Map**  
**Water Starwort Species (*Callitriche* spp.)**  
 Project 2204698

- Callitriche spp., Sparse
- Callitriche spp., Moderate
- Callitriche spp., Dense

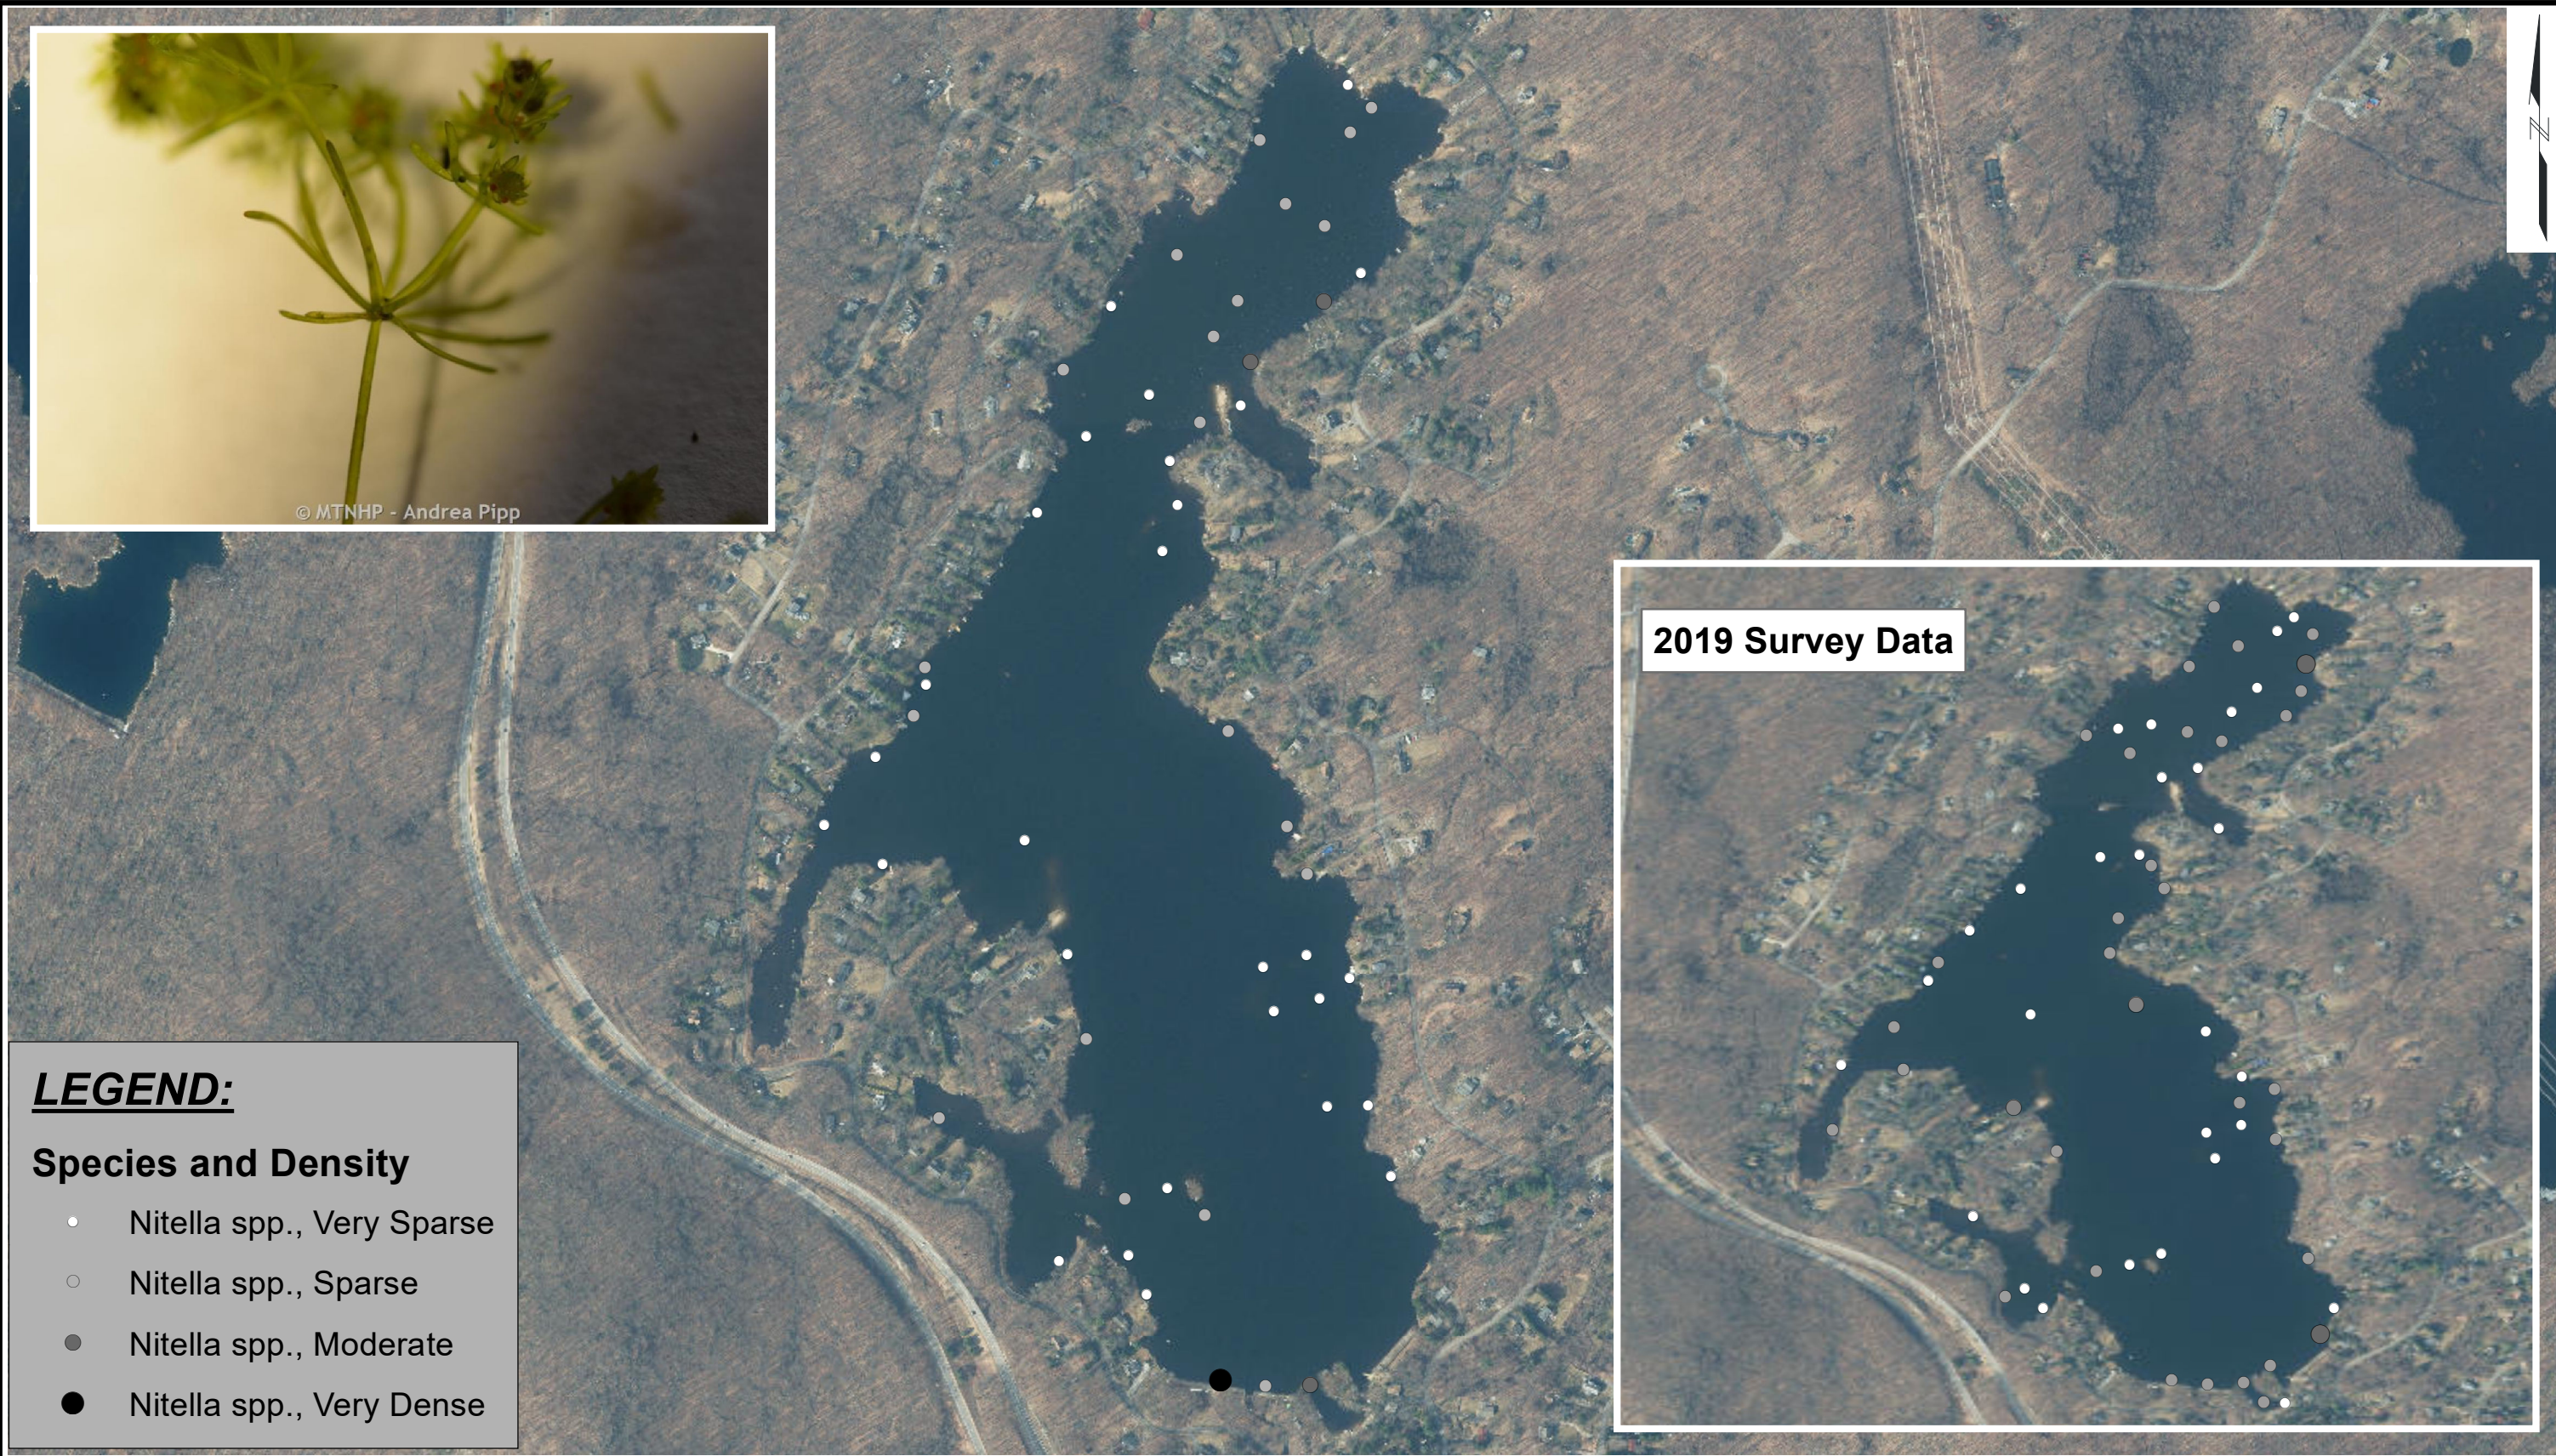
**2022 Plant Distribution Map**  
**Nitella Species (*Nitella spp.*)**

- Nitella spp., Very Sparse
- Nitella spp., Sparse
- Nitella spp., Moderate
- Nitella spp., Very Dense
