EVERBLUE
LAKES

Lake Peekskill

2024 Final Report

March 2025

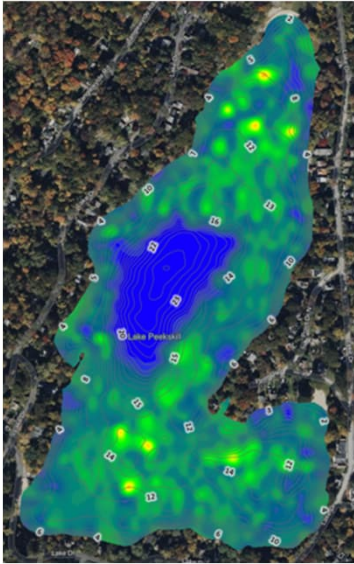
Vegetation Biovolume Analysis and Bottom Hardness Analysis for Lake Peekskill

The Aquatic Vegetation Biovolume is very close to optimal for a lake in a highly developed suburban land-use setting. There is a healthy, but not overabundant/nuisance aquatic plant community.

Aquatic plants get most of their nutrients from lake-bottom sediments. A balanced aquatic plant community means that sediment fertility is relatively under control. It is reasonable to conclude that the aeration system and past biological treatment of the lake has likely reduced lake-bottom muck and fertility. However, there additional improvement would be desirable.

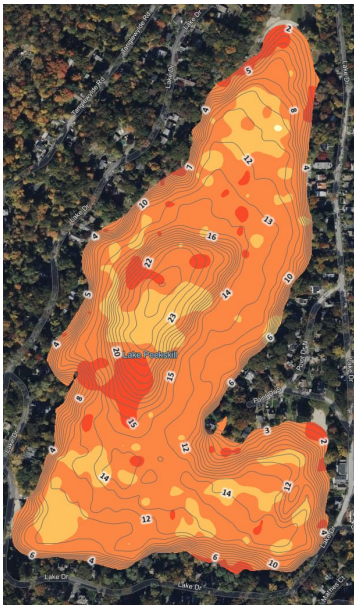
Similarly, the relative bottom-hardness analysis is indicative of a relatively hard-bottom lake. For a lake in a highly developed area, the lake bottom is more consolidated than lakes with similar development and land use patterns. This means that there is less organic sediment/muck than is common in area lakes. Again, this is a good indication that the aeration system and past biological treatment has delivered benefit to the lake.

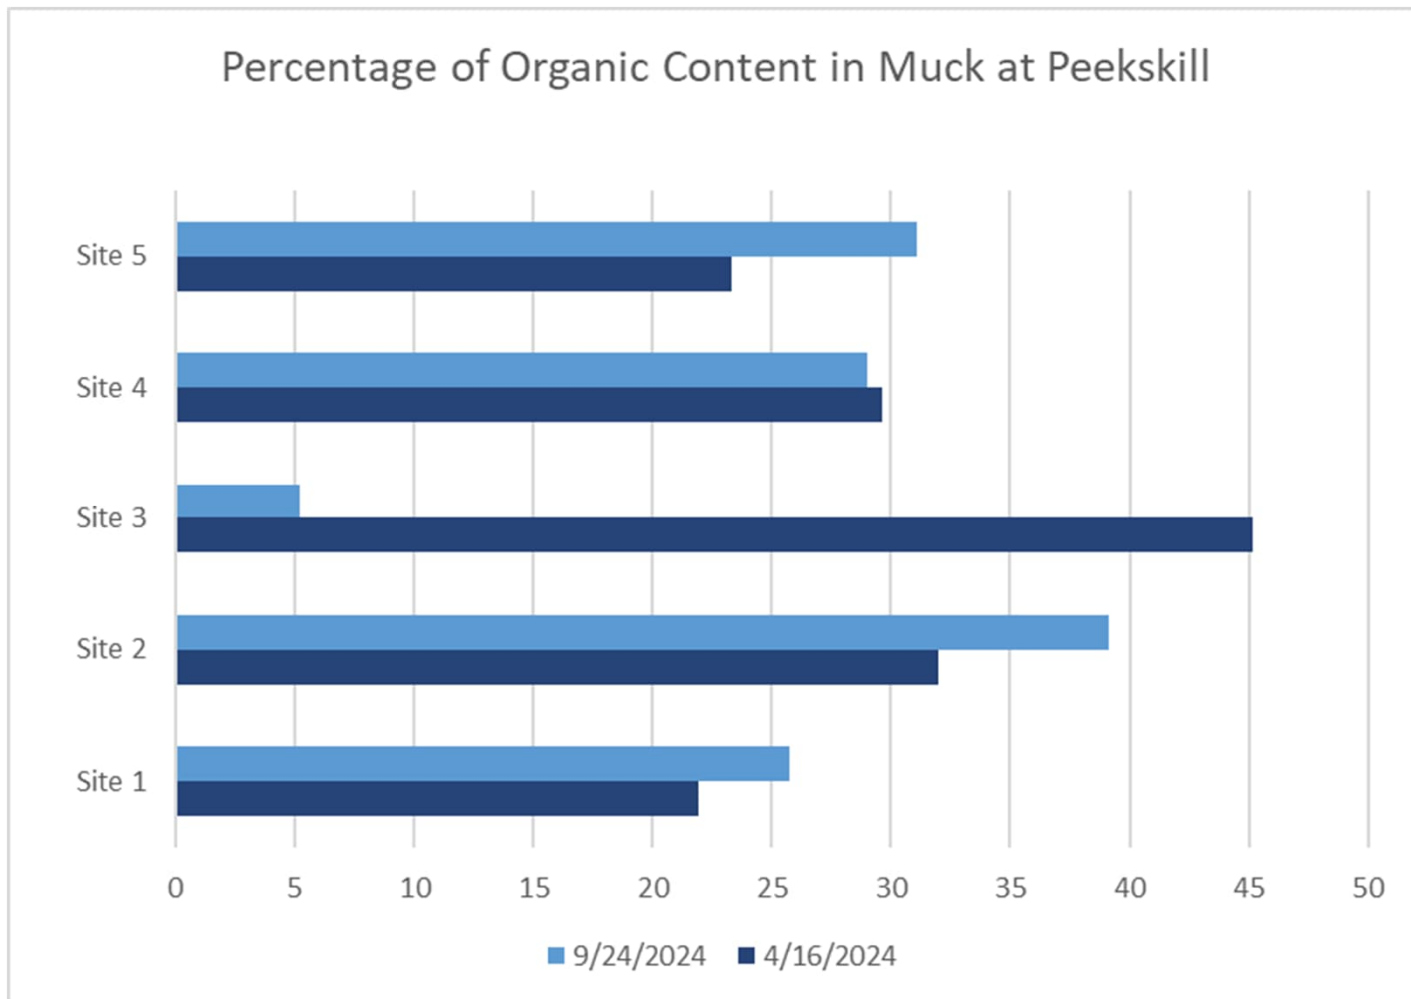
Lake Peekskill – Organic Percentage of Muck

The percentage of organic content within the muck increased in all sites except for Sites 3 and 4. Please note that at the end of the season, peat moss came up from the bottom, so theoretically it was at Site 3 location and towards Site 4.

Towards the end of the season, peat rose from the bottom of the lake, presumably at/near Site 3, which shows a drastic decrease in the amount of organic content within the lake. This “bottom shift” is important and is a further sign that the aeration system is working on the bottom of the lake. However, these events understandably cause concern among community members. Efforts were made by EverBlue Lakes and the Town to remove the floating organic material. This effort was moderately successful but should be revisited this Spring if visible organics remain at the surface.

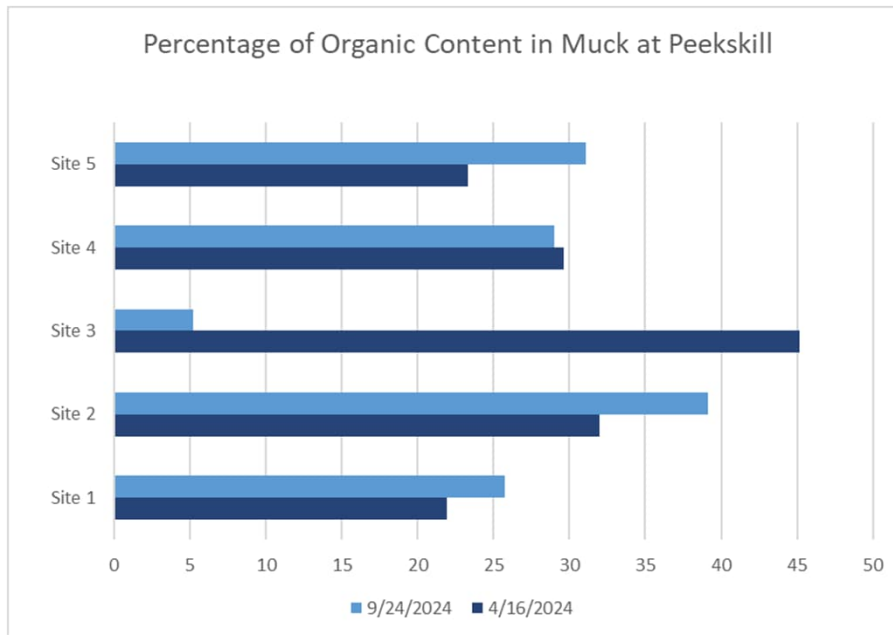
Sediment Analysis for Lake Peckskill

On average the percent organic content (fertility) for Lake Peckskill is on average lower than what is typical for lakes in highly developed areas.

On average percent organic increased through the season. This could be due to on-going inputs from the water shed, by also could be from a redistribution of the organic sediment that surfaced as tussocks or peat islands.

The bottom-line is that further improvement is needed with target to get all sites below 20% organic to reduce a critical food source for the undesirable blue-green algae.

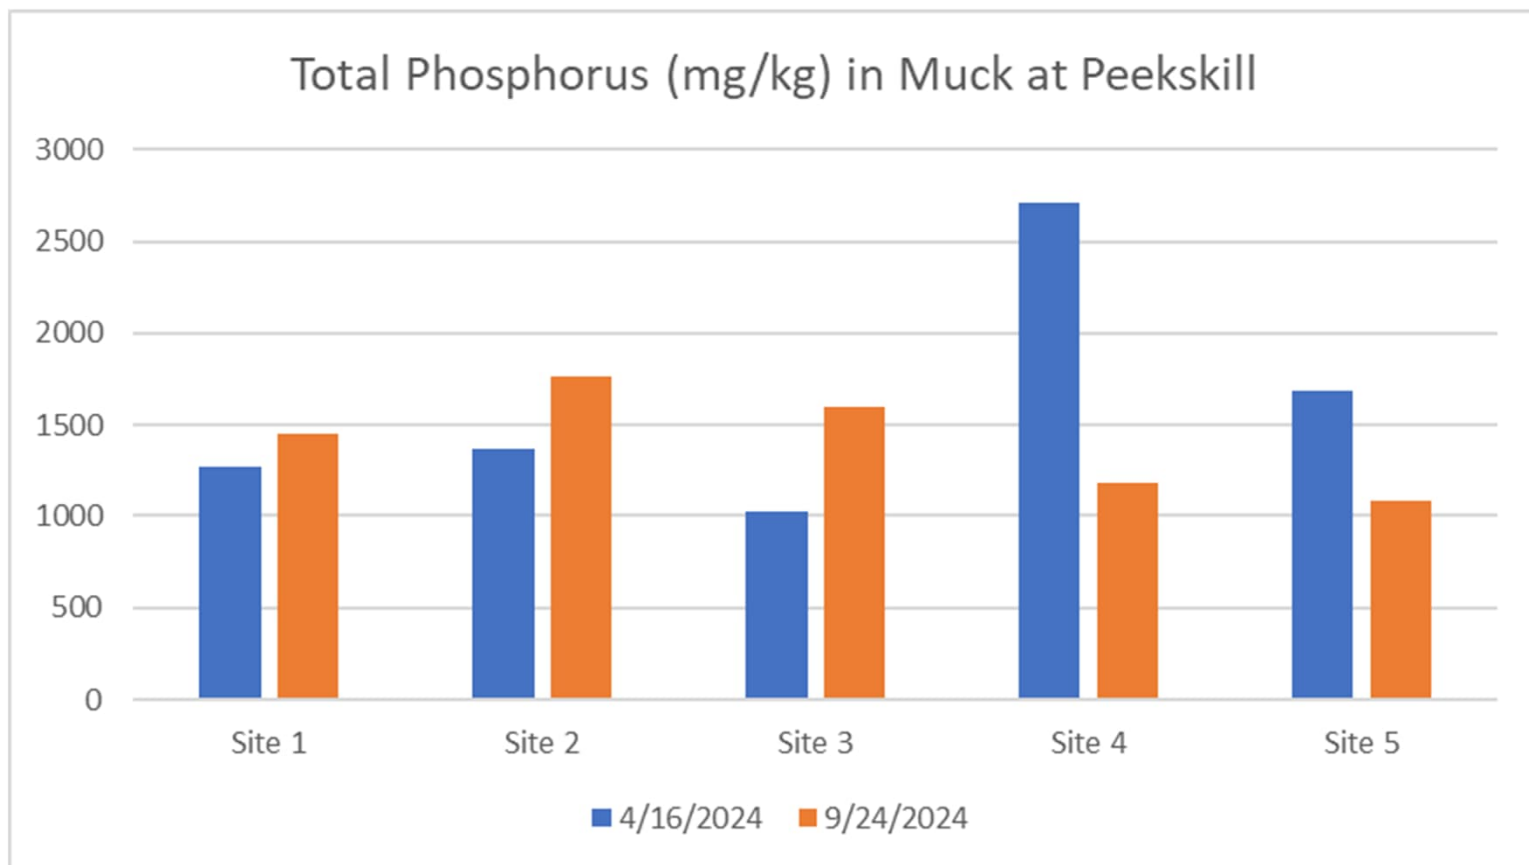
Lake Peekskill – Total Phosphorus Muck

The total phosphorus within the muck increased within 3 of the 5 sites from the initial sample. Site 4 and Site 5 had a reduction in the organic content.

It is likely that there was a redistribution of sediment phosphorus as a result of the surfacing of the tussocks from the lake-bottom. However, except for Site 4, these sediment phosphorus levels are slightly lower than what is typical for highly developed lakes with similar land use as Lake Peekskill.

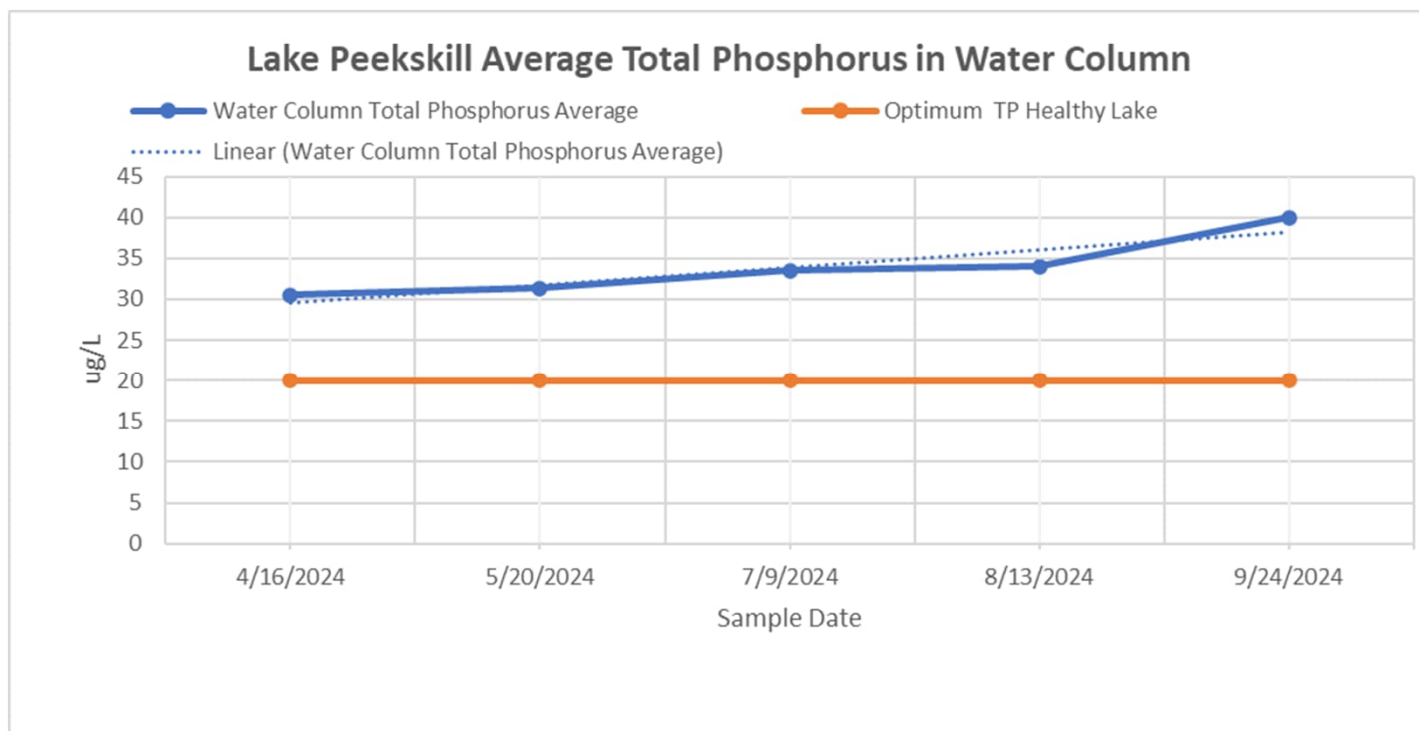
Lake Peekskill - Total Phosphorus

Excess phosphorous in the waterway will cause algae and aquatic plants to grow uncontrollably resulting in decreased dissolved oxygen. Algae blooms can be triggered with levels of total phosphorous greater than 20 micrograms per liter, but generally 30 micrograms per liter or more is the threshold for having a high risk for harmful algal blooms.

At Lake Peekskill in 2024, all visits had higher than optimum total phosphorus levels. Sampling Sites 1 and 2 overall were higher than Site 4, with the highest values being at middle and bottom depths. The highest reading at Site 1 was at the bottom water column in August with a value of 58 ug/L. Likewise, Site 2 had the highest reading at the bottom in August with a value of 59 ug/L. Site 4 was always above optimum levels, but the highest value was in September at the bottom water column at 39 ug/L.

The highest average reading was 40 micrograms per liter in September, which is 2x higher than the optimum level.

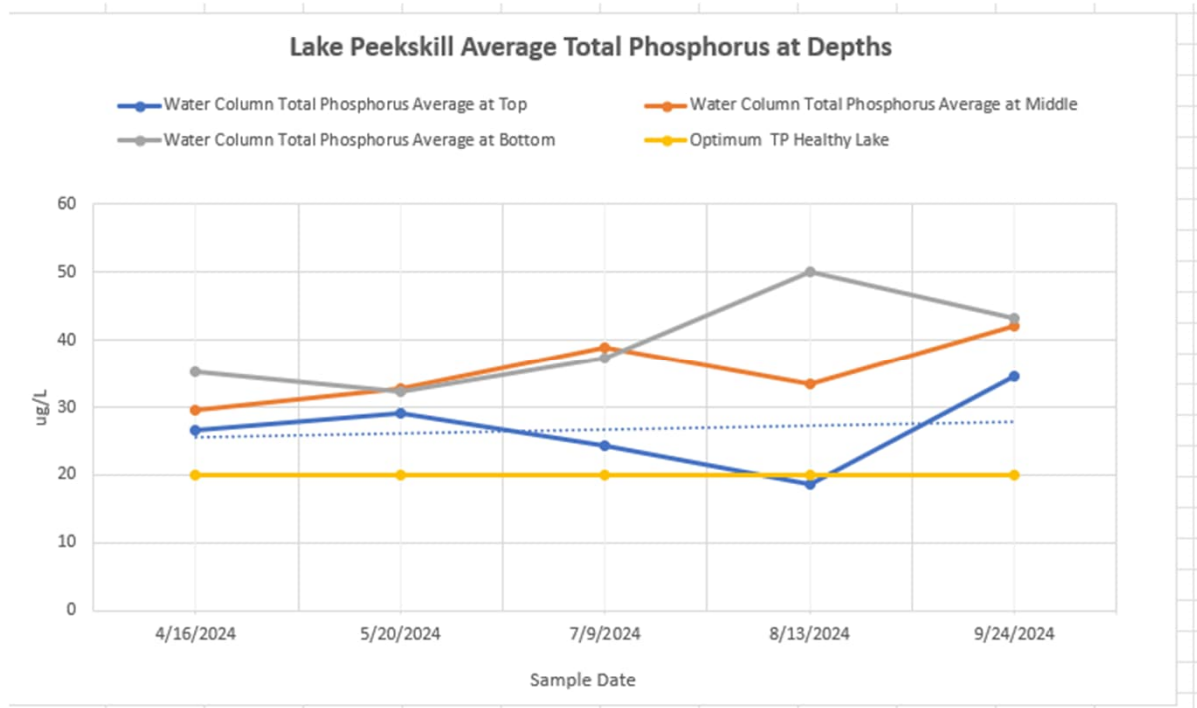
Assessing Phosphorus changes with depth provides the most important insights into why Lake Peekskill remains under continual risk for harmful algal blooms.

Phosphorus is significantly higher at the lake bottom than at the surface and higher than the middle of the water column for most of the season. Since the aeration system is keeping the lake well oxygenated all the way to the bottom, it is highly unlikely that the elevated phosphorus at depth is due to chemical release from sediments which only happens when the bottom is out of oxygen.

It is much more likely that the elevated phosphorus is from ground water seepage (septic systems) and watershed loading events where colder, phosphorus rich stormwater flows with some velocity into the lake. Because the rainwater is colder than the water in the lake it is heavier and will tend to sink and flow along the bottom of the lake rather than spread out along the surface.

While these are not easy problems to fix, it is important that the plan moving forward takes these problems into account and educates members of the lake community on why Lake Peekskill is still struggling with water quality issues despite the investments that have already been made.

The key message is to avoid “throwing out the baby with the bath water” on aeration and the current watershed efforts looking for the next “magic bullet” fix. The reality is that there is no magic bullet out there and the investments that have been made are taking the lake in the right direction. We need to get there faster and go farther.

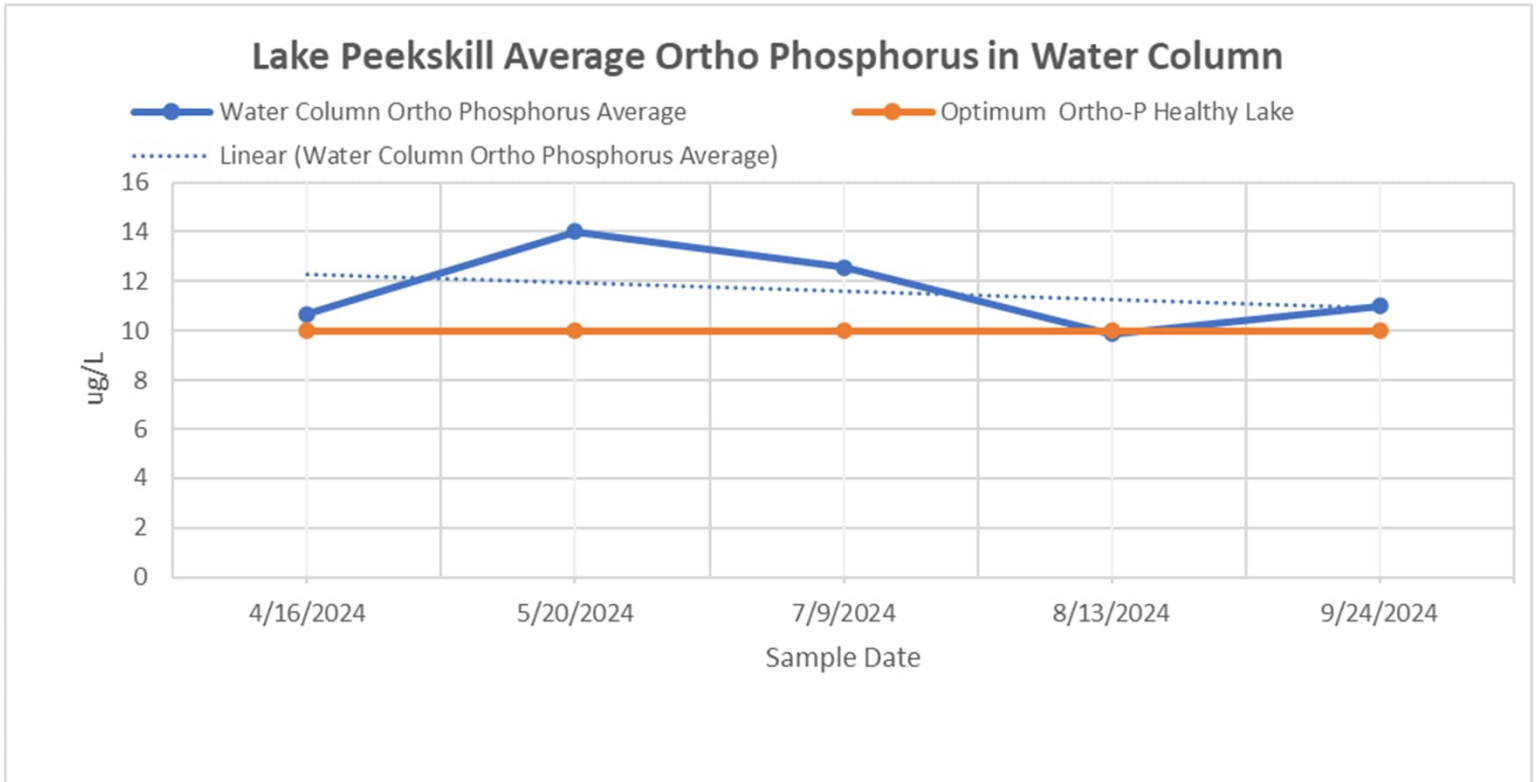
Lake Peekskill - Ortho Phosphorus

The ortho phosphorus or soluble reactive phosphorus is the form of phosphorus that is immediately biologically available for additional algal growth to utilize. An ortho phosphorus level of 10 micrograms per liter or less is considered optimal for a healthy lake. In 2024, all sampling sites were similar in value.

The ortho phosphorus was at or above the optimal level during all the visits with the highest average being 14 ug/L in May. Generally, the ortho phosphorus was consistent throughout the water column but the highest values were found at the surface and the bottom.

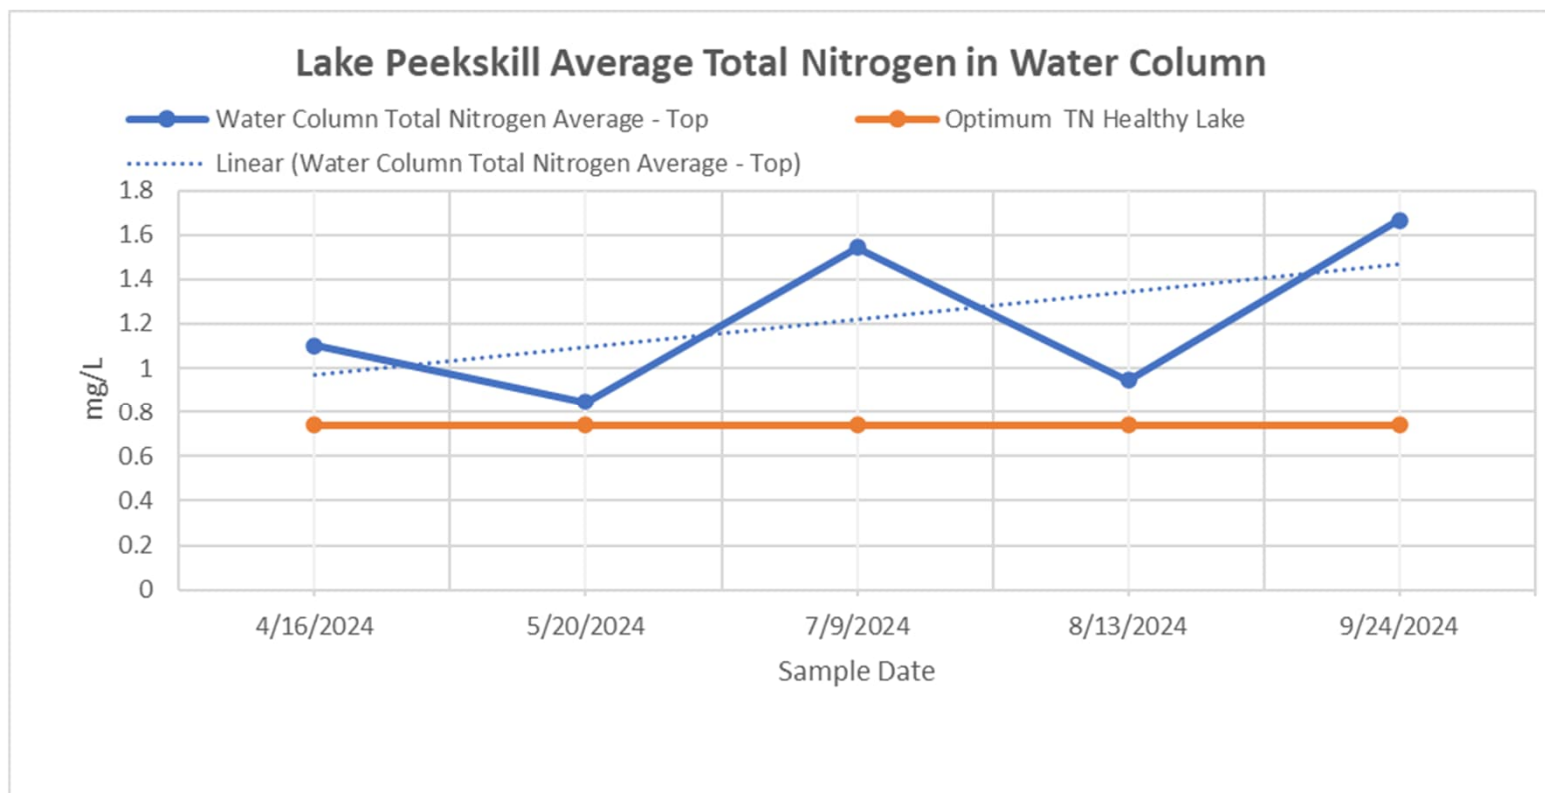
Lake Peekskill – Nitrogen

Nitrogen is the second most important nutrient within a lake for plant and algal growth. Nitrogen can increase due to runoff, decomposition and even some blue-green algae is capable of “fixing” atmospheric nitrogen into the water column.. At Lake Peekskill, the total nitrogen (which includes nitrite, nitrate, organic nitrogen and ammonia) had various spikes throughout the season but was always above the optimum level.

Nitrite levels in healthy lakes are less than 1 mg/L. From the analysis, all nitrite levels were unremarkable and not elevated.

The nitrate levels did fluctuate throughout the season like the total nitrogen (which can be part of the reason for the peaks there). Levels of nitrate should be below 0.5 mg/L within a healthy lake, but if decomposition is occurring, there will be typically higher values at the lake bottom. The nitrate was elevated in the bottom water column during the visits. In August, the nitrate was analyzed at 0.7 mg/L at the surface in Site S4. There was also elevations in the nitrate levels in the middle depths in July and August at Site S1.

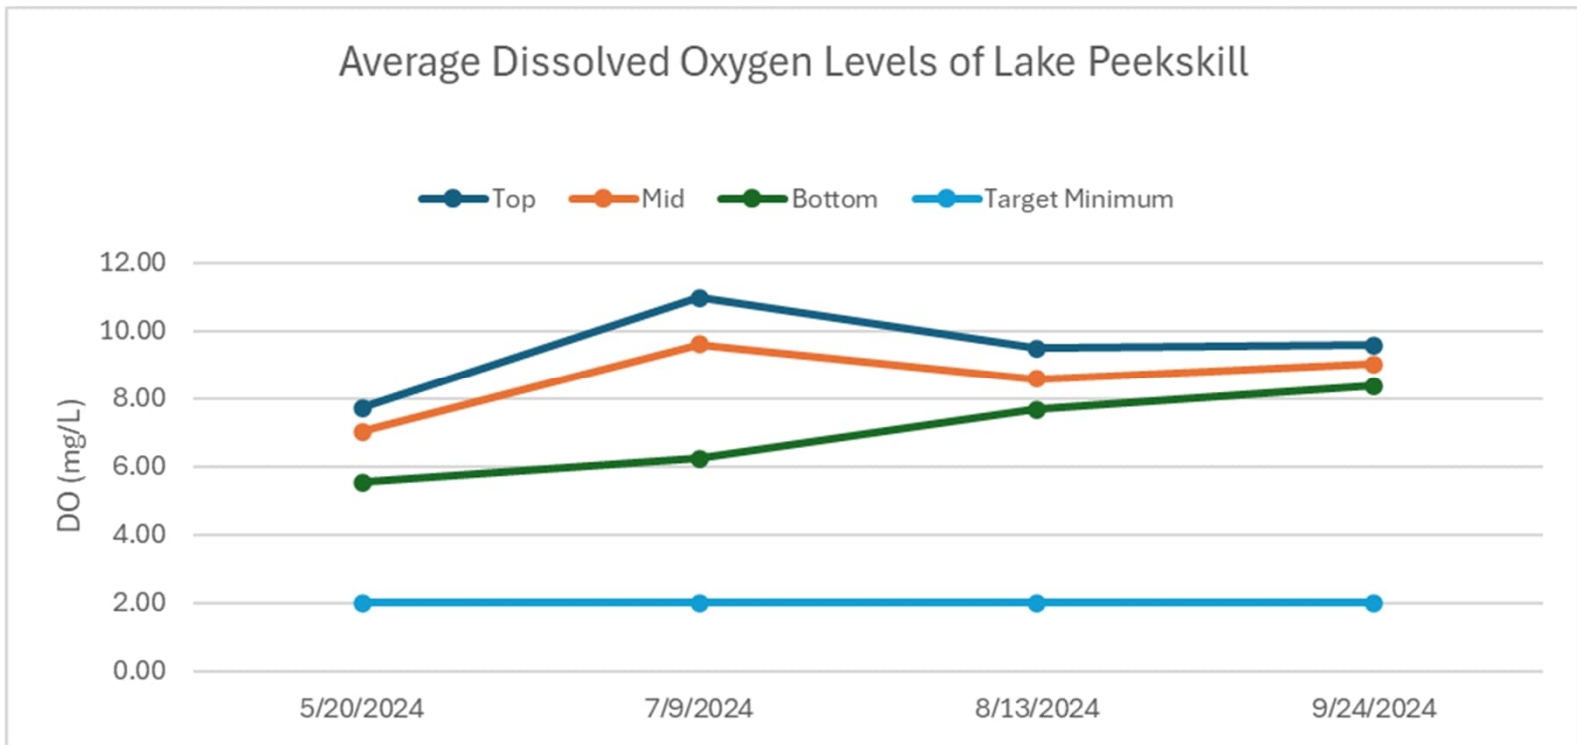
Lake Peekskill – Dissolved Oxygen

With the aeration system, the average dissolved oxygen levels remained high throughout the sampling period. However, in Sampling Point 2, the dissolved oxygen level did dip slightly below 4 mg/L at the bottom in May but increased and remained between 5.13 mg/L – 7.9 mg/L for the remainder of our in-situ sampling dates.

This data confirms that the aeration system is adequately designed, operated effectively in 2024 and is delivering the benefits expected from this management method.

Because the lake experienced serious, detrimental bloom conditions in 2024, it remains clear that additional management methods are needed to reduce/eliminate harmful algal blooms moving forward.

Unfortunately, the peroxide-based algaecide treatments applied to mitigate active blooms did not deliver the desired results in 2024. Other management strategies in conjunction with aeration should be evaluated for 2025.

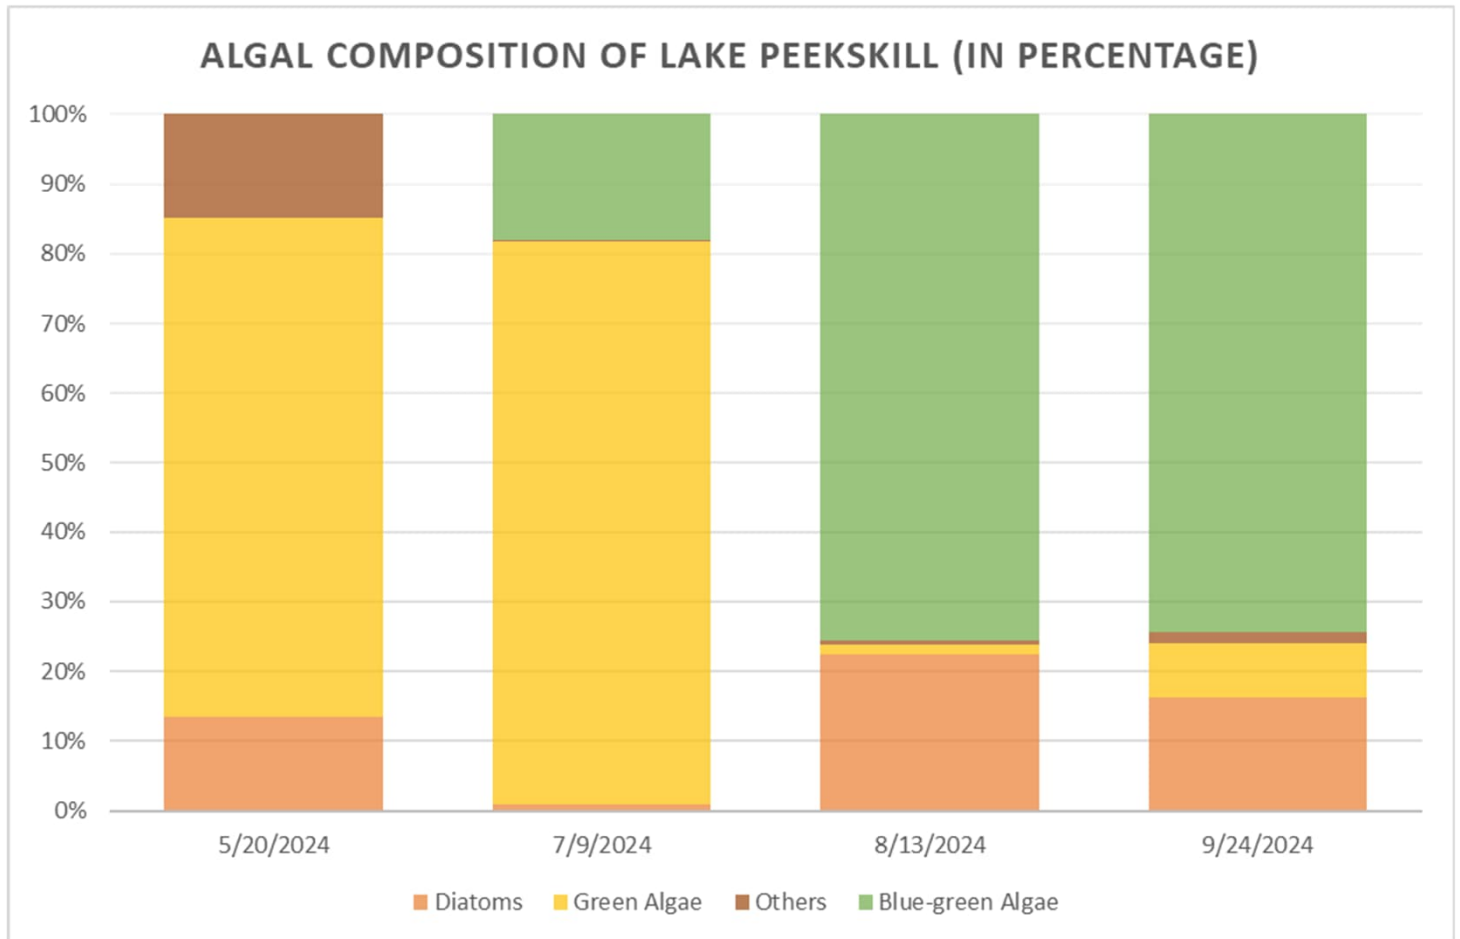
Lake Peekskill – Algal Composition

Initially green algae was the dominant species but by August, blue-green algae was fully dominant and remained that way through September to the end of the season.

We suspect that the shift was already well under way during and shortly after the July 9 sampling event and correlated with excessive warm water conditions measured on the July 9 sampling event creating the perfect environment for blue-green algae to take over.

Please note that besides July, diatoms remained around 20% of the phytoplankton composition.

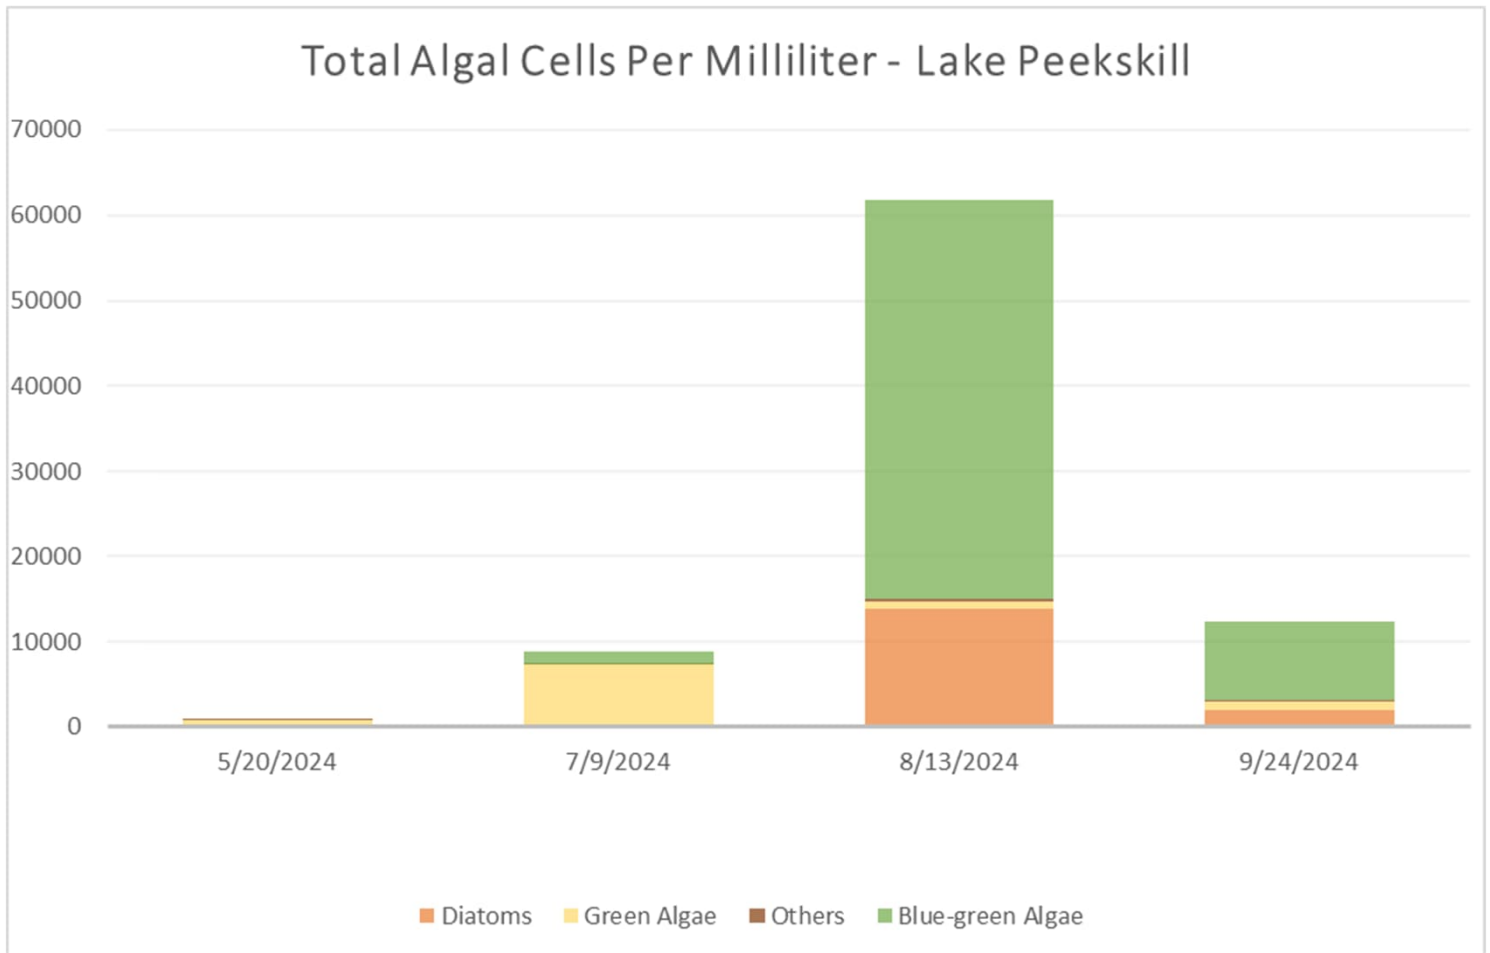
Lake Peekskill – Total Cell Count

Lake Peekskill's total cell count became the highest recorded in August with a total cell count of 61,828 cells/ml with 46,742 cells/ml being blue-green algae. WHO recommends an advisory be posted when blue-green cell counts are above 20,000 cells/ml. By September, the cell counts were lower with only 9,173 cells/ml being blue-green algae.

A key lesson learned in 2024 is that once the lake shifts to blue-green algae dominance, it is very difficult to get it back.

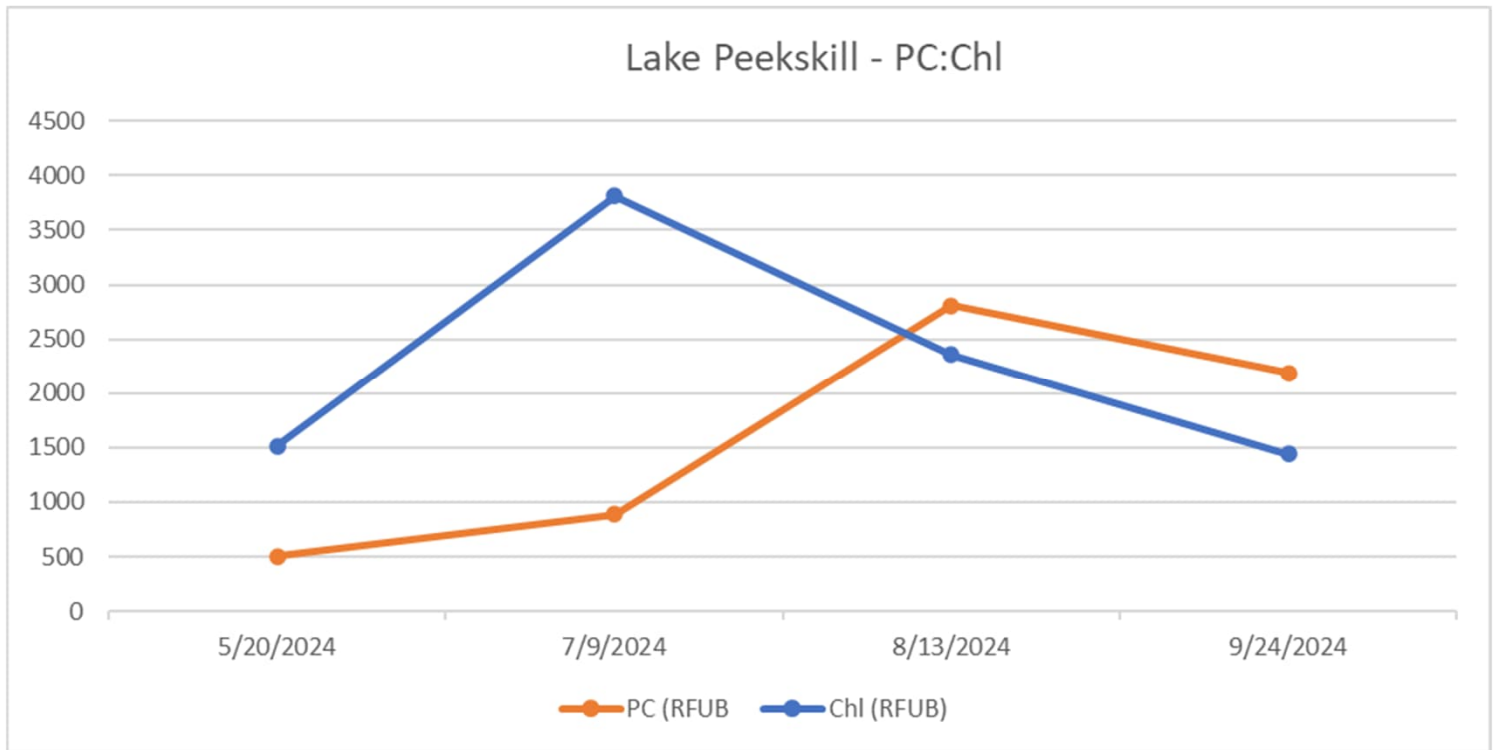
Lake Peekskill – PC and Chlorophyll

The higher the chlorophyll values within a lake/pond, then the higher the chances of algae and vegetation are present. The PC:Chl ratio helps determine how significant a blue-green algae bloom is happening, with a lower ratio equaling a lower blue-green algae value. So, as shown on the graph, the PC line is above the Chl line in August and September, which is when the most severe blue-green algal blooms were occurring.

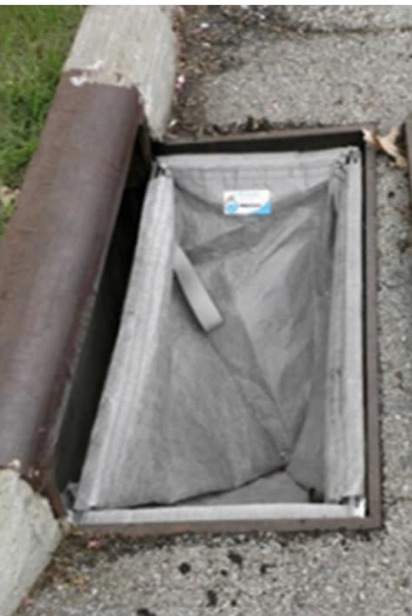
1. Catch Basin Insert

- Pilot Testing of Storm Drain Inserts – EverBlue has identified a promising technology for improving stormwater filtration from road drains. The Technology is low cost and easy to install.

The cost per basin is \$600 - \$800 per basin for the complete system depending on basin size and configuration. We recommend targeting 2 – 3 basins to start as a pilot test.

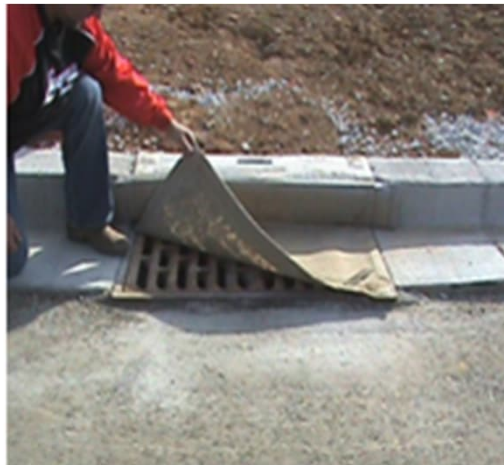
2. Catch Basin Filter Cover with insert in basin

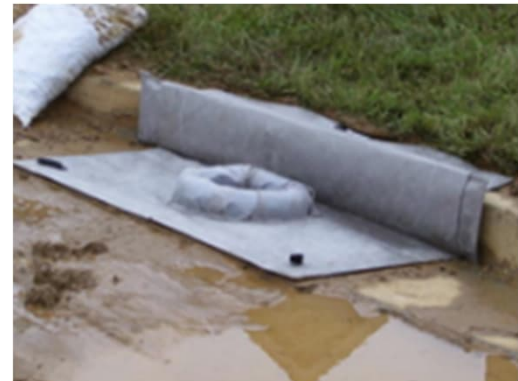
3. Catch Basin Filter Cover with overflow protection with insert in basin
