Lake Oscawana Management Advisory Commission
Town of Putnam Valley, NY

Lake Oscawana

Management Update
June 13, 2026

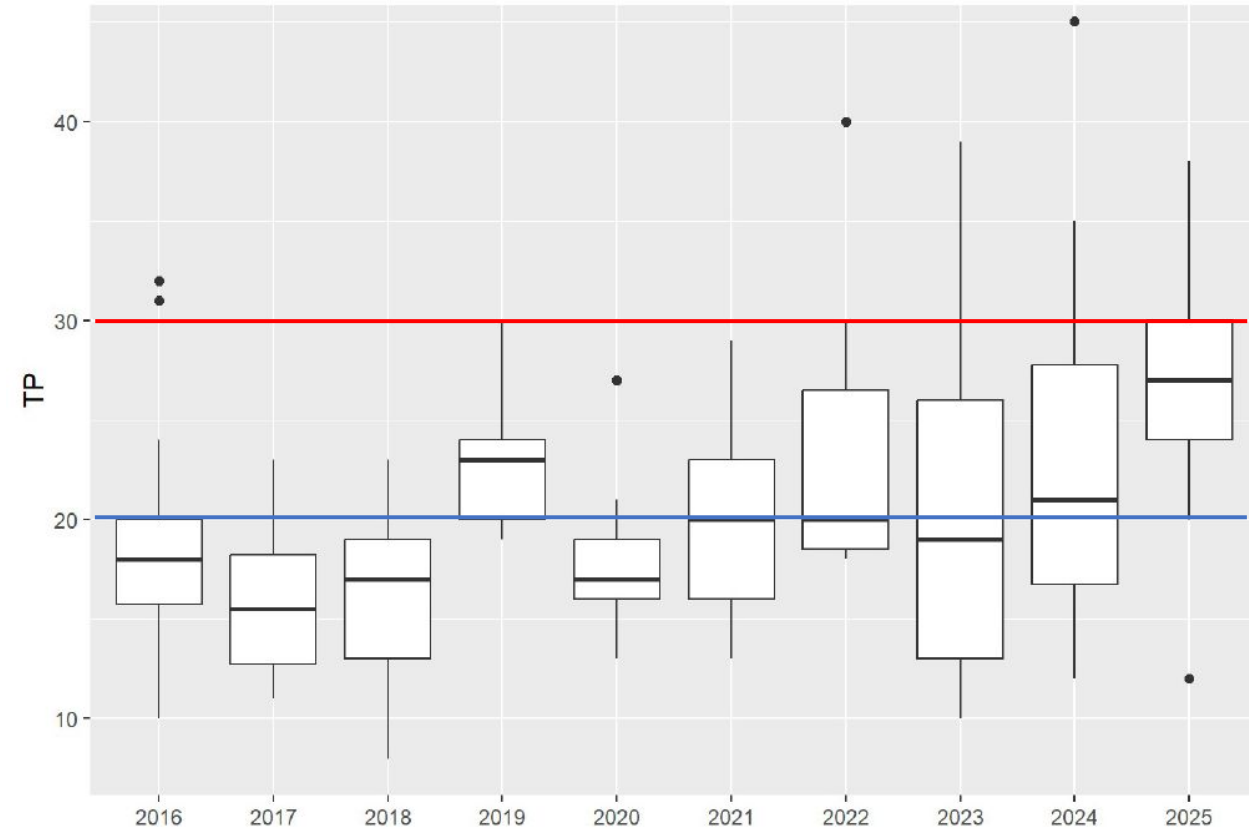
Figure 15. Combined Stations 2016-2025 Surface TP Boxplots

Surface Nutrients (Phosphorus & Nitrogen)

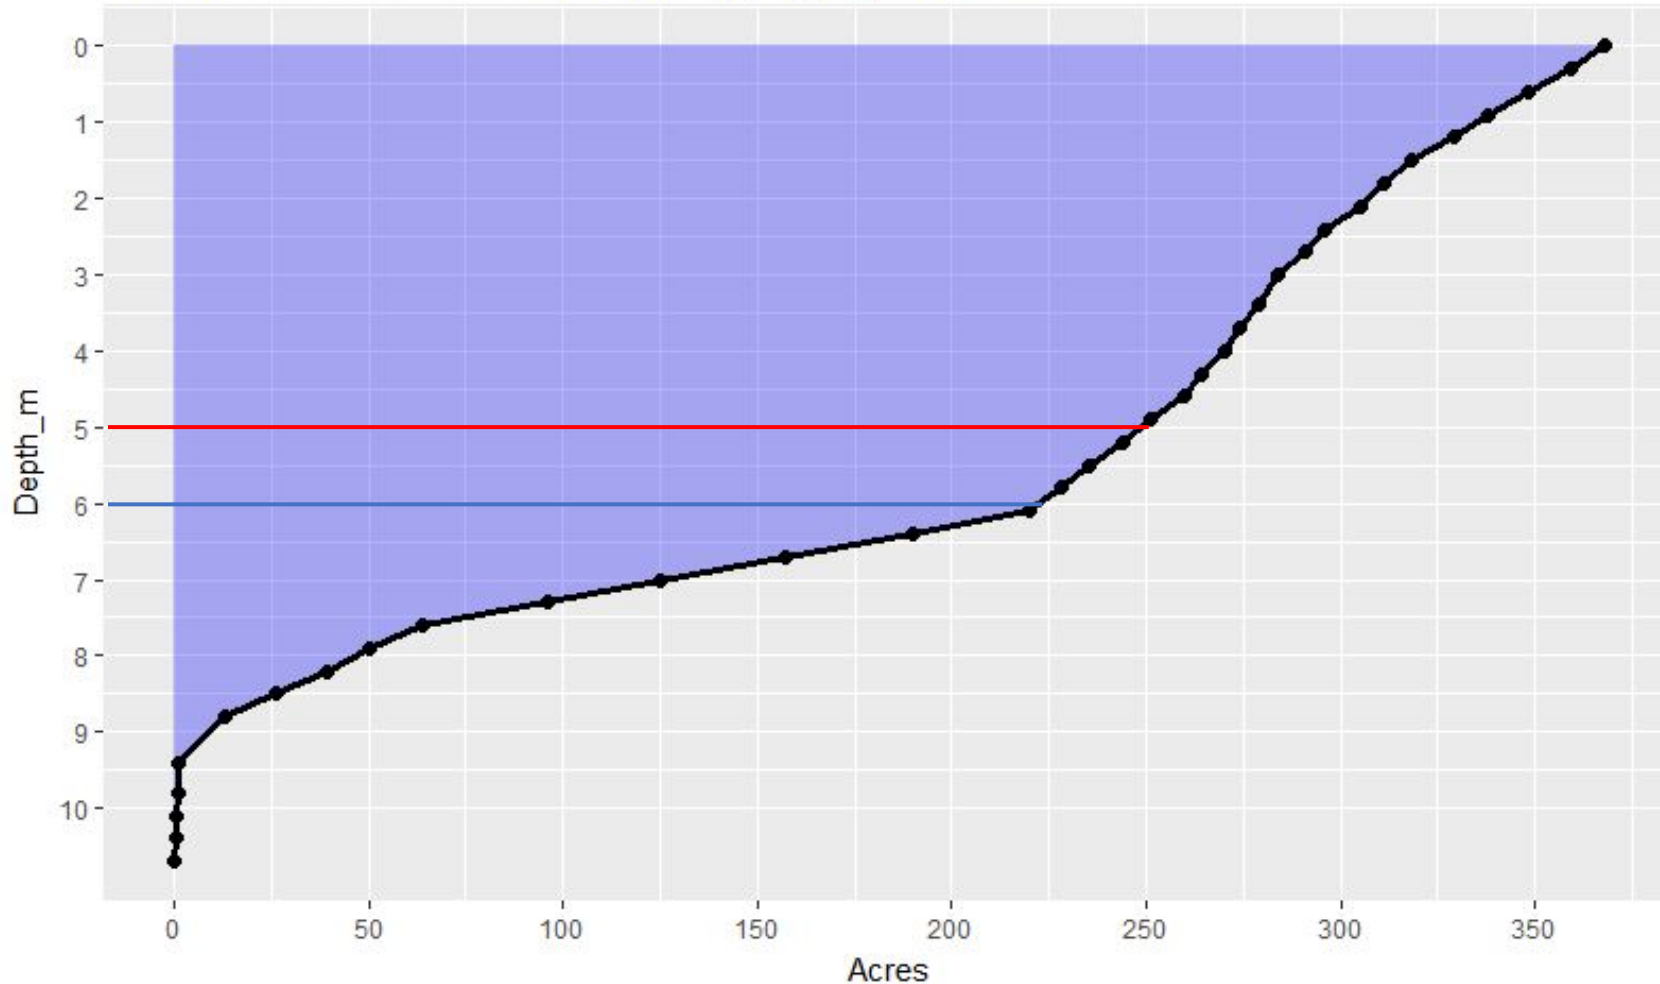
Oscawana Surface Area vs. Depth Hypsographic Curve

- Target 6m maximum anoxic boundary
- In 2023 & 2025, the anoxic boundary reached 5m
- Results in an extra 25+ acres of anoxic sediment surface that then contributes to internal P and N release in that season
- When anoxic boundary is above 6m, it interacts with the lake thermocline
- Results: more P released, easier for epilimnetic (above thermocline) algae to access that P

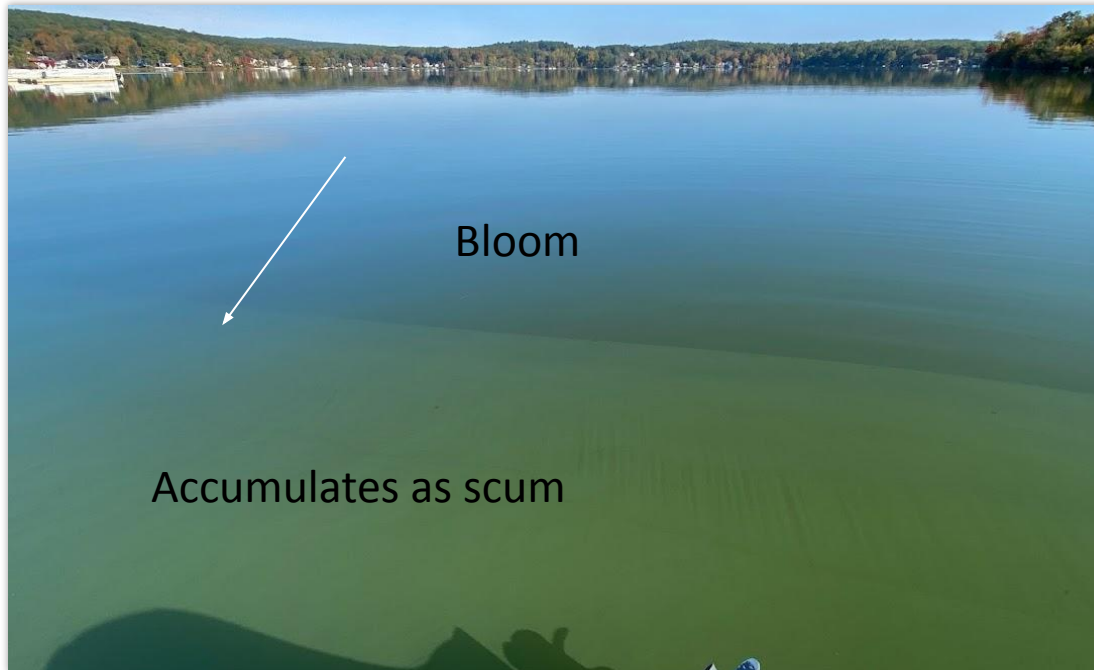
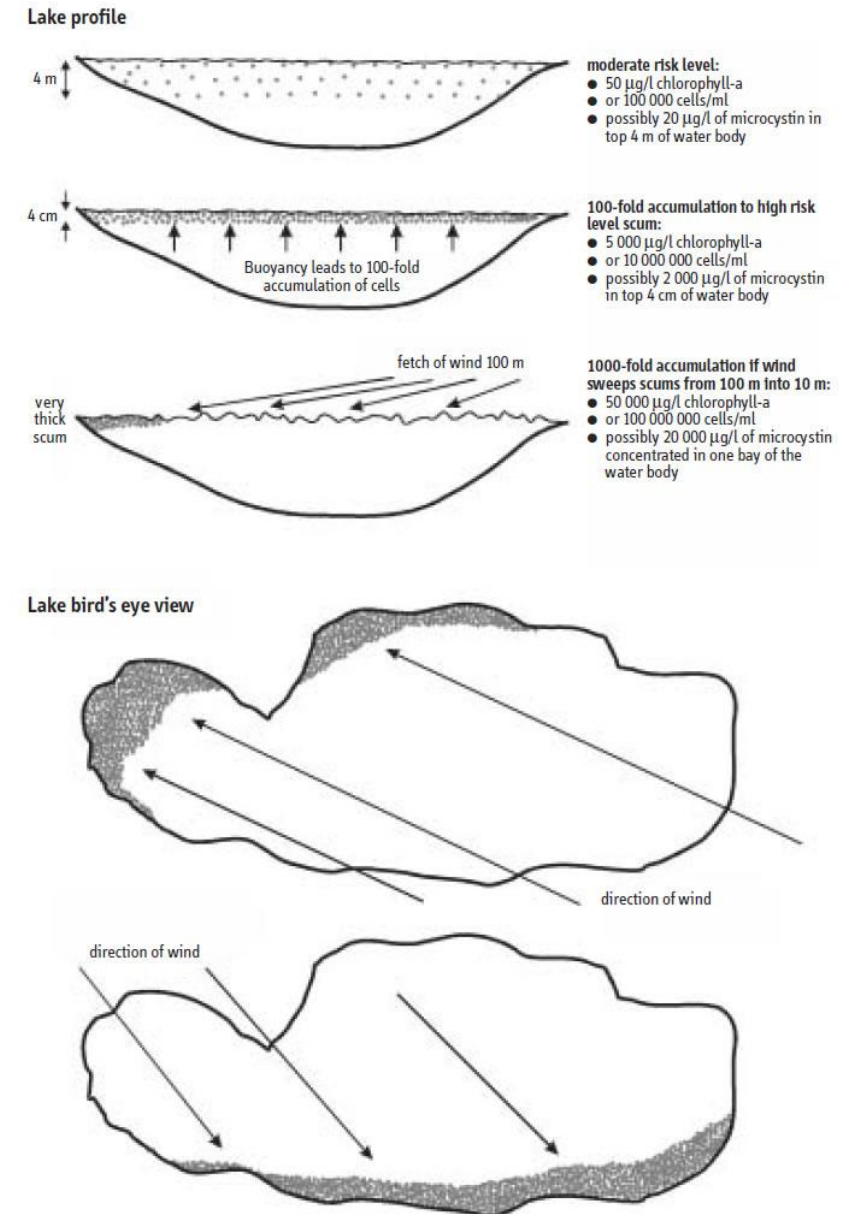
FIGURE 8.1. SCHEMATIC ILLUSTRATION OF SCUM FORMATION CHANGING THE CYANOTOXIN RISK FROM MODERATE TO HIGH (CHORUS & BARTRAM, 1999)

- Typical surface bloom formation – **when cyanobacteria respond to environmental conditions:**

- Weather (temperature, light, wind)
- Availability of nutrients (primarily nitrogen and phosphorus)
- More evidence about cyanobacteria also responding to physical disturbance of sediments and resuspension from boat traffic

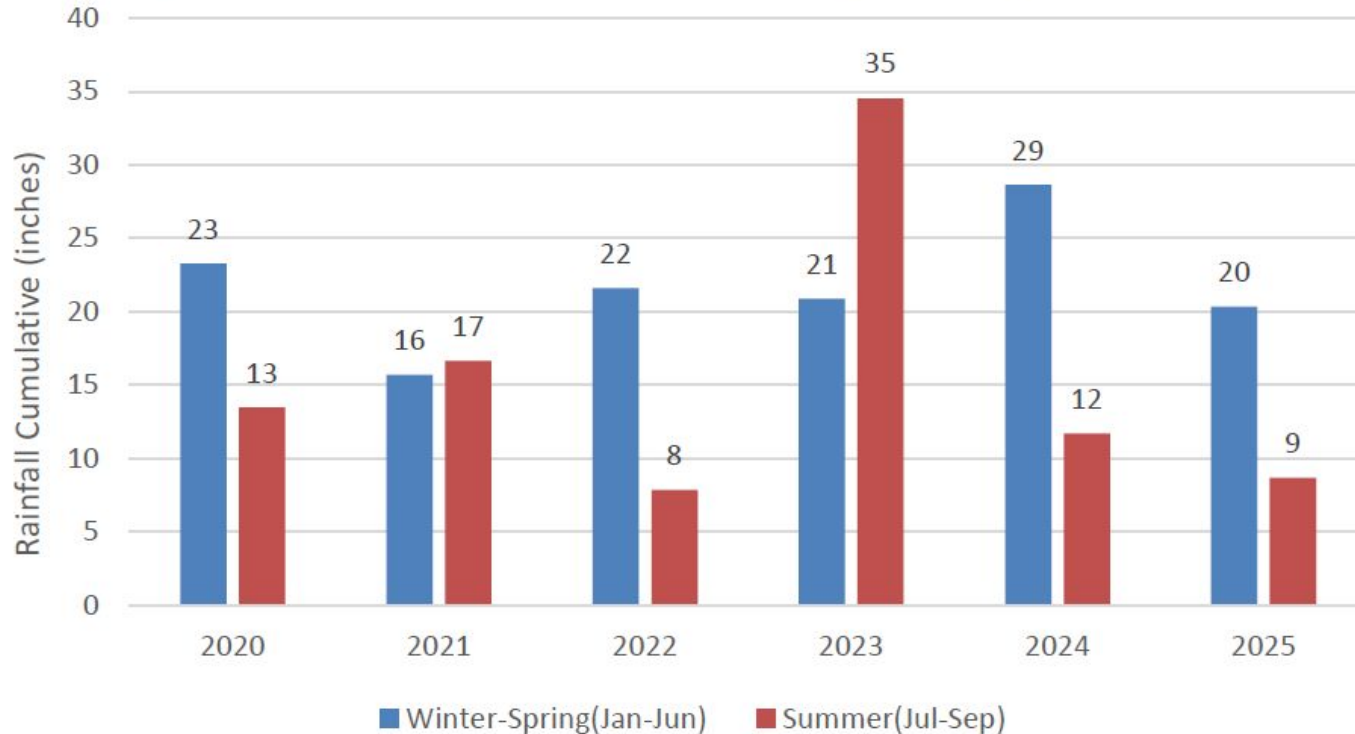
Figure 21. Seasonal Cumulative Rainfall Patterns (RainDrop Application, NOAA/NASA data)

Both 2023 and 2025 had poor lake quality, worse anoxia, and summer cyanobacteria blooms – despite drastically different weather (high vs. low summer rainfall)

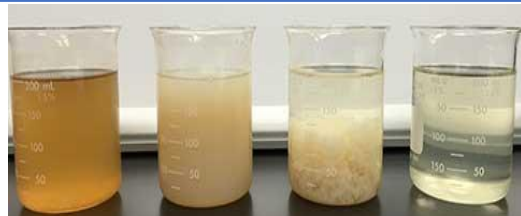
1. Treatment Application

Aluminum Sulfate [$\text{Al}_2(\text{SO}_4)_3$] and Sodium Aluminate [NaAlO_2].

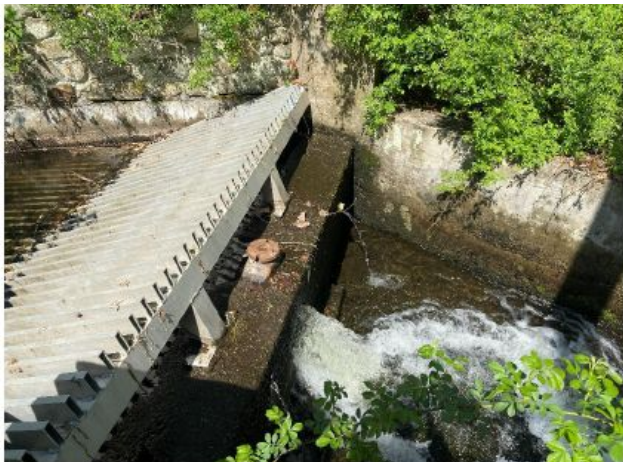
4/29/2024

- Spring to end of October 2025 water level down ~14 inches
- Water level should ideally be about 1-2 inches above the Abele spillway elevation in spring, maintaining that level for as long as possible
 - Only opening in spring in anticipation of heavy rainfall, to prevent flooding
- Formal MOU needed for how to proceed with outlet opening/closing procedures – data-driven

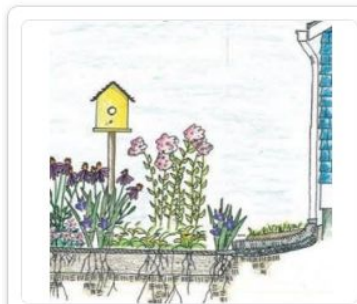
Rain Gardens (Design/Instal...

Description
a sunken, flat-bottomed garden that uses soil and plants to capture, absorb, and clean-up runoff water (from Soak Up the Rain New ...

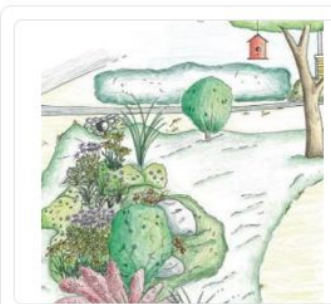
Vegetated Swale

Description
A shallow channel with native vegetation that slows runoff water and directs it to an area where it can soak into the ground (from Soak U...

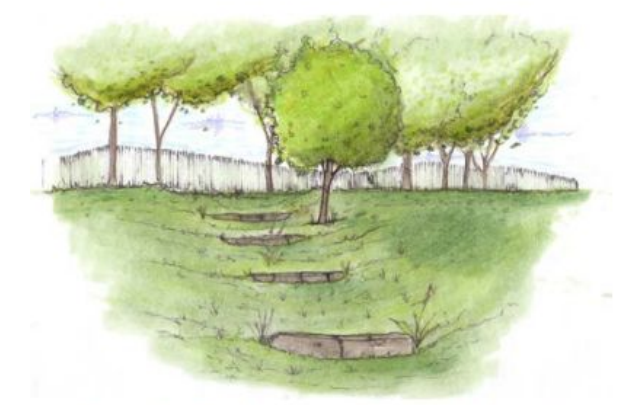
Figure 2. Check dams within a swale slow the flow, allowing sediments to settle out and some infiltration to occur.
